Re: Hurricane Irene Storm Damage

**Re:     *Reconstruction of Bear Tavern Road  
          Bridge Number 214.2 ( 1100-060 )  
          Bear Tavern Road Bridge ( CR579 ) over Jacobs Creek  
          Priority E Repair***

**JACOBS CREEK BRIDGE  
PLAN AND ELEVATION  
SKETCH**

COUNTY BRIDGE #1100-060  
 COUNTY ROUTE 579 OVER JACOBS CREEK  
 HOPEWELL TOWNSHIP, MERCER COUNTY

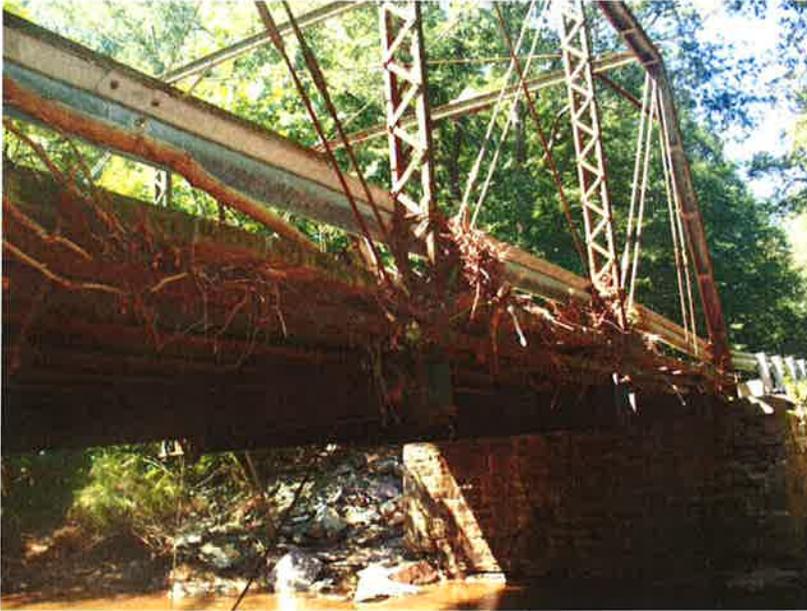
Floodwaters have caused numerous abutment stones to dislodge or loosen directly below all four truss bearing support points. In addition, it was evident that floodwaters overtopped both the bridge and approach roadway, as noted by the large amount of debris lodged in floor support members and on the top of the deck (See Photo 1), pavement failure and a large scour hole which has formed on the southwest quadrant of the bridge. The Bridge southwest wingwall fronting the scour hole has collapsed (See Photo 2).

**Photo 1:** General view showing large amount of flood debris lodged between the lower chord of the truss and the bridge mounted guide rail. Photo taken on the north side of the bridge looking south-west.

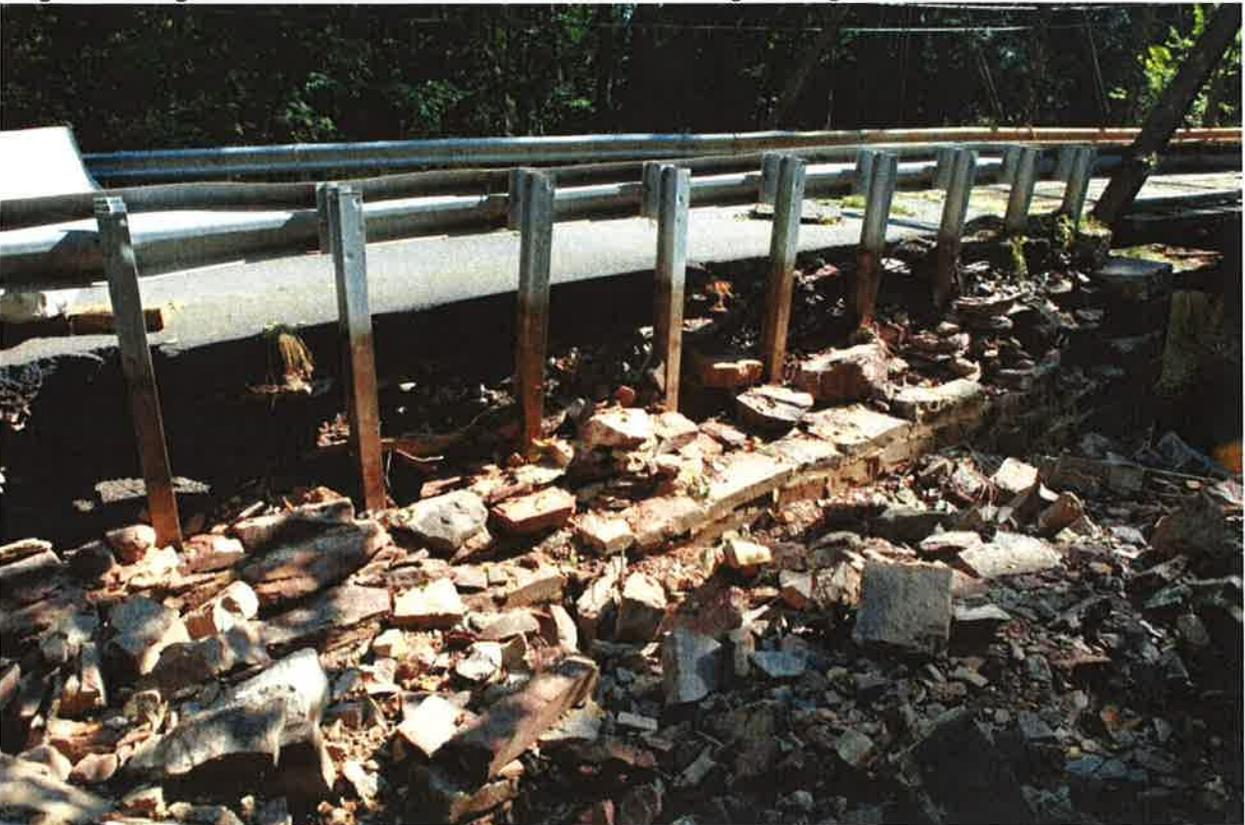
A significant portion of the existing southwest wingwall has collapsed and the existing roadbed has become undermined which likely occurred from the floodwater overtopping the roadway at this location (See Photos 2 and 7). Severe scouring has occurred at the Northeast, Southeast and Southwest embankments, as noted in the before and after photos in Photos 8 through 11.

**Photo 2:** Complete failure of the stone wing wall on the southwest quadrant of the bridge due to large scour hole in front of the wall. Looking Northeast

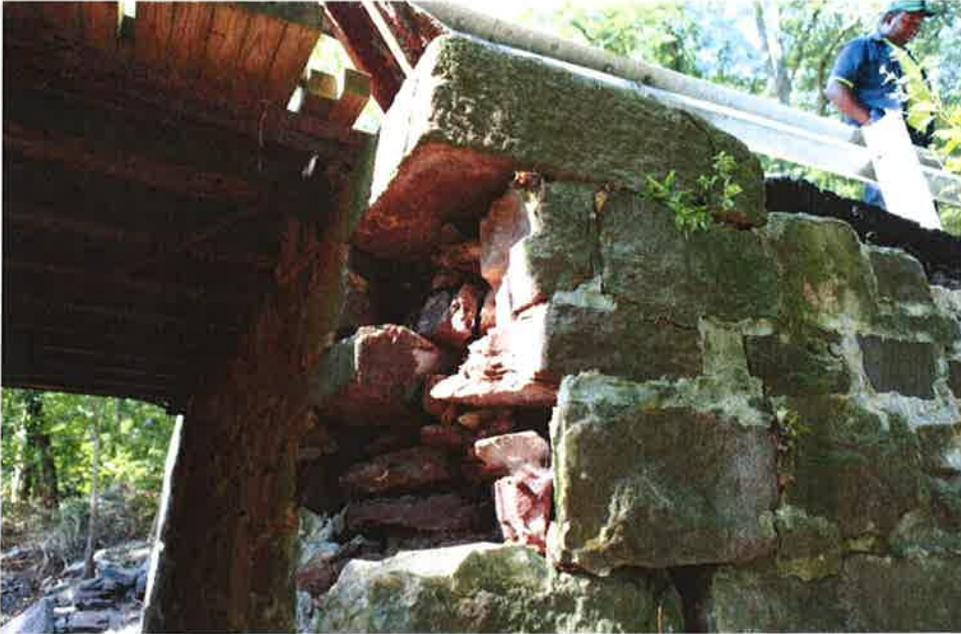
Most of the pointing between abutment stones is missing under the truss bearings (See Photos 3,4,5, 6, 11 and 12). Capstones and supporting foundations below each bearing point show signs of settlement (east side) with voids forming below each support (west side). Significant areas of concern were noted at the northwest corner and east abutment corners which compromise the bridge's structural stability. At the northwest corner, masonry abutment stones have completely dislodged (See Photo 3) creating large voids below the capstone undermining more than 50% of the support area. Only one remaining stone supports the bridge at this bearing point (See Photo 4). Failure of this stone will likely result in a partial or complete collapse of the bridge superstructure. At the eastern abutment, both bearings have settled downwards and rotated (See Photos 5, 6, and 12 ). At the southeast corner, the top of the stone abutment breastwall is bowed slightly outwards (towards the west). Continued or future settlement / bowing of this abutment will result in complete failure of the easterly abutment and subsequent collapse of the bridge.

**Photo 3:** Area of significant concern at the northwest corner of the structure. A large void has developed below the capstone undermining more than 50% of the support area.

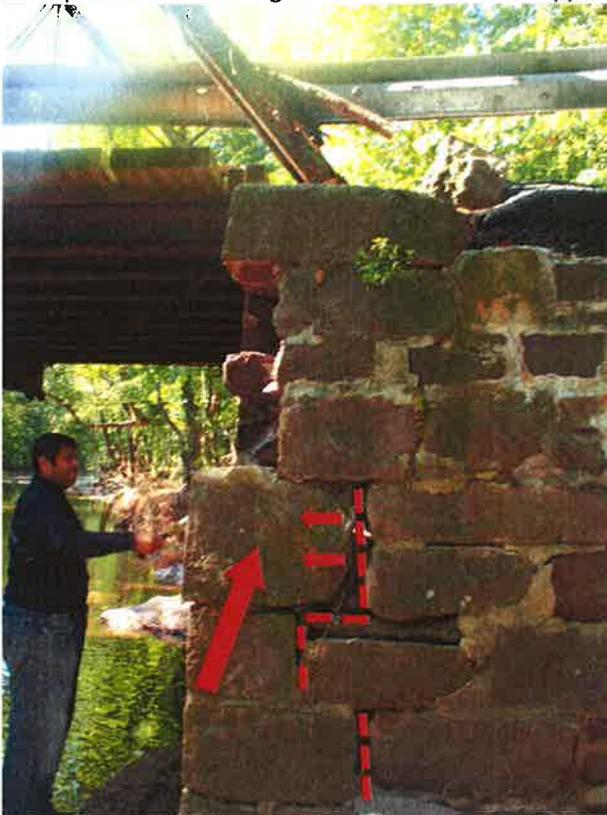
**Photo 4:** Note if one large stone becomes dislodged then a collapse or partial collapse of the superstructure is likely. Looking Southwest

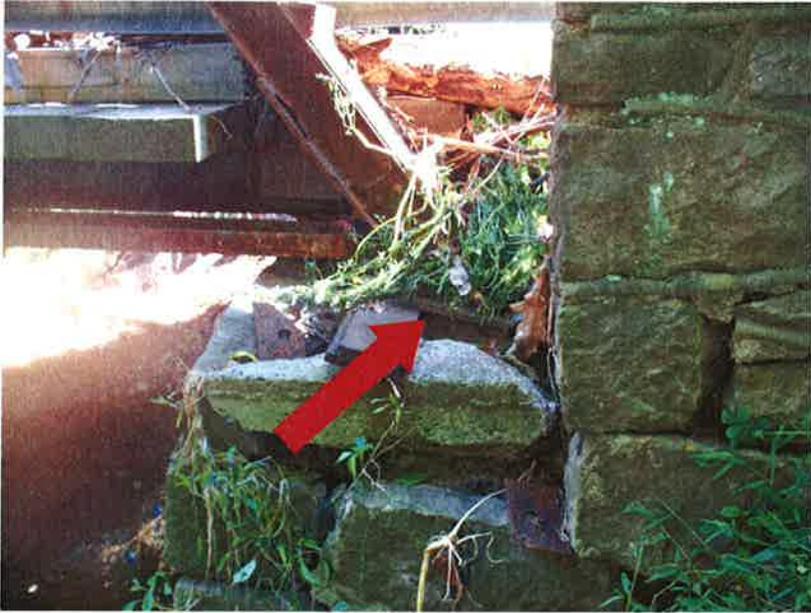
**Photo 5:** Southeast truss bearing exhibits settlement and rotation due to movements of the substructure. Note the loose supporting stone and lack of mortar between stones directly below the bearing. Looking north

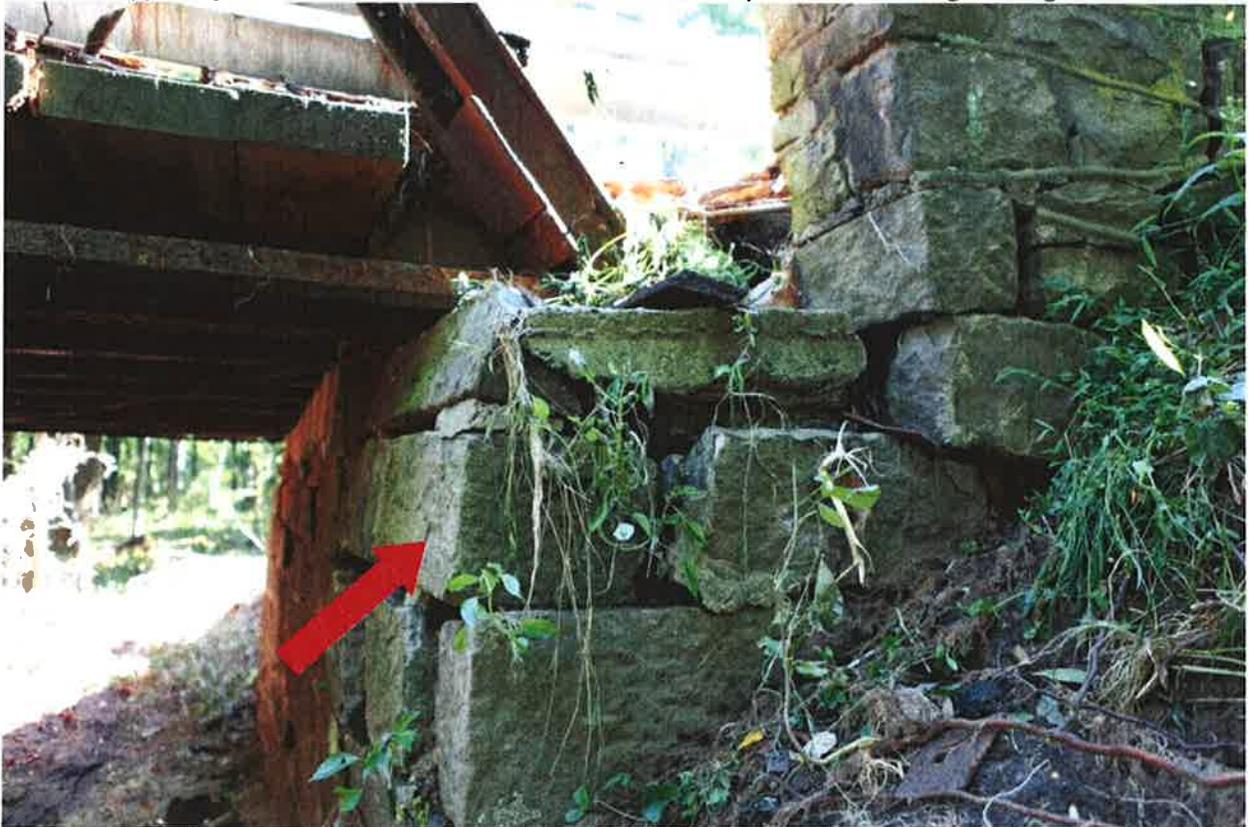
**Photo 6:** Loose bowed stone below the Southeast truss bearing. Looking south

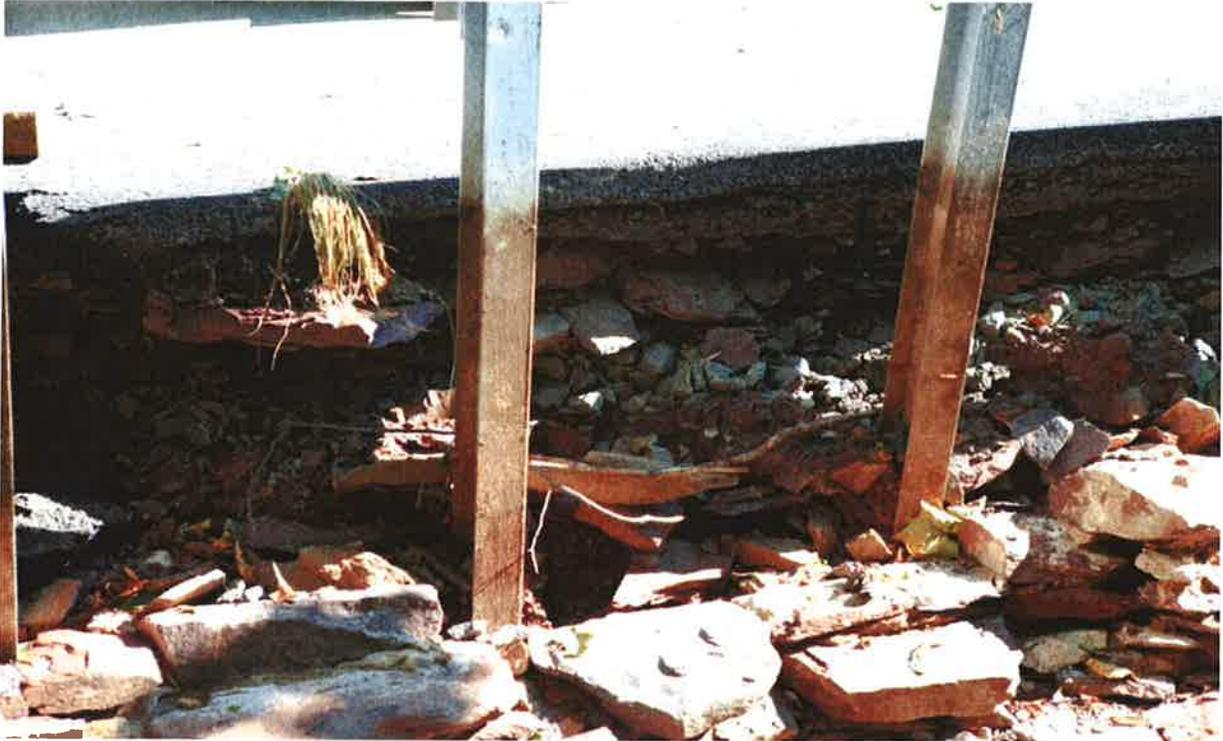
**Photo 7:** Undermining of the west approach roadway on the south side due to overtopping floodwaters. Looking North

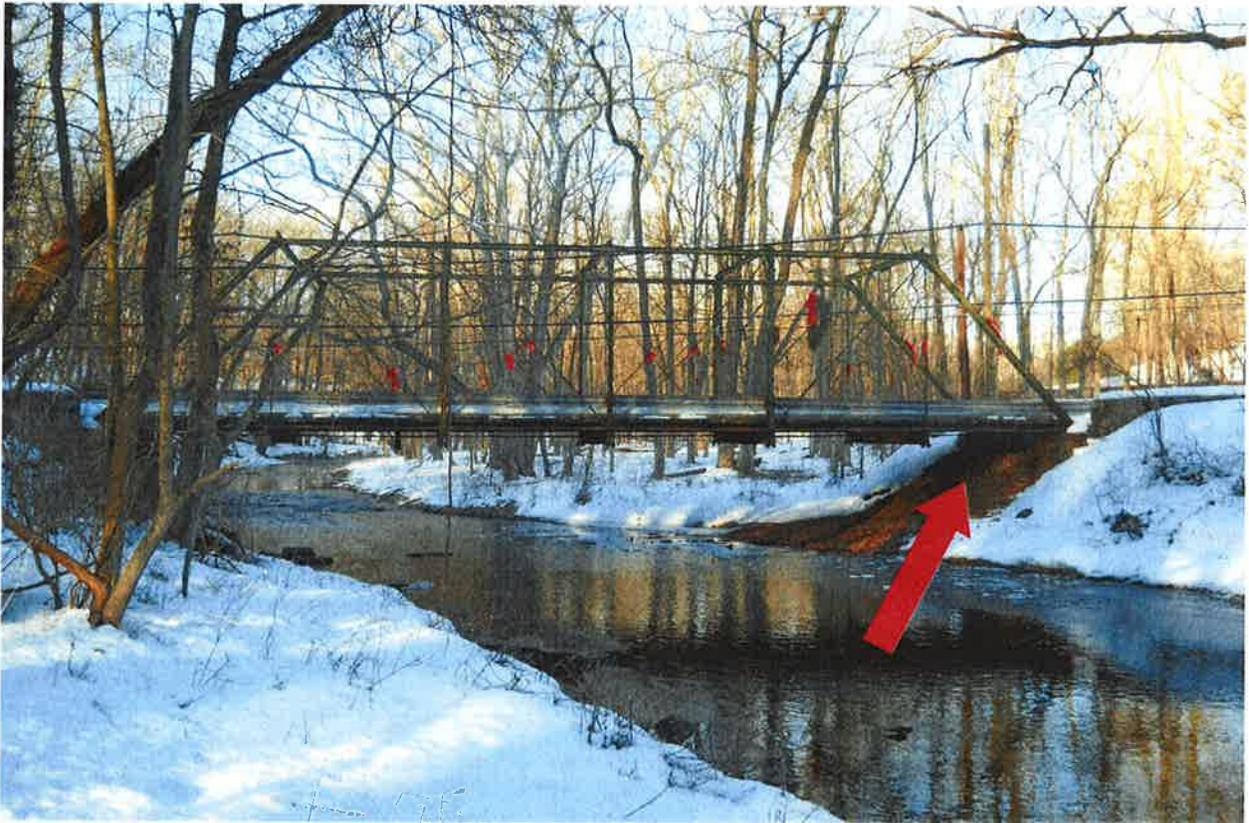
**Photo 8:** South Elevation of the bridge taken in February 2011. Note the location of the easterly riverbank. Looking North.

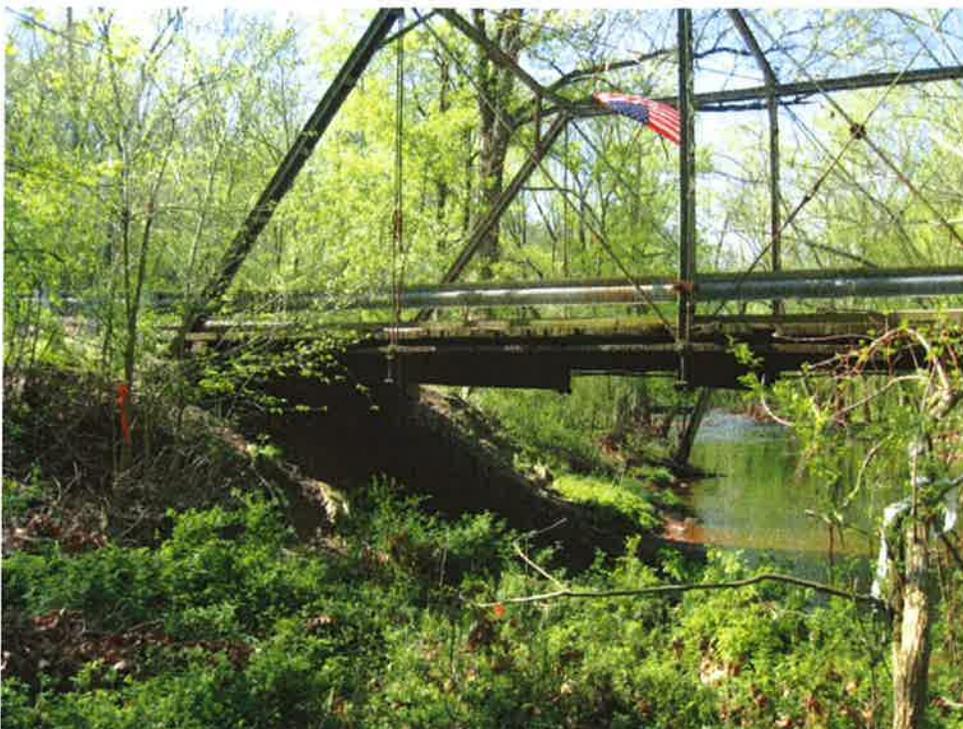
**Photo 9:** Location of embankment in front of the easterly abutment looking east. Photo taken on 4-27-11.

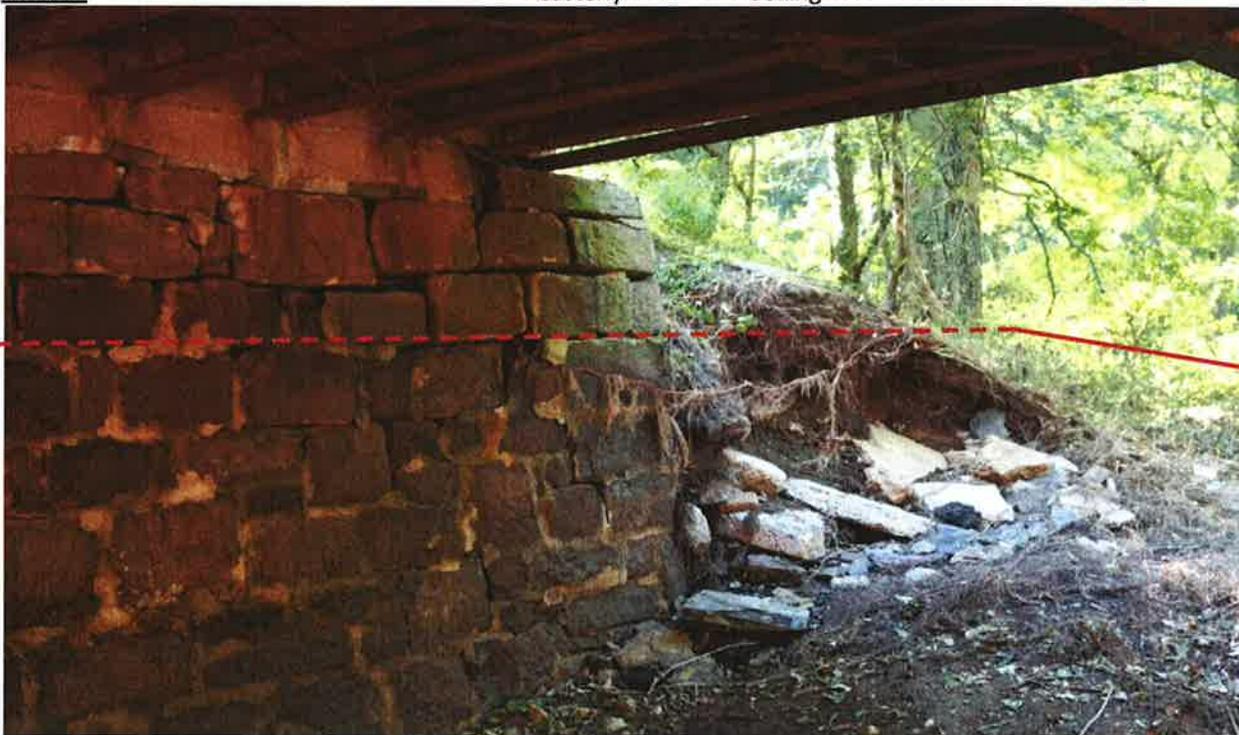
Previous  
Grade Line

**Photo 10:** Location of embankment in front of the easterly abutment. Note the significant erosion in front of the stone abutment wall as compared with photo 9 and large scour hole on the southeast corner. Photo is looking southeast.

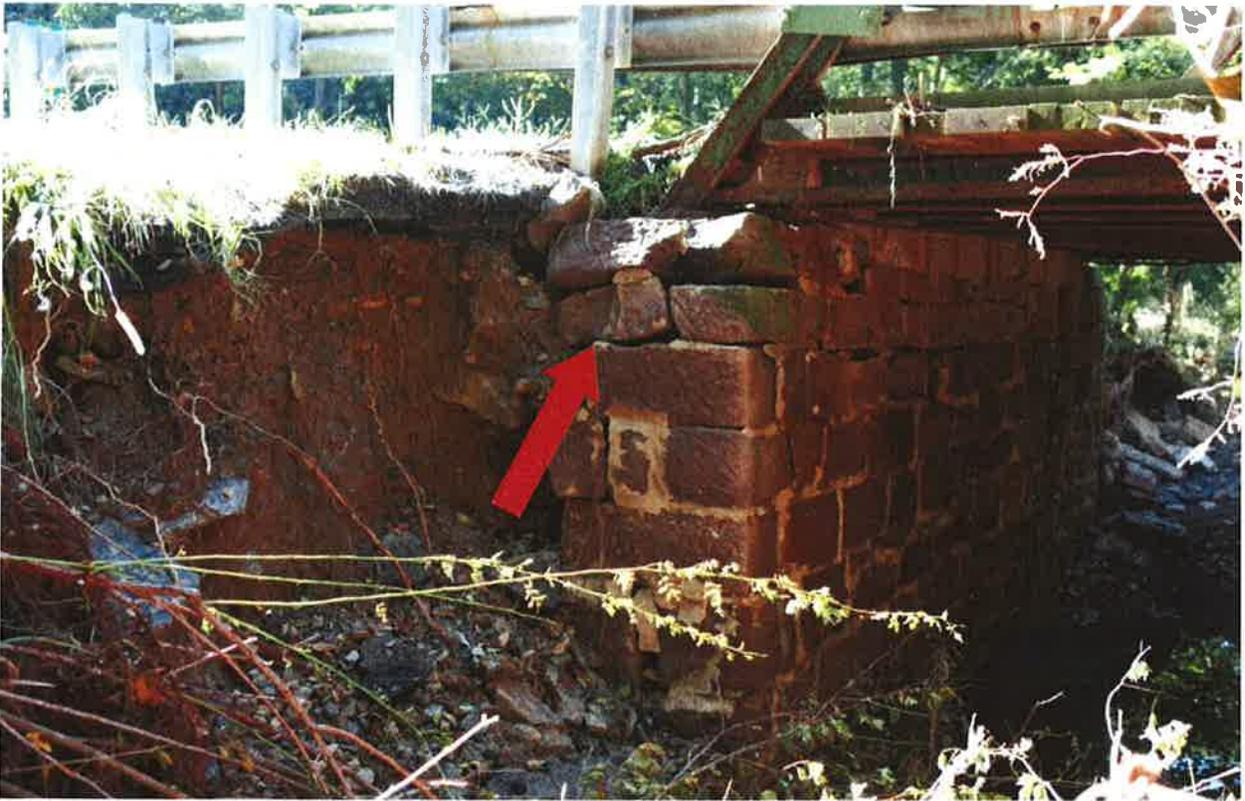
**Photo 11:** Large scour hole on the northeast corner of the bridge. Also note loose un-pointed stones below the truss bearing. Photo is looking southeast.

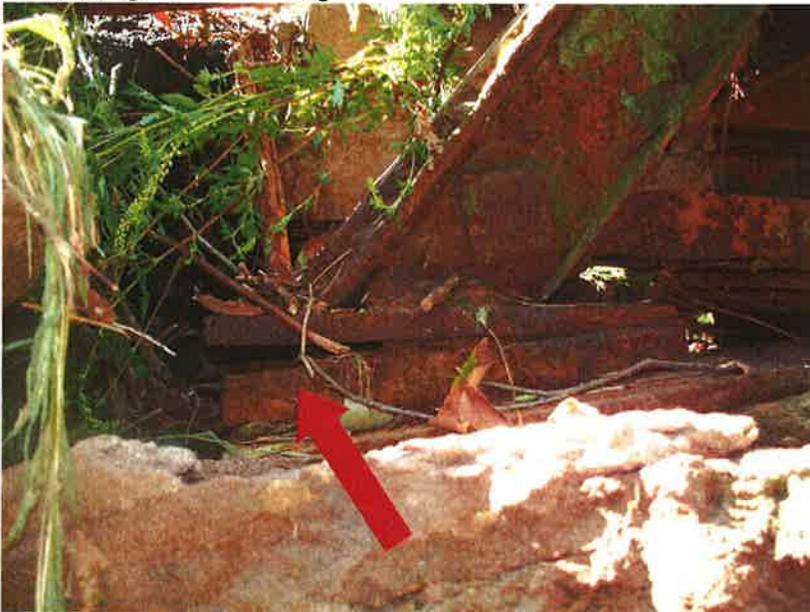
**Photo 12:** Rotated bearing and settled/bowed abutment.

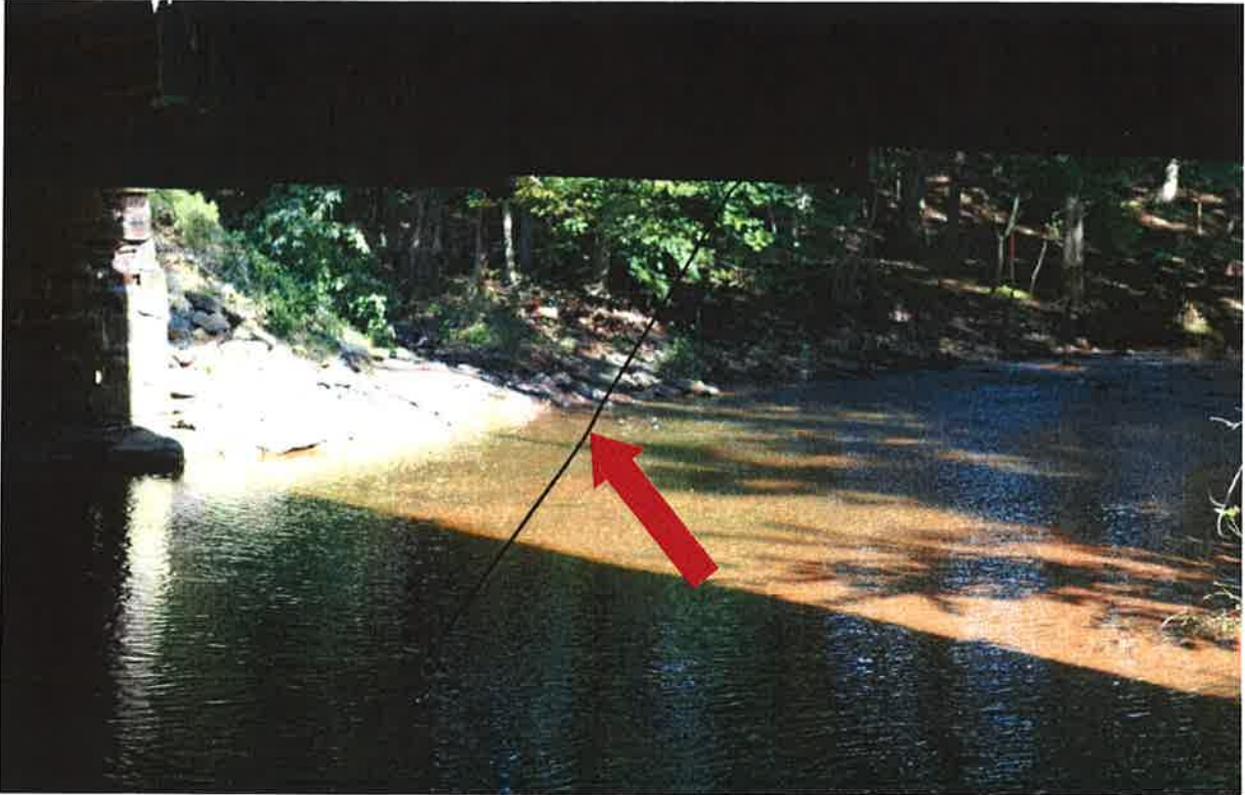
In addition, a few lateral bracing members have become severed below deck and are hanging downwards into the riverbed (See Photo 13) which will reduce the structural stability of the superstructure.

**Photo 13:** Loose underdeck lateral bracing members hanging down off the superstructure. Looking North
