# HOPEWELL TOWNSHIP MUNICIPAL BUILDING EVALUATION REPORT

APRIL 24, 2009

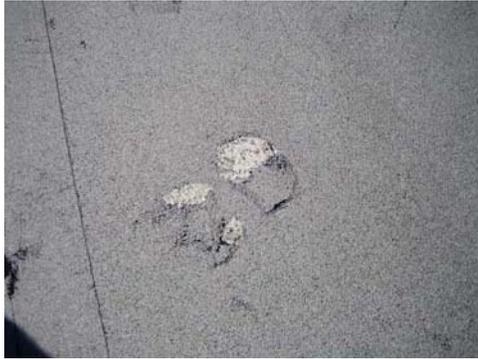
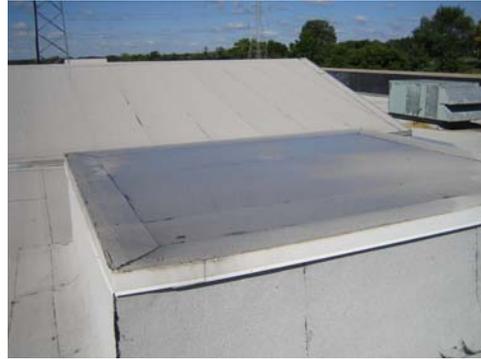
### *Observation 1 & 2*

The roof is estimated to have been replaced in 2000. Although the roofing manufacturer is unknown, it is thought to be a Siplast roof, and there are several areas in need of repair. There are what appears to be footprints that were made when the roofing was installed that have compromised the roofing membrane. The roof edges were not reinforced and this has led to some cracking at horizontal to vertical intersections. Ponding is occurring in a few locations on the roof due to minimal slope, the worst of which occurs above the elevator shaft where there appears to be no slope.

Due to the relative age of the roof, we recommend contacting the manufacturer and installer of the existing roof, to make any necessary roof repairs under the current warranty.

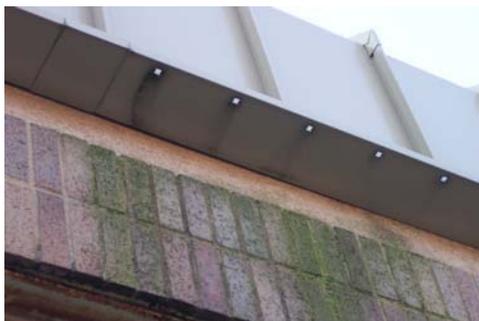
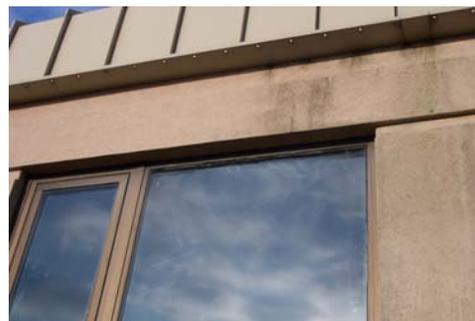
### *Observation 3*

The existing mansard roof has no gutters or down spouts. Currently the water travels down the sloped roof continuing onto the vertical panels to a series of drip holes. These holes force the water to drain into a recess in the EIFS façade. This allows the water to be collected in the recess possibly getting behind the façade and inside the wall. This has also resulted in staining of the exterior façade. Water also puddles on the sidewalk causing icing and erosion of landscaping beds.

We recommend three different options to resolve the issues with the mansard roof.

- A. The first option is to modify the roof design so that a metal gutter can be affixed to the existing metal panels. This would entail cutting the panels at the transition between sloped and vertical roof, attaching a metal gutter, adding downspouts onto the façade, and extending underground to the existing storm drainage system.
- B. The second option is to remove the mansard roof in its entirety and install a new metal coping sloped back to the flat roof so that the water will all be collected on the flat roof and thereby drain using the existing roof drains.
- C. The third option is to leave the mansard roof as is and provide a larger gutter at the base of the existing vertical transition to receive most of the run off; add downspouts onto the façade, and extending underground to the existing storm drainage system.

If options A or C are selected, portions of the existing site would require modifications to accommodate new underground drainage piping that connects to the existing line under the parking lot. This work would entail removing portions of the sidewalk and parking lot, excavating to the storm line, and patching all modified areas.

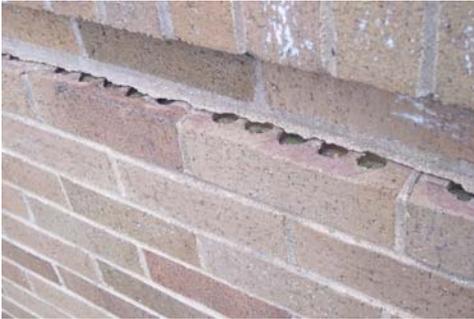
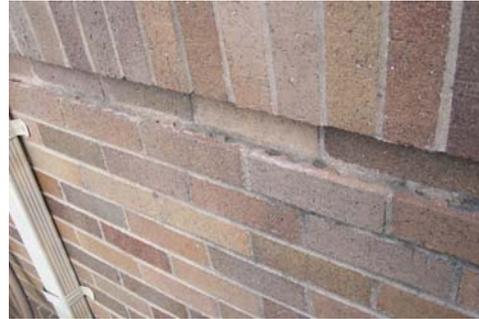
### *Observation 1*

In examining the masonry, there are several areas of concerns. The first of which is in recessed brick reveal areas where open core bricks were used and are therefore exposed to the weather. Solid brick should have been originally used in these areas. Although in some areas attempts were made to mortar fill the cores, in many cases the cores were never filled completely solid allowing the water to migrate into the walls.

To correct the issue whereby the brick reveal exposes the cores of the brick to the weather, we recommend the following: *Option A should be combined with either options B or C.*

- A. At the top of the brick wall install a metal cap
- B. We recommend a cement wash to seal the cores.
- C. We recommend a new brick band, possibly of an accent color, be installed flush with the existing brick face to eliminate the lip that could allow water infiltration.

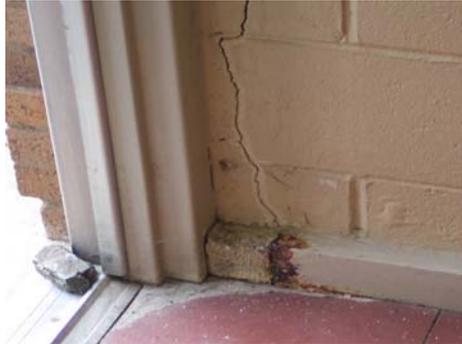
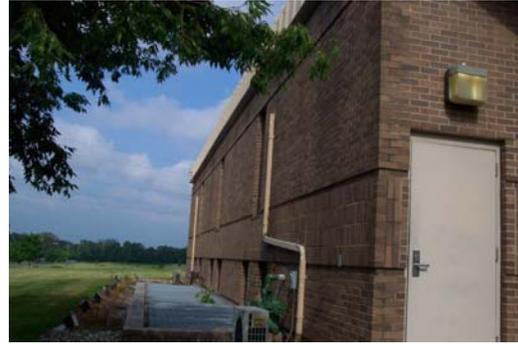
### *Observation 3*

Additionally, our observations revealed that there are no control joints in the masonry walls. The lack of control joints in masonry walls contributes to unwanted cracks.

We recommend cutting in control joints in the exterior brick veneer, 16 inches from every corner, and every 25 feet on the longer walls. This will allow the wall to expand and contract properly and should reduce future cracking in the masonry walls. In addition we also recommend cutting in control joints on the interior masonry walls where cracks are forming. We would also recommend repointing the brick work that has developed cracks.

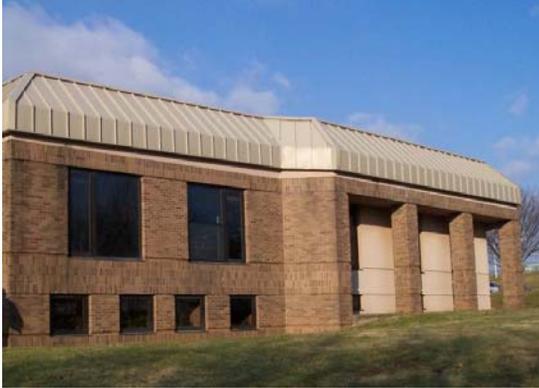
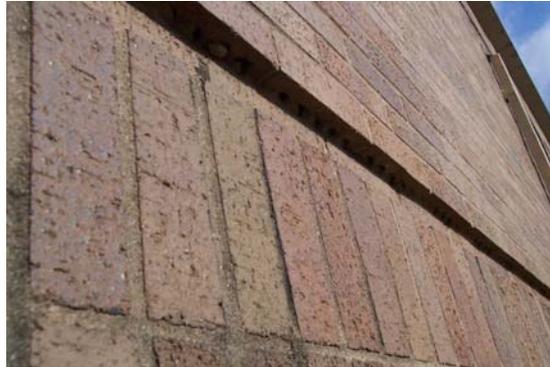
### *Observation 5*

The existing brick veneer construction contains a number of unconventional details that are outlined in the previous observations. The number of repairs required to address these concerns are extensive.

We recommend replacing the brick veneer system in its entirety with new brick, galvanized steel lintels, thru-wall flashing, weeps and appropriate details.

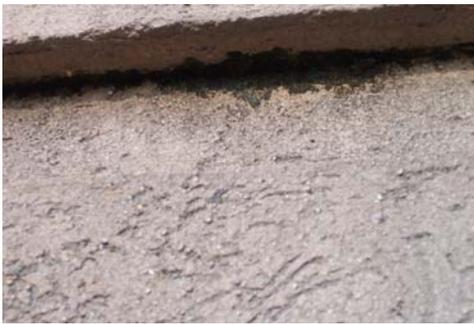
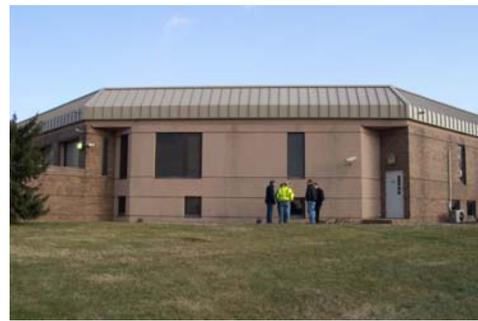
### *Observation 1*

The existing EIFS on the building is original to the 1986 addition. Therefore, its 23 years old age has reached it's life expectancy. The included infrared report prepared by Jersey Infrared indicates that large portions of the façade are suspected of having water damage. Currently a portion of the perimeter has been sealed with expandable foam where the EIFS adjoins the walkway. This product tends to absorb water and retain moisture behind the EIFS.

The EIFS façade has exceeded its expected service life of 20 years. As illustrated, there are numerous deficiencies which without repair will lead to further deterioration. This deterioration could lead to increased water infiltration and therefore possible indoor air quality issues. As shown on the attached report from Jersey Infrared, the existing EIFS is expected to be saturated. Our recommendation is to completely replace the existing EIFS with a new drainable EIFS system or an alternate exterior siding material such as fiber-cement board siding, metal wall panels or thin-brick.

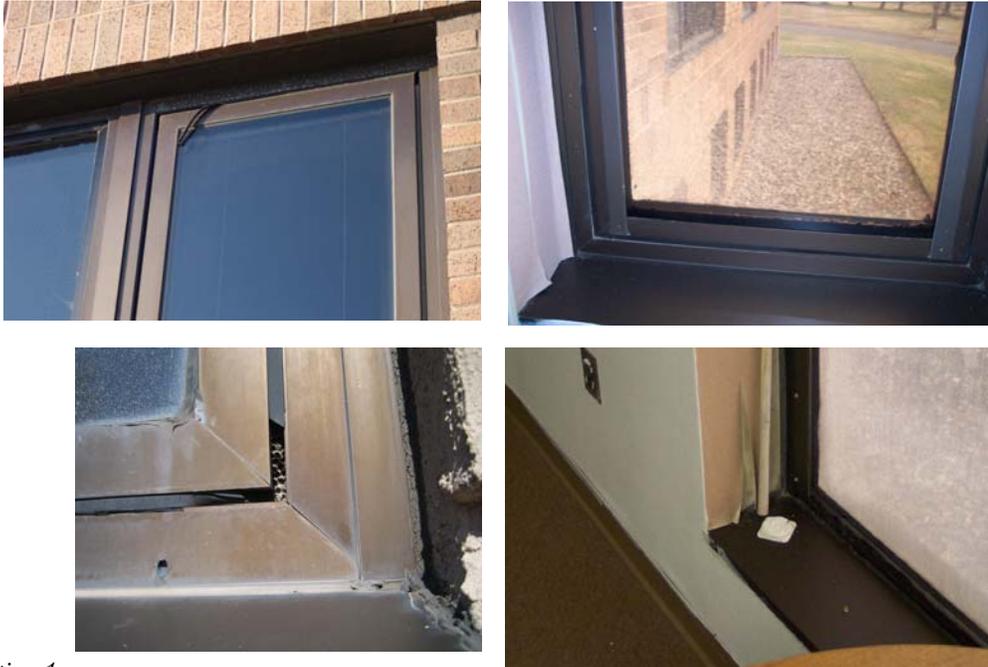
### *Observation 1*

The seals around most of the existing windows are completely worn out and damaged. In many instances gaps occur around the windows that are large enough to allow visible light, thus allowing air and moisture to enter and exit the building. The existing window frames are not thermally broken. This allows for a transfer of temperature through the frame and is another avenue for moisture to potentially enter the building. Our observations included peeling wallpaper adjacent to the windows. The majority of the operable windows have been damaged over the years and are no longer operable. This was evident at several window locations throughout the building. The bullet-proof glass on the south facing wall, particularly in the Judge's Chambers is delaminating and no longer allows visibility through the glass. It is evident that the thicker bullet-proof glass was not originally intended to be installed in the frames and required additional metal trim attached to the inside face to accommodate the additional glass thickness.

Our recommendation is the complete replacement of all windows in their entirety. The windows are over 20 years old, are inoperable and the single-pane glass makes them very inefficient. Windows should be replaced with thermally broken aluminum windows with dual low-e glazing and integral window blinds. Installations would include complete new perimeter caulking for weather tightness. Bullet-proof glazing can also be integrated in areas that require additional protection.

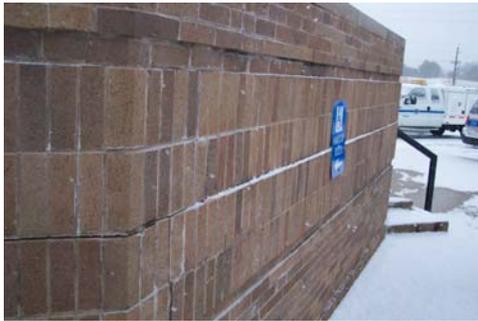
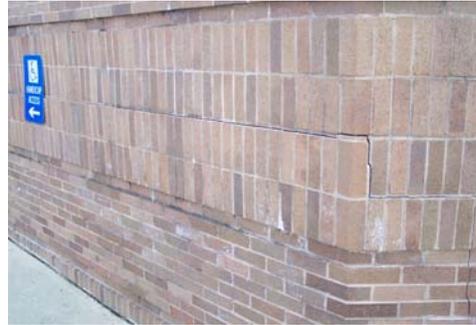
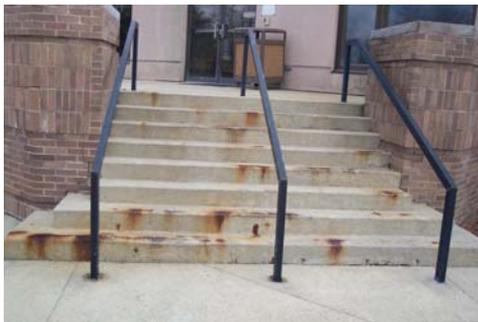
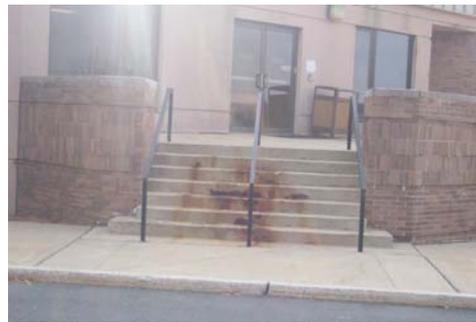
### *Observation 2*

Rust stains on the steps leading to the municipal building and the police station were evident. The rust is a result of the steel reinforcement within the concrete steps which was either originally installed too close to the concrete surface or the steps have been continuously over salted thereby gradually eroding the concrete surface. Additionally, the center brick pier at the police station entrance is cracking and beginning to shift.

It is our recommendation that the center brick pier and all low brick walls be removed and reconstructed in their entirety at the police entrance. The police station entrance presently does not have ADA accessibility so the construction of a new handicap accessible ramp should be coordinated within the design (refer to General Observation No. 4). All concrete steps should also be replaced in their entirety. The rust stains on the municipal entrance steps are minimal and we therefore do not recommend the replacement of these steps at this time. This issue should be revisited if this condition worsens.

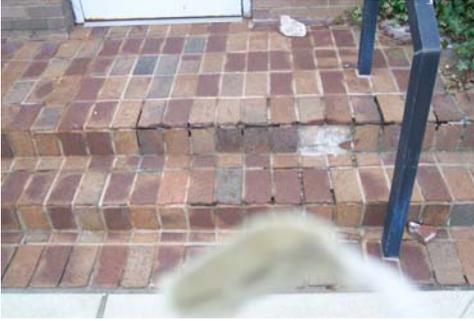
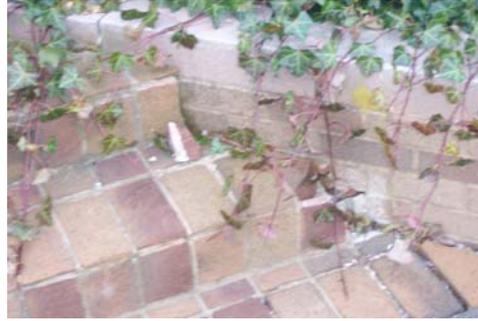
### *Observation 3*

The thin brick pavers set on concrete steps at various entrance locations have begun to crack.

Areas with damaged brick pavers should be replaced with concrete.

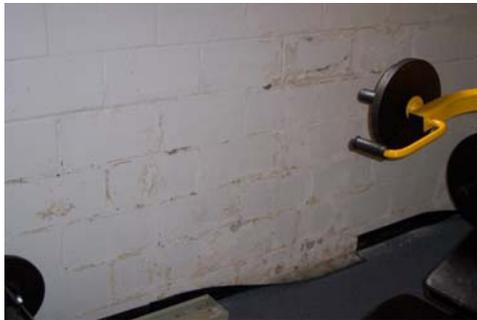
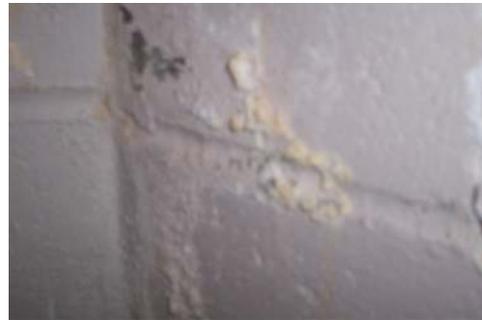
### *Observation 4*

Water damage is evident in the masonry walls of the fitness room. Paint is peeling and an unidentified substance is present on the interior wall surface. The majority of the damage is present at or below the window level, which coincides with the exterior grade level. The original construction drawings indicate the design to include waterproofing to be installed between the EIFS layer and masonry wall from 16 inches above grade to the foundation footing. It is possible that this waterproofing has been compromised, was not installed correctly, or possibly is not present. Additional selected demolition and investigation outside this scope of work may be required to assess the cause of the water infiltration.

Additional selected demolition and investigation outside this scope of work is recommended to assess the cause of the water infiltration within the fitness room.

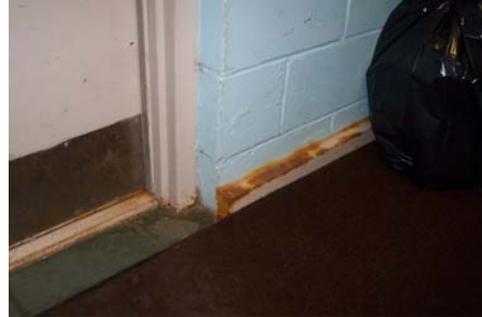
### *Observation 1*

There is evidence of rust and corrosion on the interior stair steel stringers in the front stairwell. This appears to be caused by a mixture of storing salt in the stairwell, over salting the steps outside of the doorway, and water getting under to door and into the stairwell.

It is recommended that the existing exterior hollow metal door and frame to the front stairwell be replaced with a FRP door and aluminum frame with proper weather seals and hardware. The FRP door and aluminum frame are less susceptible to damage from water and salt and is therefore recommended for exterior applications. Additionally, the steel stair stringers in the entire stairwell should be sanded, prepped, treated, and repainted.

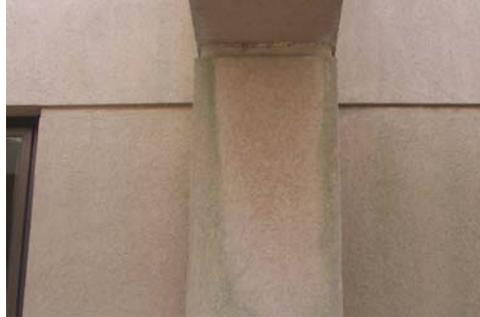
### *Observation 2*

The existing open light wells at the front entrance are provided with screens only and therefore allow rainwater to enter the covered roof area as well as discoloration of the EIFS on the pilasters between the windows.

We recommend the installation of enclosed skylights to provide a weather tight situation under the covered roof. This will maintain the natural light into the adjacent office spaces.

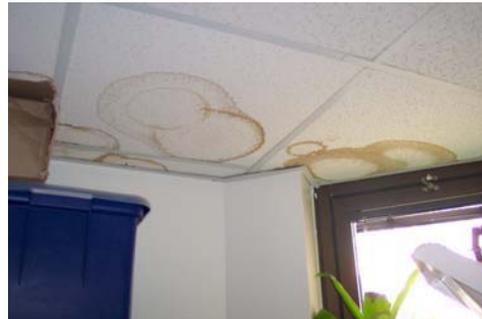
### *Observation 3*

During our observations, we were advised by the on-site maintenance staff that there had been a previous problem with mold in the lower level of the building in the Health Care Suite. The maintenance staff suggested that the problem was related to condensation from overhead pipes and that indications of water damage would appear after heavy rain storms. We were also advised that the ceiling tiles in this area have been replaced several times a year because of the water damage and that the finishes on some ceiling diffusers have been compromised.

Further investigation is required to fully ascertain the cause of the aforementioned issues. We recommend that additional surveying and testing be performed by a plumbing/mechanical professional engineer.

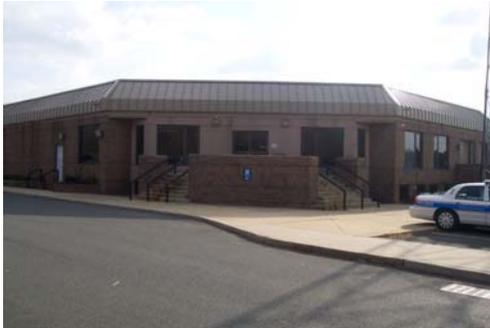
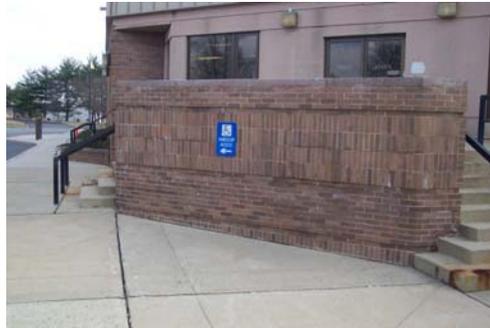
### *Observation 4*

The police station entrance presently does not have ADA accessibility.

It is recommended that a new handicap accessible ramp be constructed at the police station entrance. This recommendation is made in concert with replacement of the existing entrance steps and low brick walls (refer to Site Evaluation Observation No. 2).

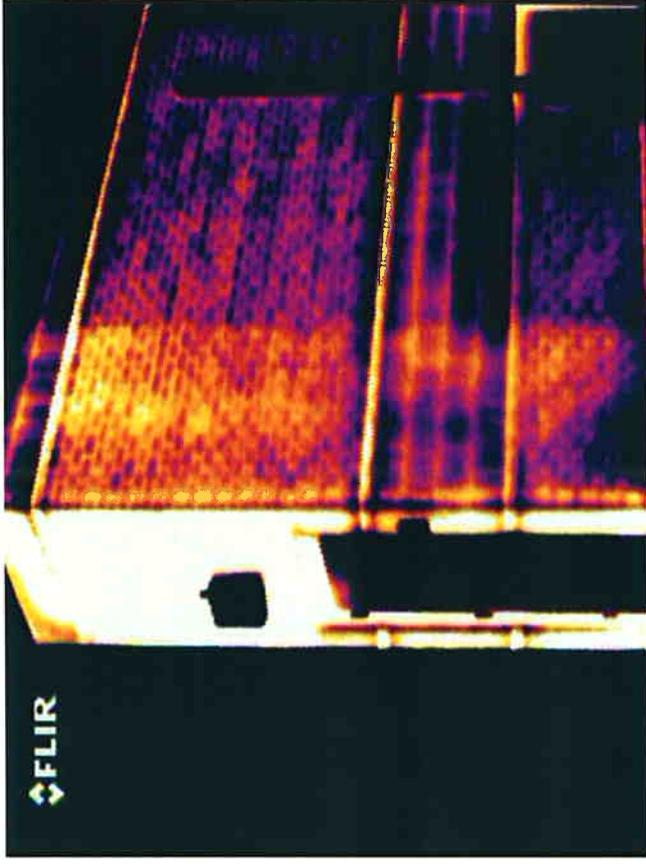
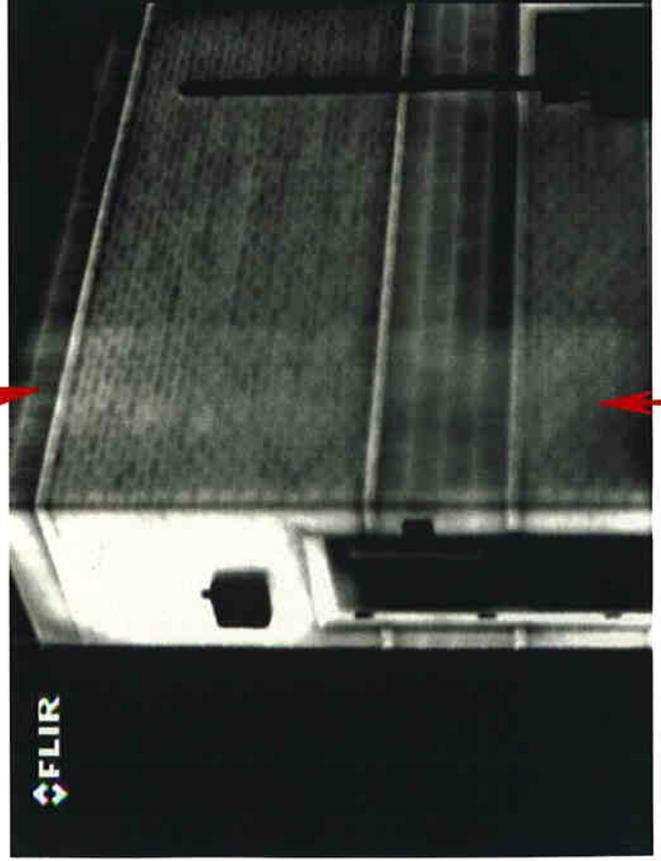
Comments Thermogram shows thermal pattern typical of latent moisture within brick facade.

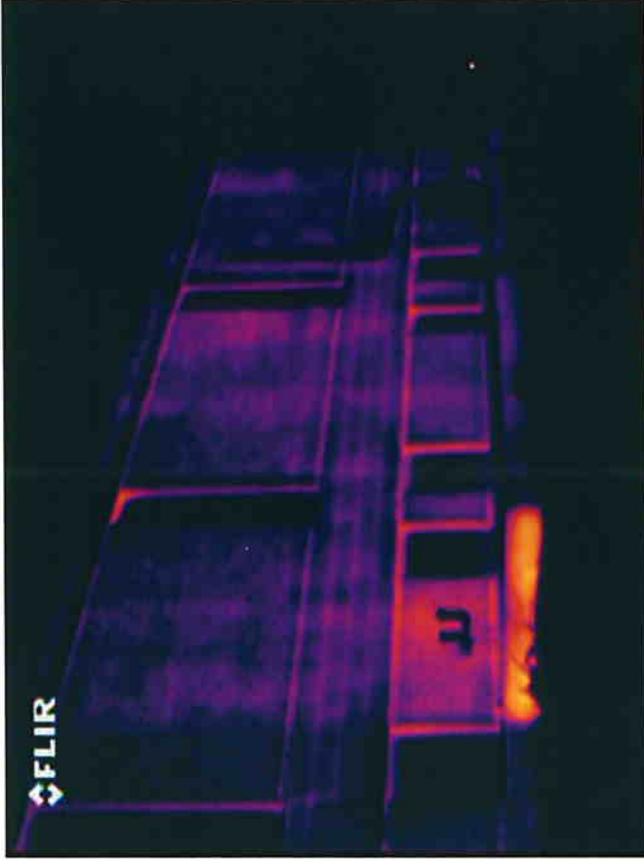
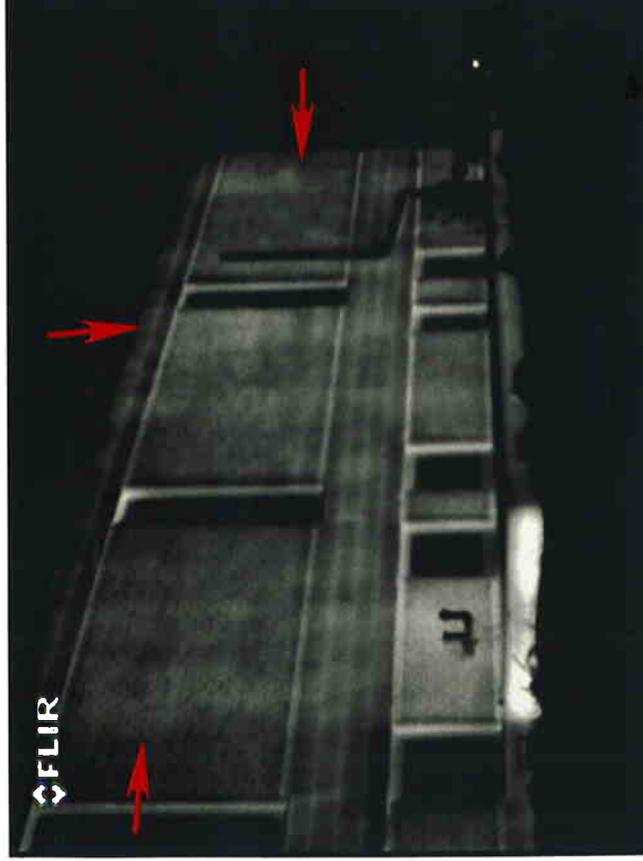
Area/Picture No. 2 Job No. 09-2617.1 Date 3/30/09

Comments Thermogram shows thermal pattern typical of latent moisture within brick facade.

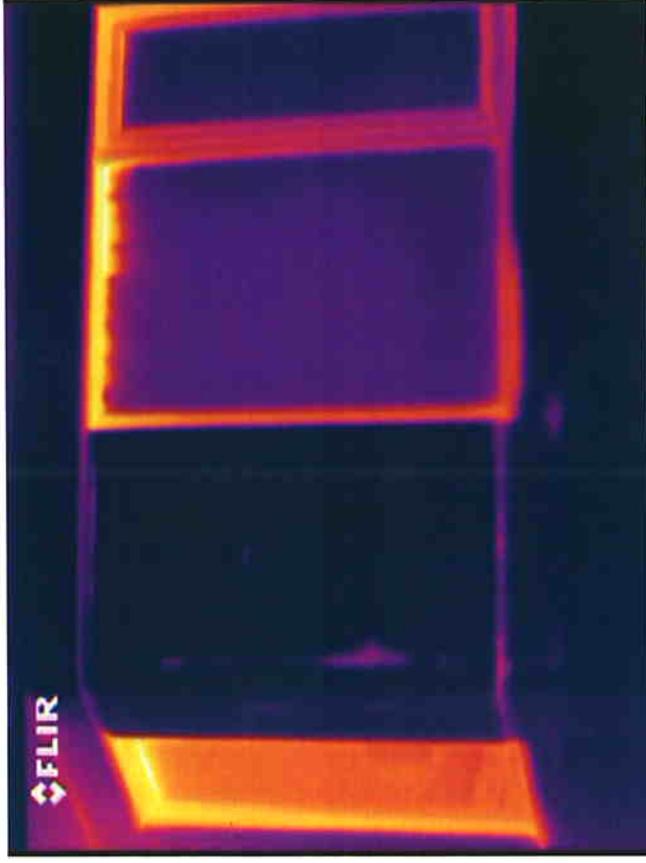
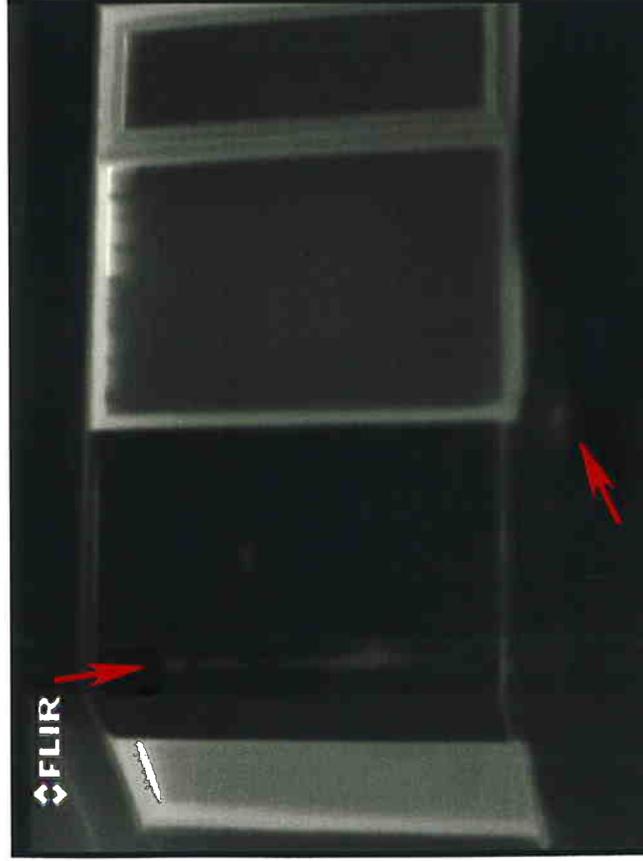
Area/Picture No. 3 Job No. 09-2617.1 Date 3/30/09

Comments Thermogram shows thermal pattern typical of latent moisture.

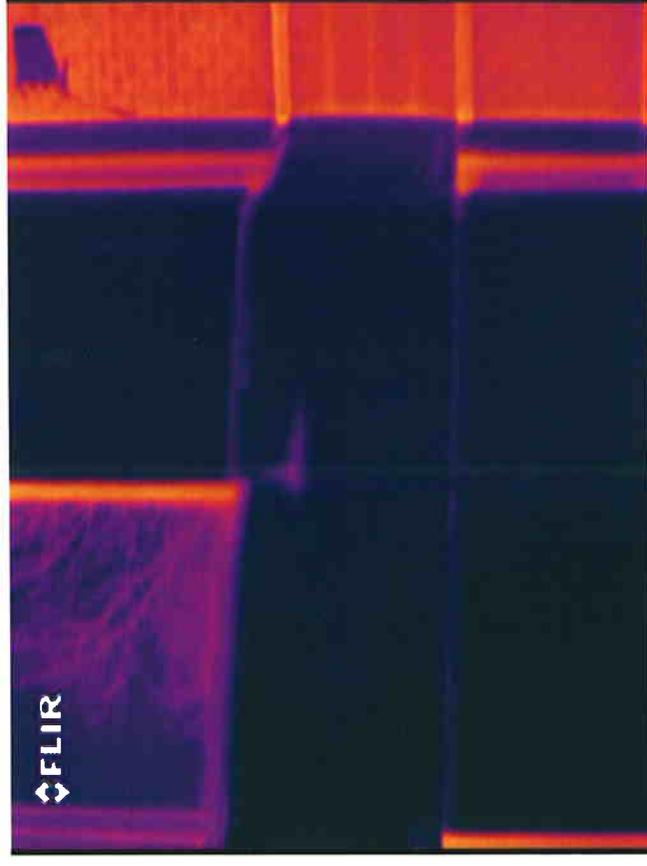
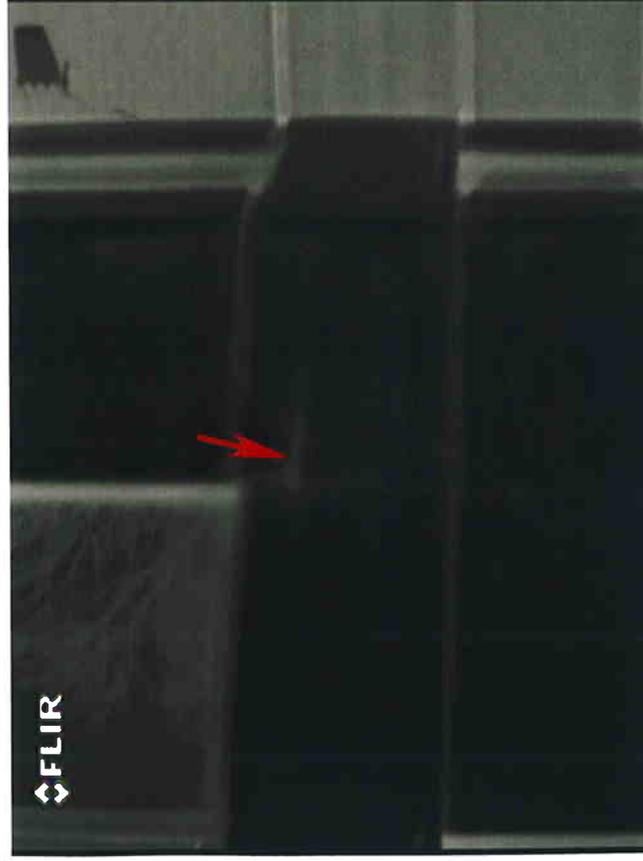
Area/Picture No. 4 Job No. 09-2617.1 Date 3/30/09

Comments Thermogram shows thermal pattern typical of latent moisture.

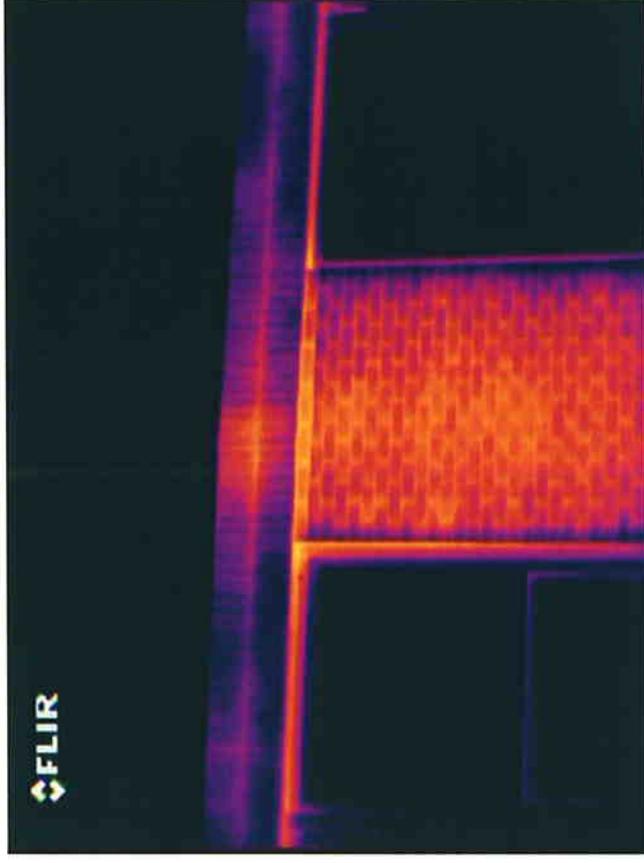
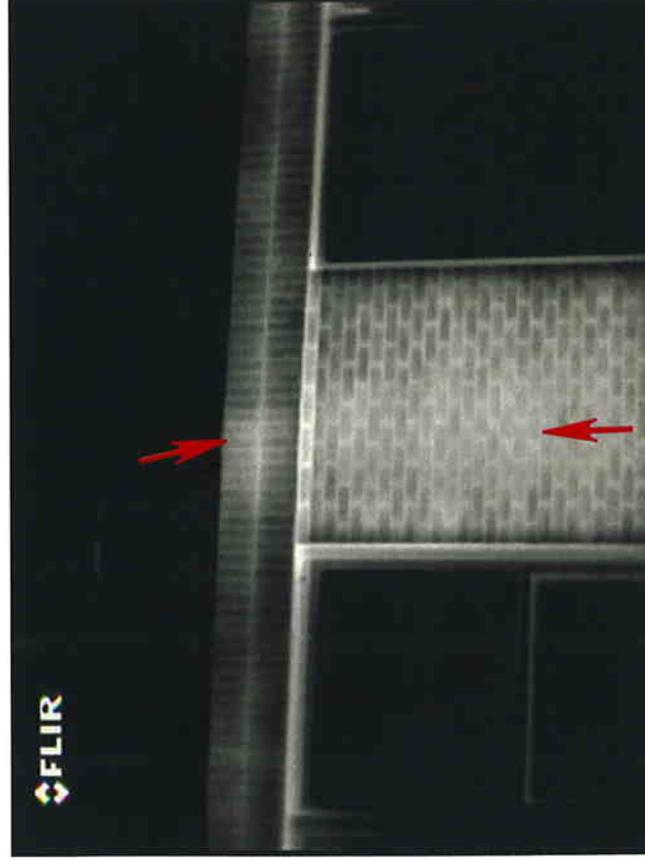
Area/Picture No. 5 Job No. 09-2617.1 Date 3/30/09

Comments Thermogram shows thermal pattern typical of latent moisture within brick facade.

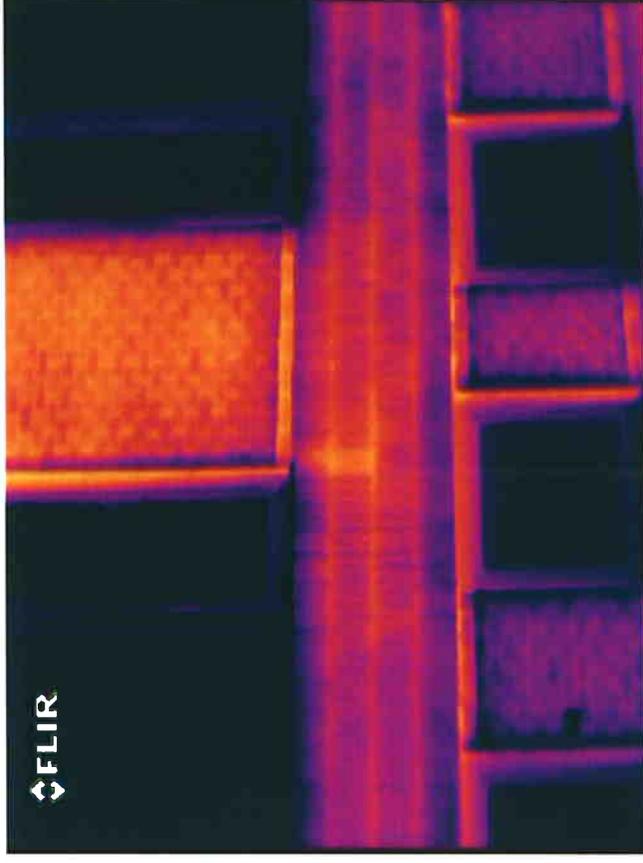
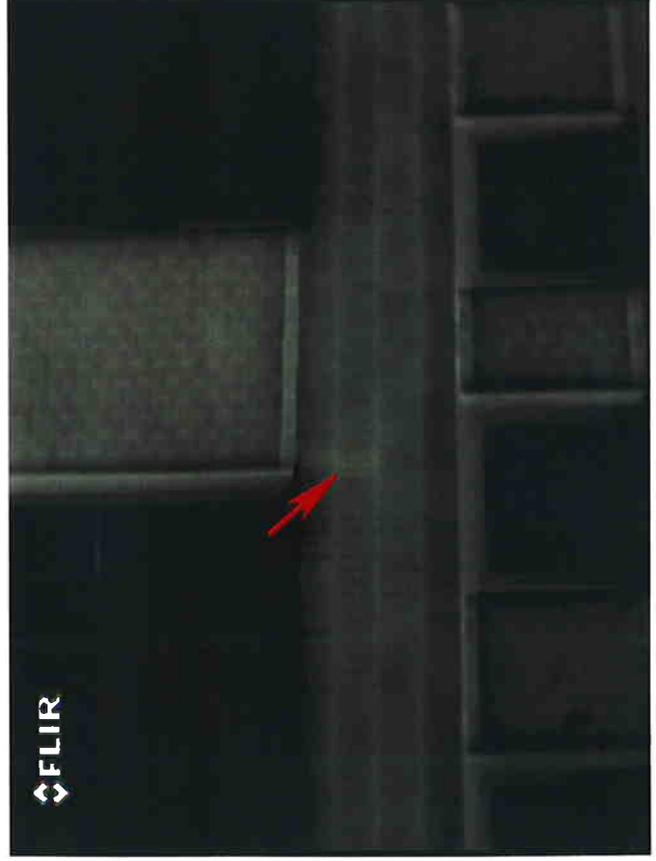
**Area/Picture No.** 6    **Job No.** 09-2617.1    **Date** 3/30/09

**Comments** Thermogram shows thermal pattern typical of latent moisture.

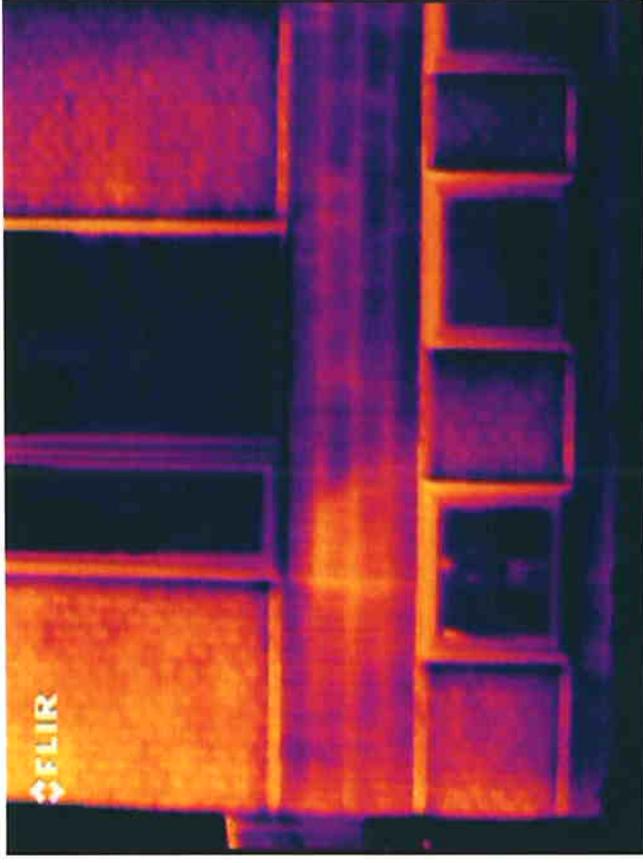
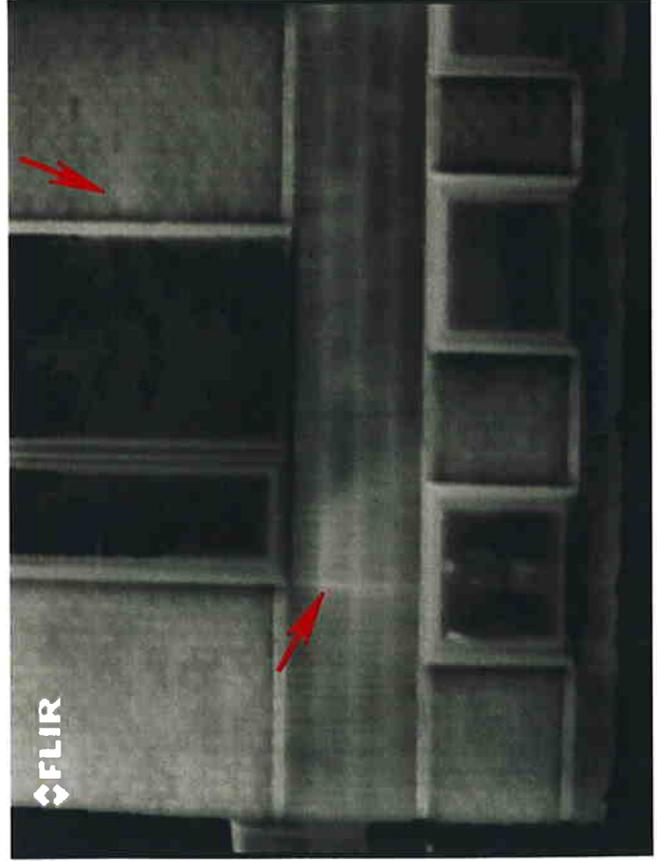
Area/Picture No. 7 Job No. 09-2617.1 Date 3/30/09

Comments Thermogram shows thermal pattern typical of latent moisture.

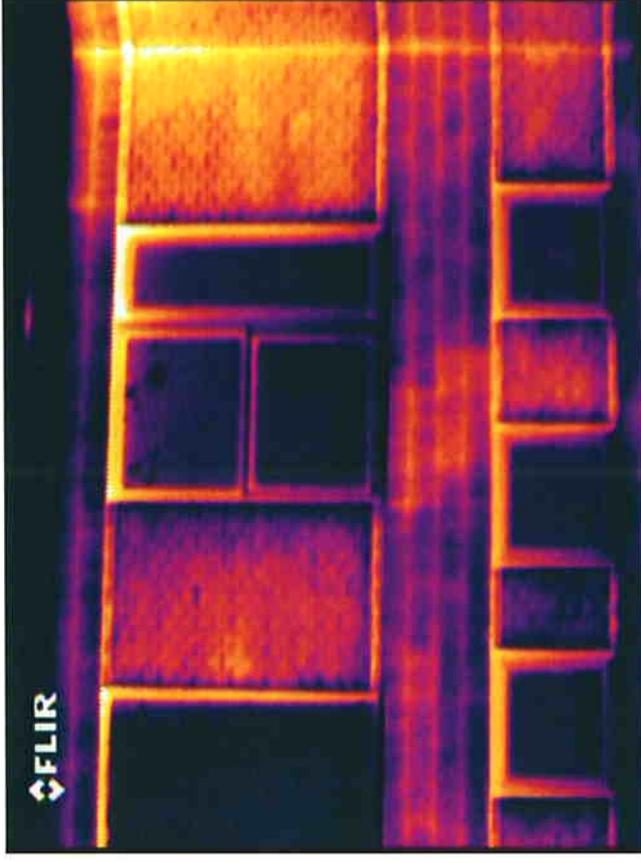
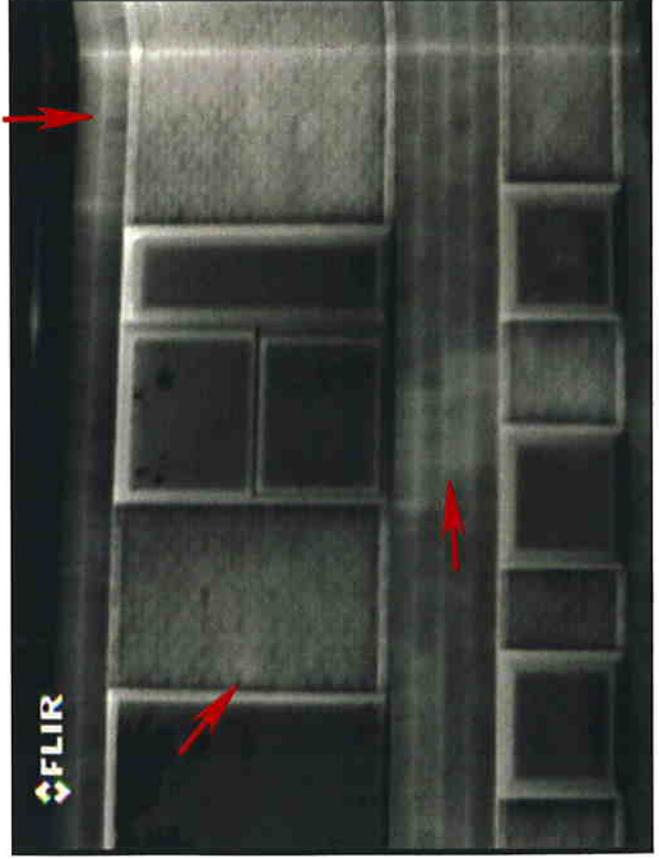
Area/Picture No. 8 Job No. 09-2617.1 Date 3/30/09

Comments Thermogram shows thermal pattern typical of latent moisture.

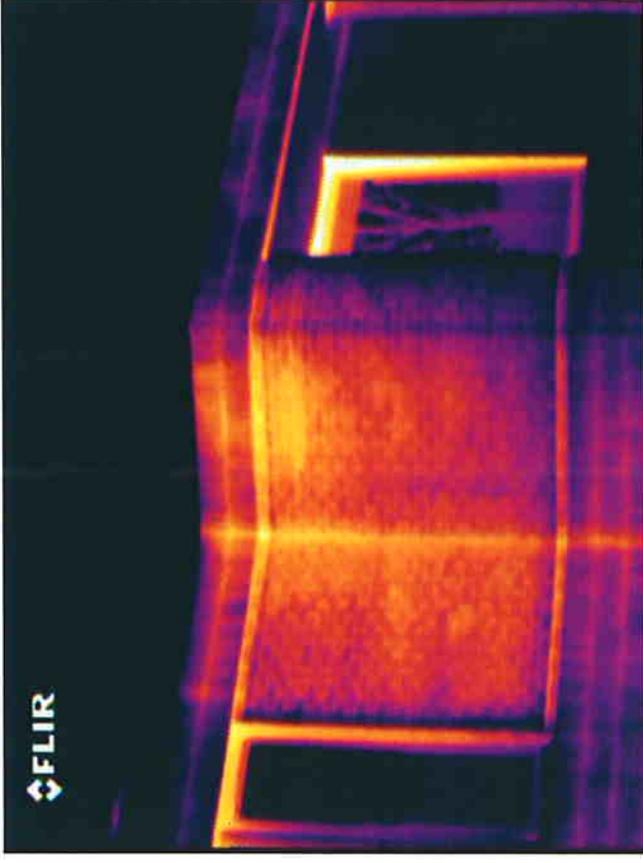
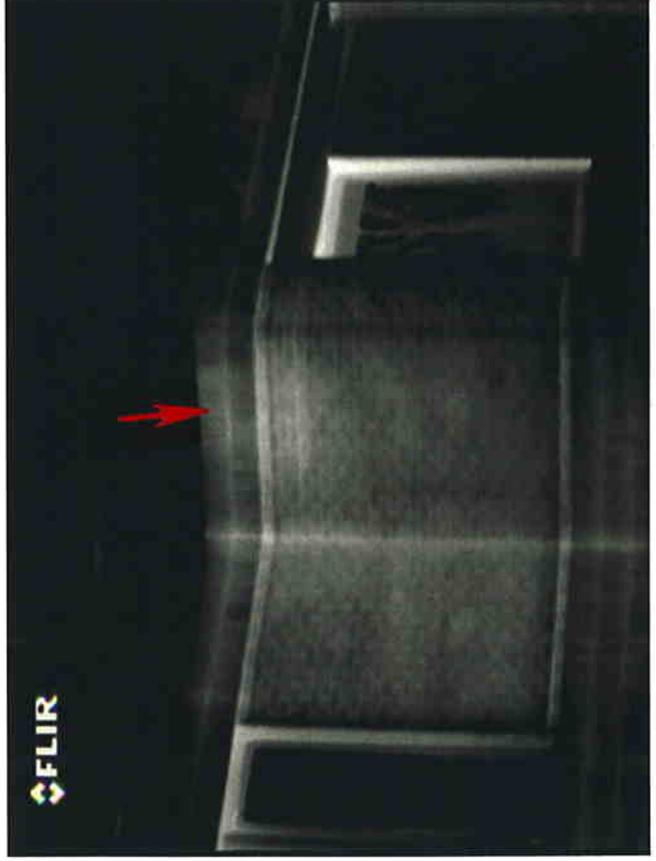
**Area/Picture No.** 9    **Job No.** 09-2617.1    **Date** 3/30/09

**Comments** Thermogram shows thermal pattern typical of latent moisture within brick facade.

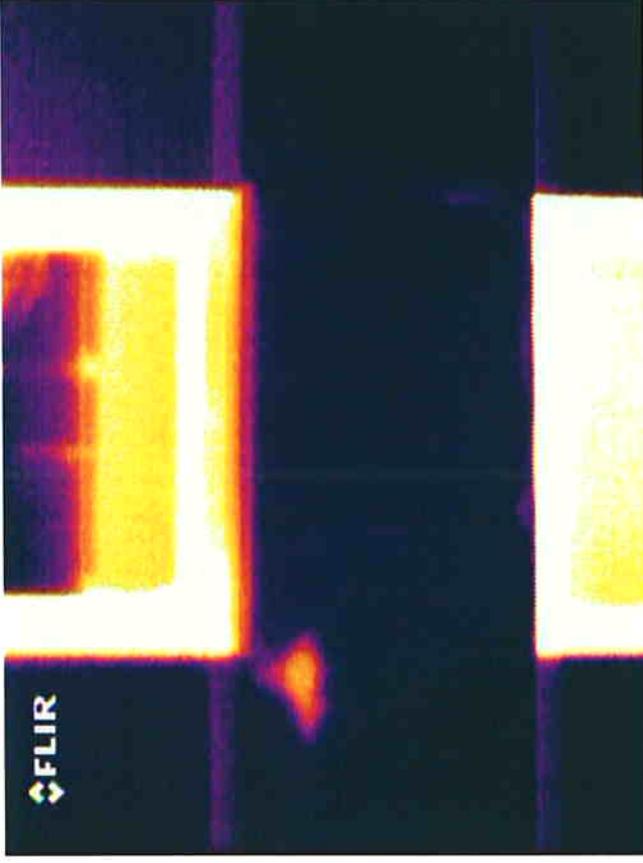
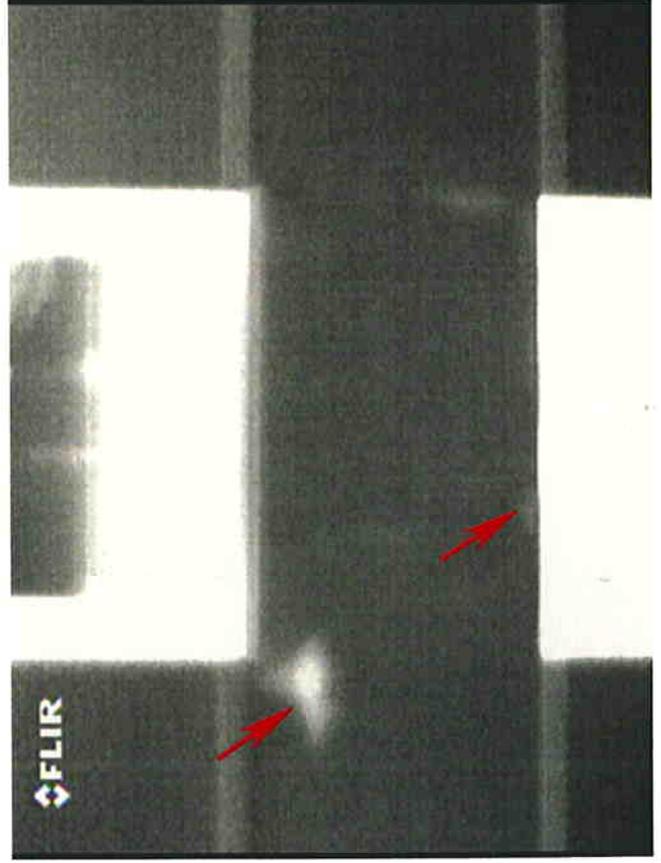
Area/Picture No. 10 Job No. 09-2617.1 Date 3/30/09

Comments Thermogram shows thermal pattern typical of latent moisture.

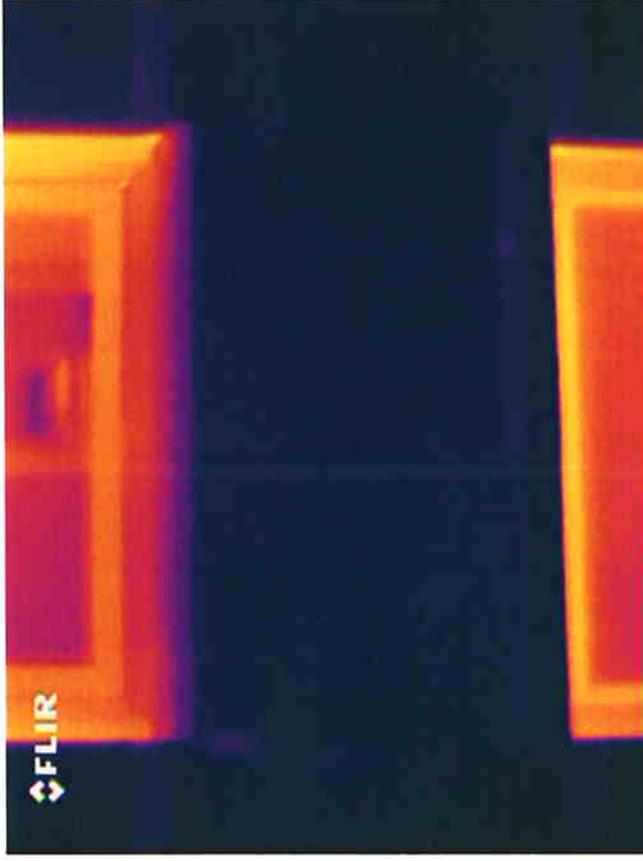
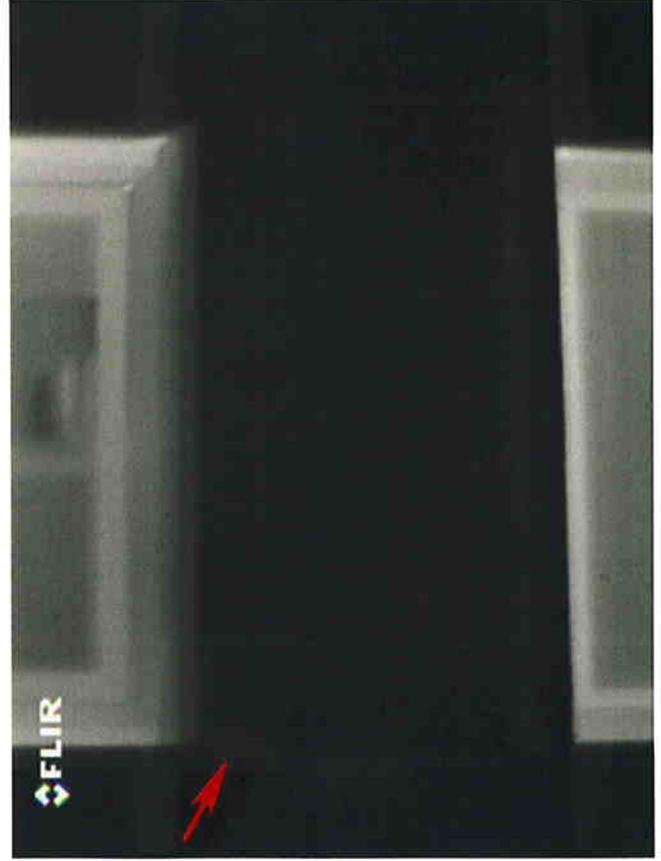
**Area/Picture No.** 11    **Job No.** 09-2617.1    **Date** 3/30/09

**Comments** Thermogram shows thermal pattern typical of latent moisture.

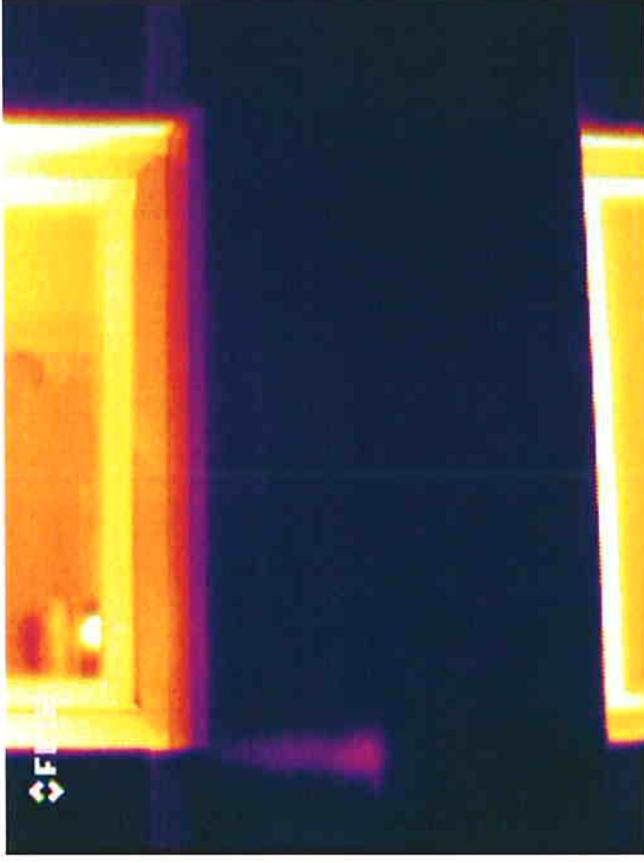
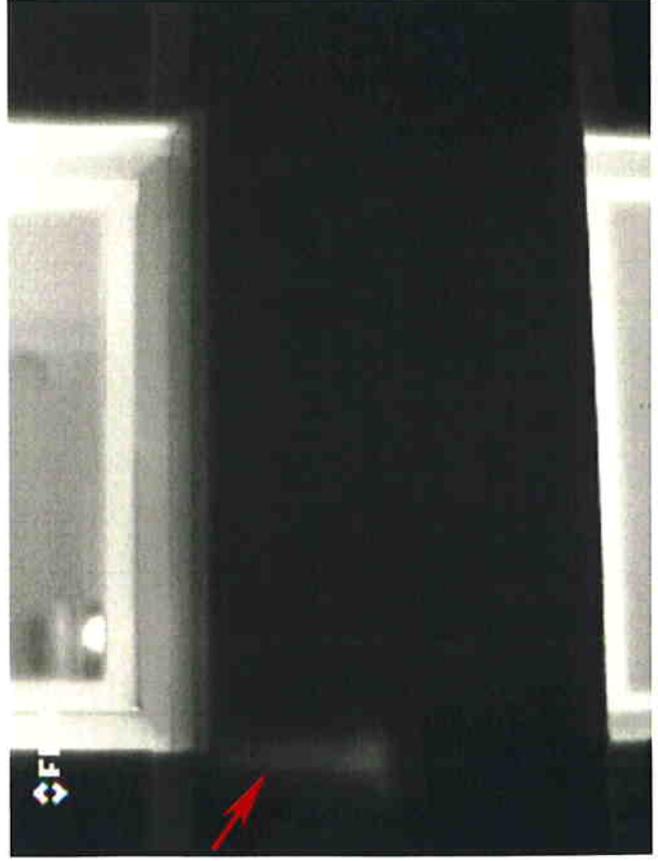
Area/Picture No. 12 Job No. 09-2617.1 Date 3/30/09

Comments Thermogram shows thermal pattern typical of latent moisture.

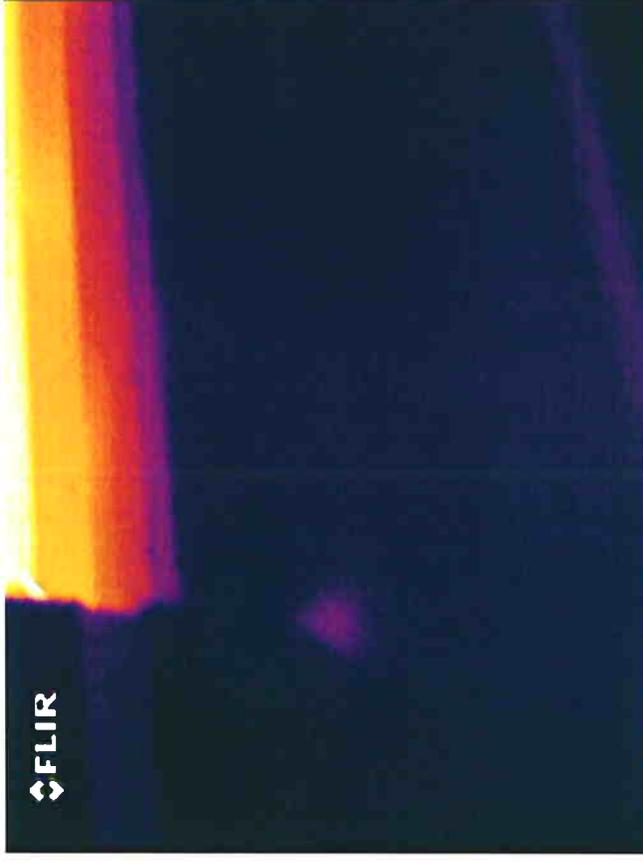
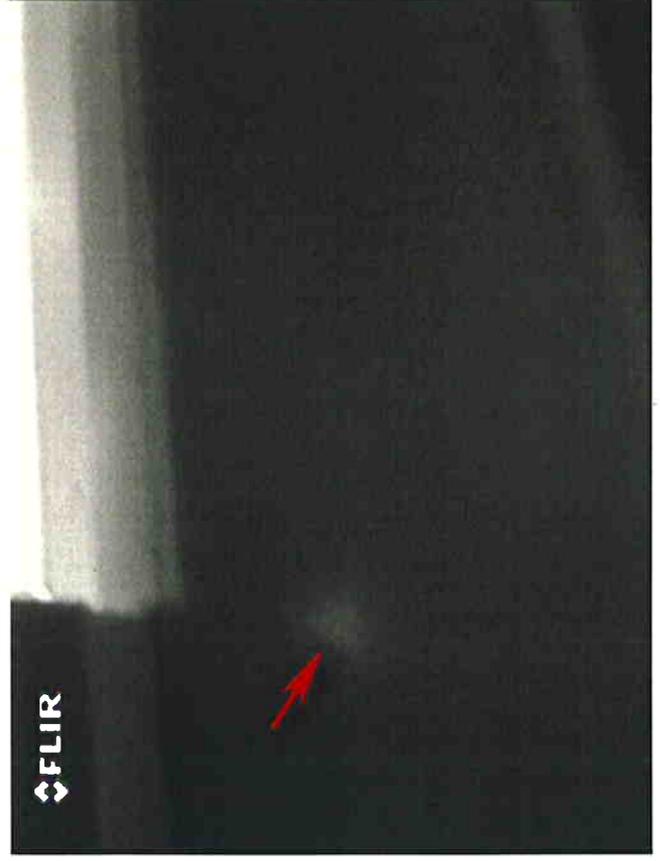
Area/Picture No. 13 Job No. 09-2617.1 Date 3/30/09

Comments Thermogram shows thermal pattern typical of latent moisture.
