# HOPEWELL TOWNSHIP MUNICIPAL BUILDING EVALUATION REPORT

APRIL 24, 2009

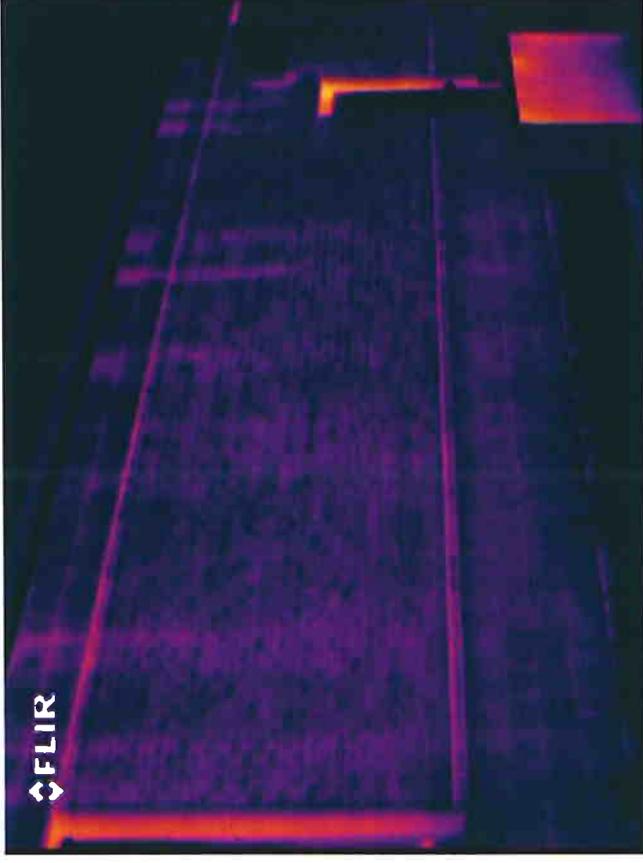
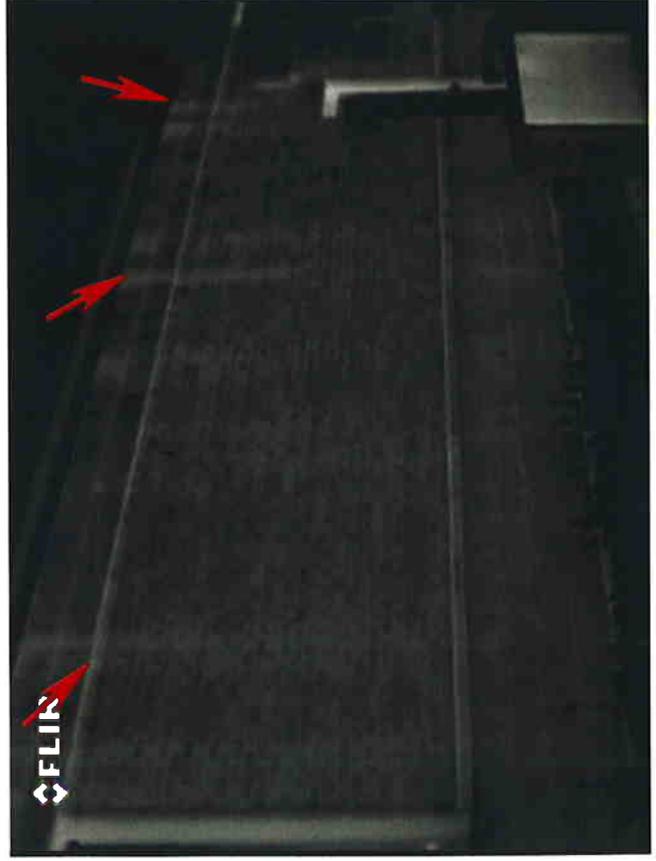
Area/Picture No. 14 Job No. 09-2617.1 Date 3/30/09

Comments Thermogram shows thermal pattern typical of latent moisture.

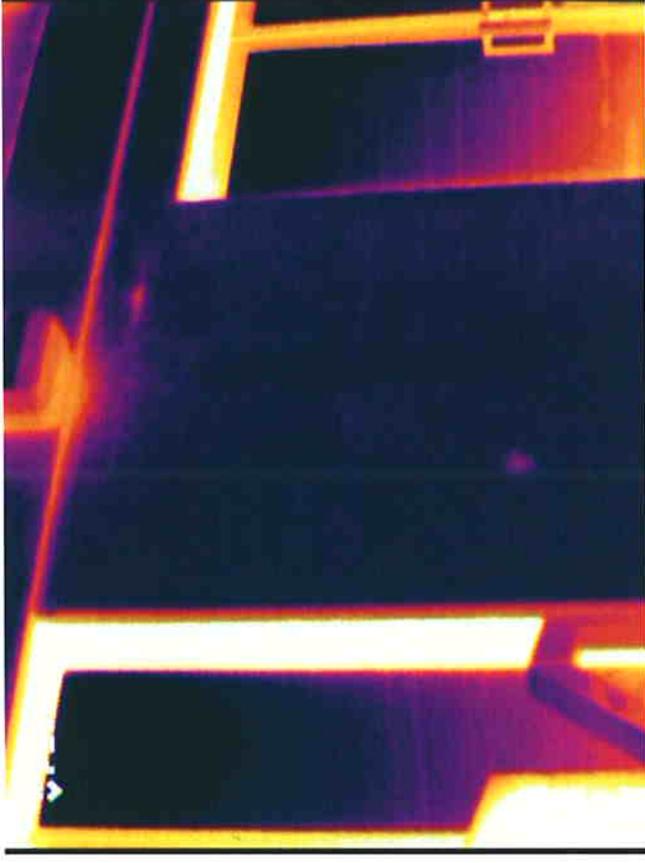
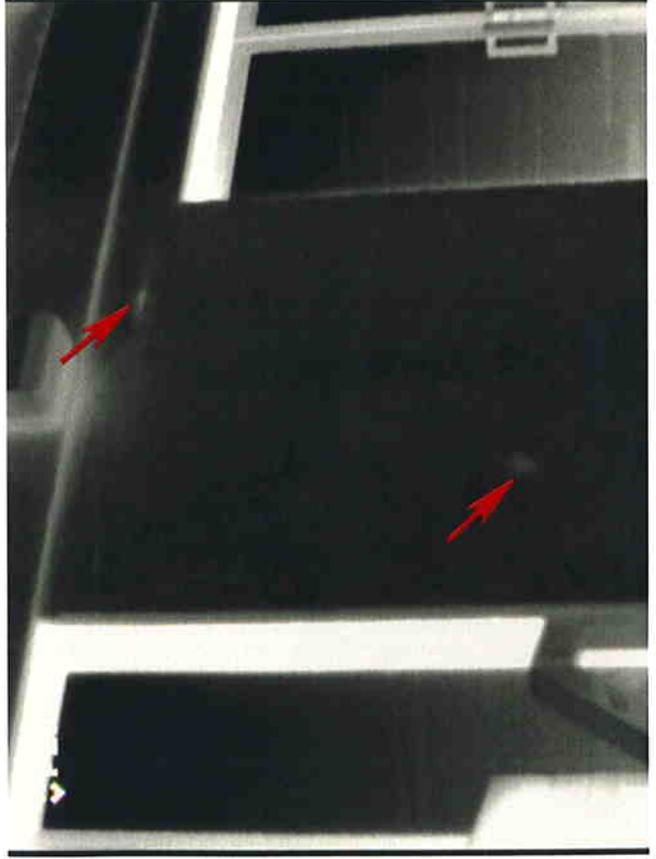
**Area/Picture No.** 15    **Job No.** 09-2617.1    **Date** 3/30/09

**Comments** Thermogram shows thermal pattern typical of latent moisture.

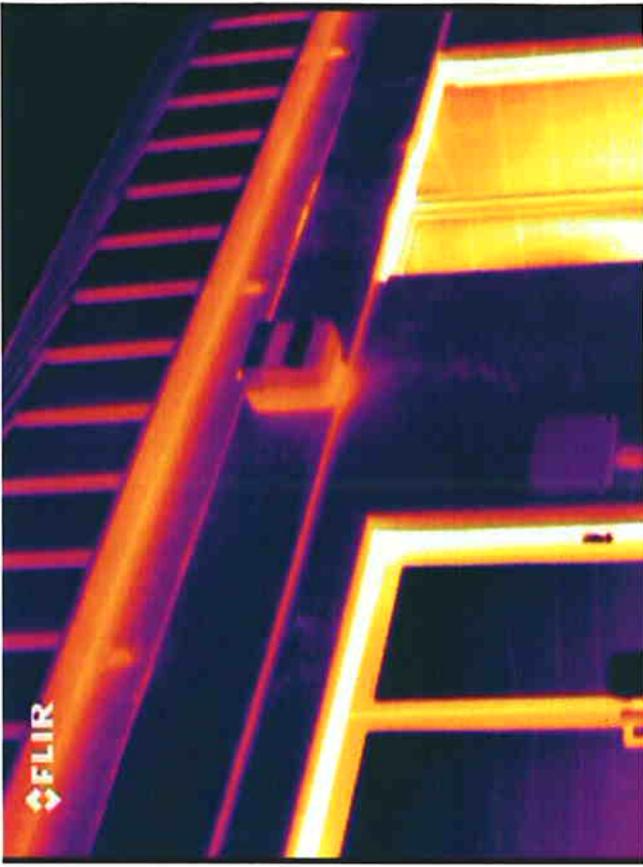
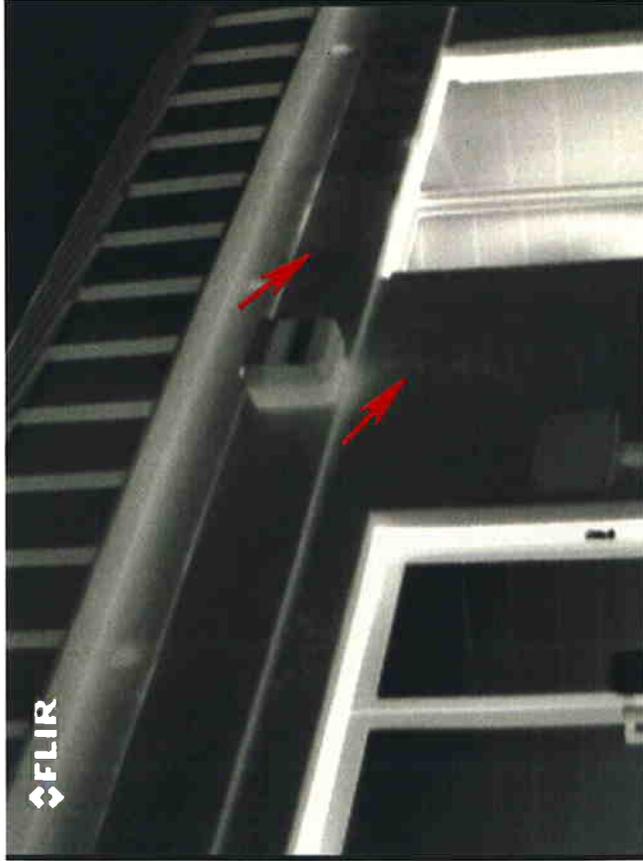
**Area/Picture No.** 16    **Job No.** 09-2617.1    **Date** 3/30/09

**Comments** Thermogram shows thermal pattern typical of latent moisture.

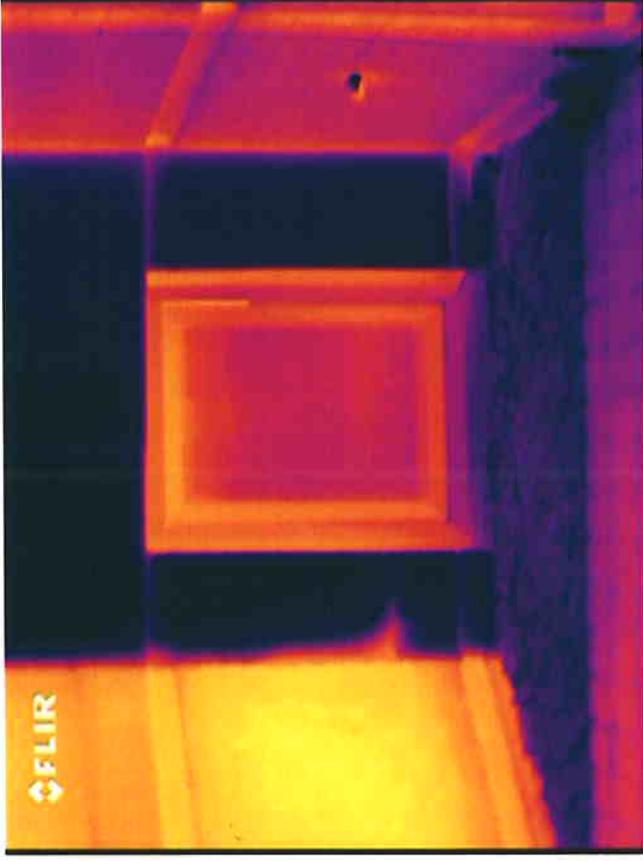
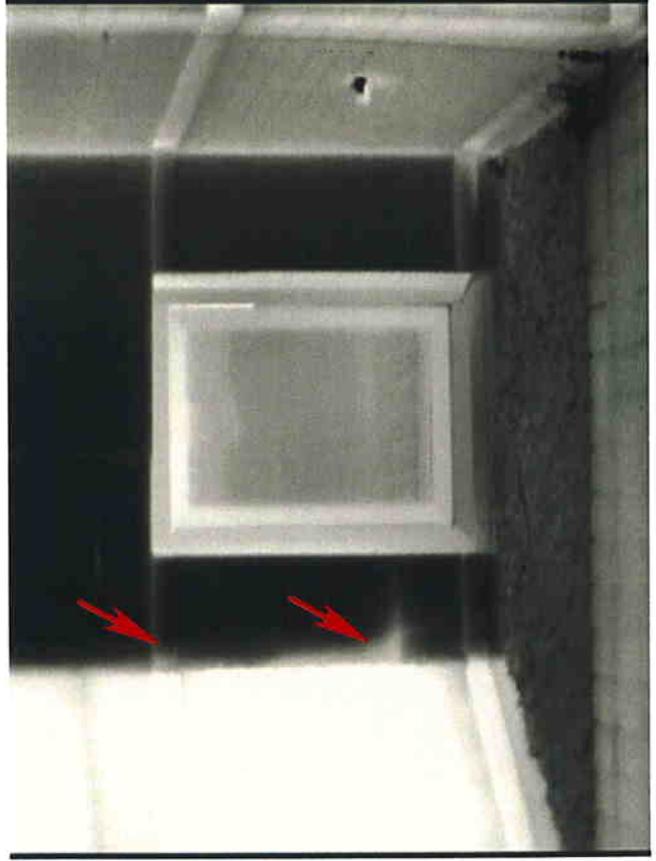
**Area/Picture No.** 17    **Job No.** 09-2617.1    **Date** 3/30/09

**Comments** Thermogram shows thermal pattern typical of latent moisture.

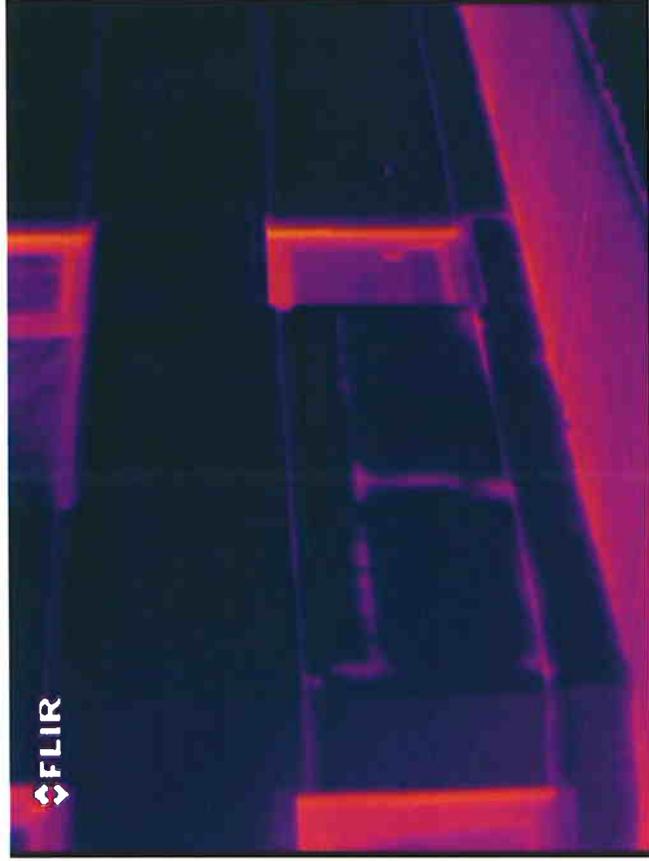
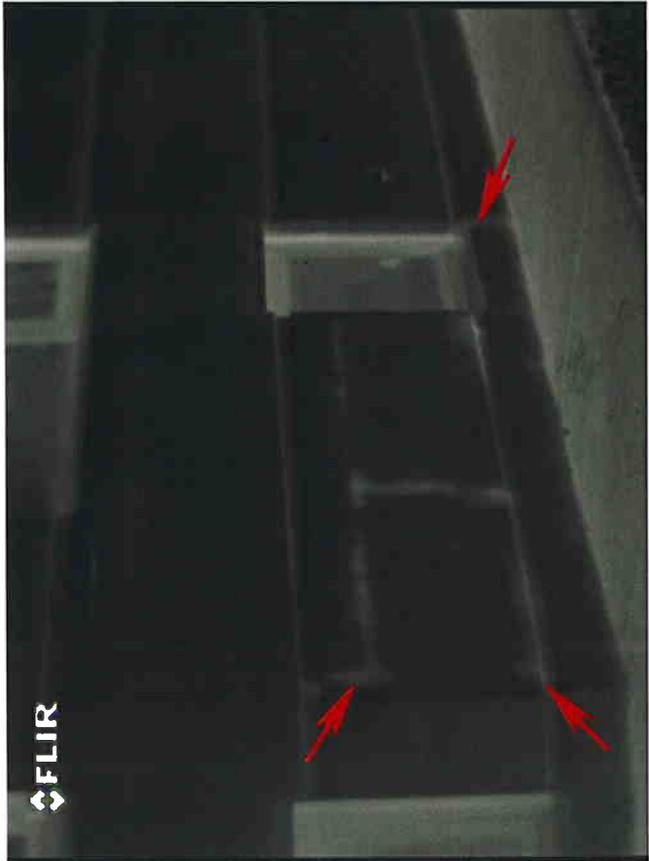
**Area/Picture No.** 18    **Job No.** 09-2617.1    **Date** 3/30/09

**Comments** Thermogram shows thermal pattern typical of latent moisture.

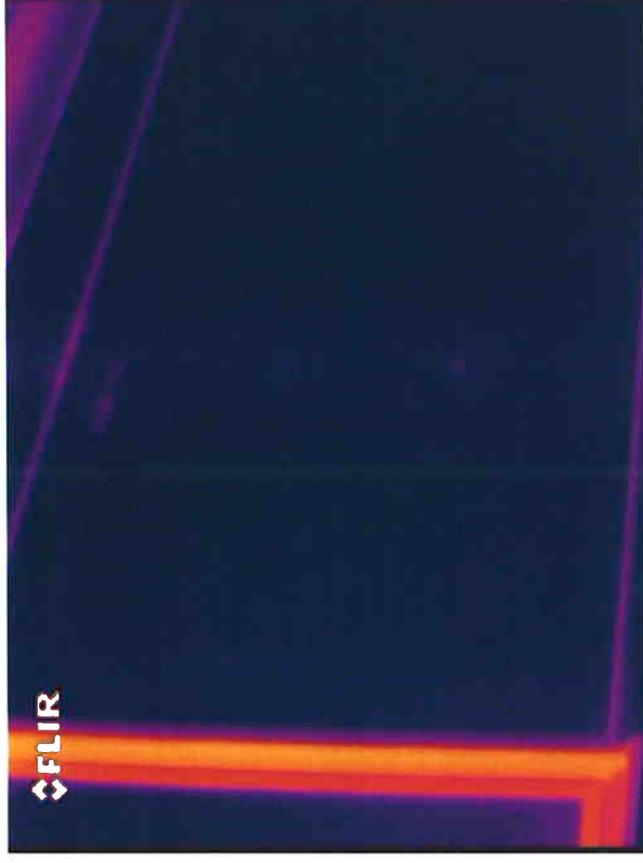
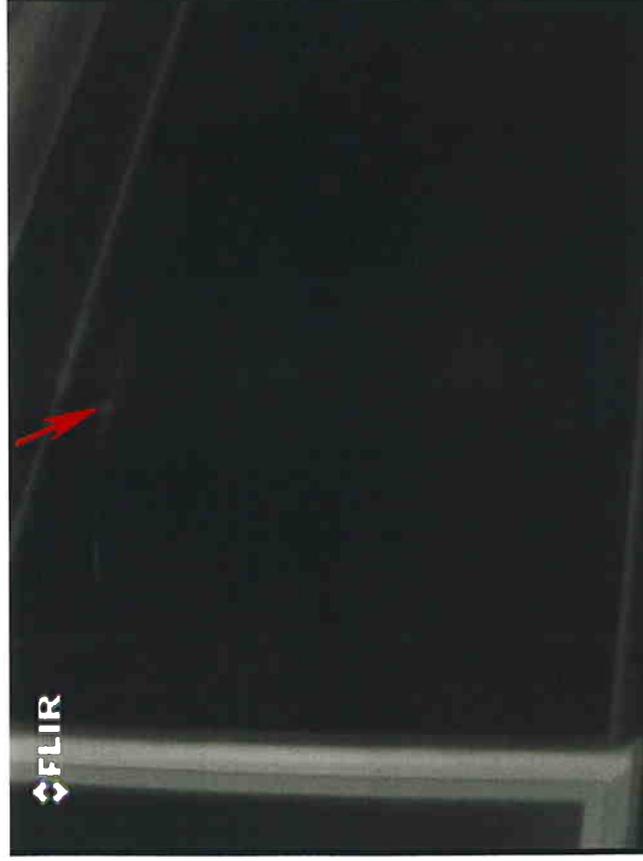
**Area/Picture No.** 19    **Job No.** 09-2617.1    **Date** 3/30/09

**Comments** Thermogram shows thermal pattern typical of latent moisture.

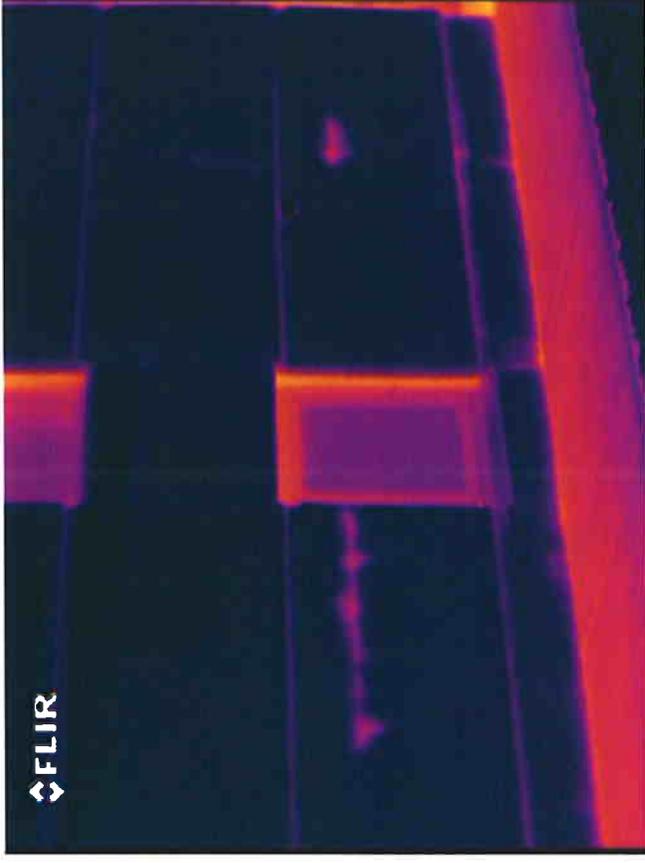
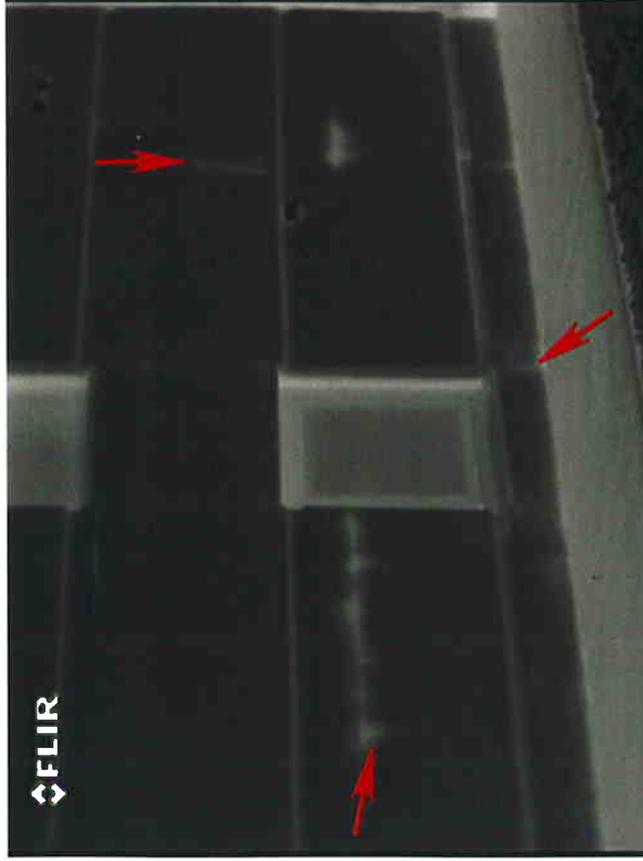
Area/Picture No. 20 Job No. 09-2617.1 Date 3/30/09

Comments Thermogram shows thermal pattern typical of latent moisture.
