**DESIGNATION OF HISTORIC LANDMARKS AND HISTORIC DISTRICTS  
IN THE TOWNSHIP OF HOPEWELL, MERCER COUNTY, NEW JERSEY  
(as per Section 4, Municipal Ordinance No. 00-1142, March 2, 2000)**

Common Historic Name: **Runyan – Titus Barn**

# TITUS-BURD BARN

**Stabilization/Mothball Work  
Township Barn  
Route 31  
Hopewell Township, New Jersey**

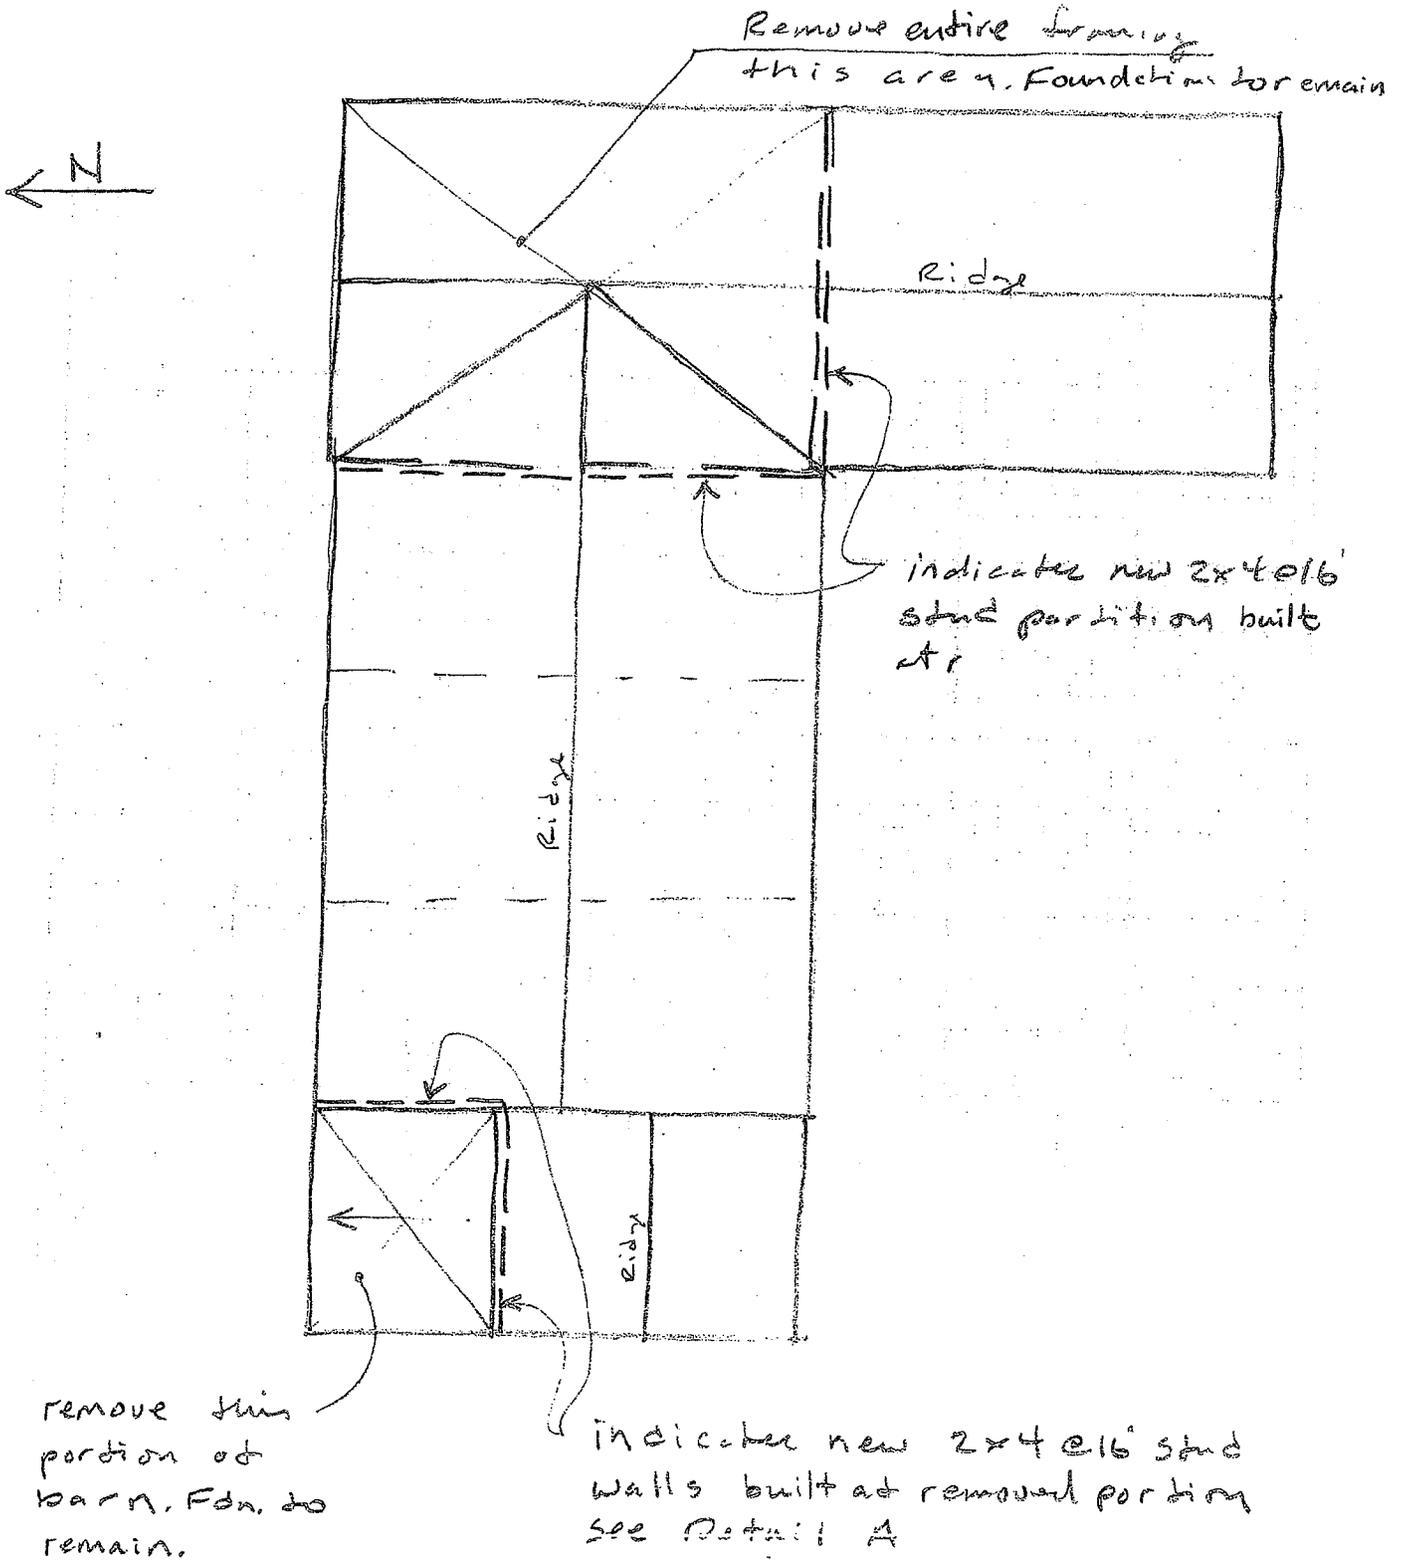
# Root Plan

- A. Re-nail all loose metal roofing material with appropriate roofing nails with rubber washers.
- B. Cut metal roof at removed areas of barn and nail all edges securely
- C. Perform a visual inspection for loose nails or loose metal roofing. Nail or re-nail loose material.
- D. Provide new nails at 8" on center at all edges of roofing on gable ends.

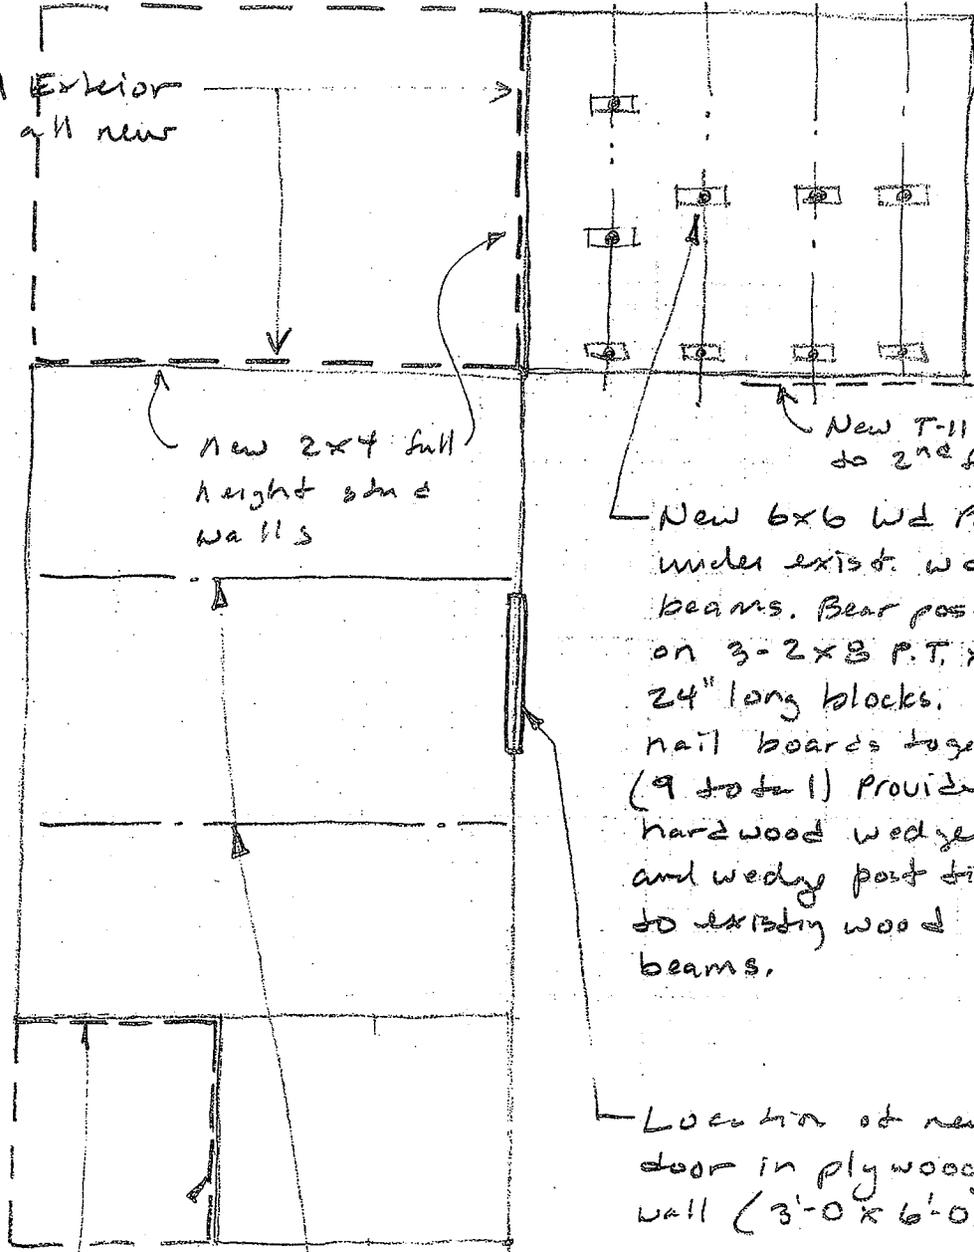
Building Plan  
NTS

Provide Full Exterior Siding on all new stud walls

- A. Upon completion of all work, board all openings with 3/4" plywood with 3" wood deck screws at 16" on center. Build 2x4 framing in large openings to support edges of plywood. **Paint all plywood white with exterior grade paint.**
- B. Build a door in plywood closures where shown on plans. Door to have metal hinges and locking mechanisms for padlock.
