# **Pennytown Village Wastewater System Evaluation**

May 1, 2009

Edward A. Clerico, P.E.  
Alliance Environmental, LLC  
2 Clerico Lane, Suite 210  
Hillsborough, NJ  
08844

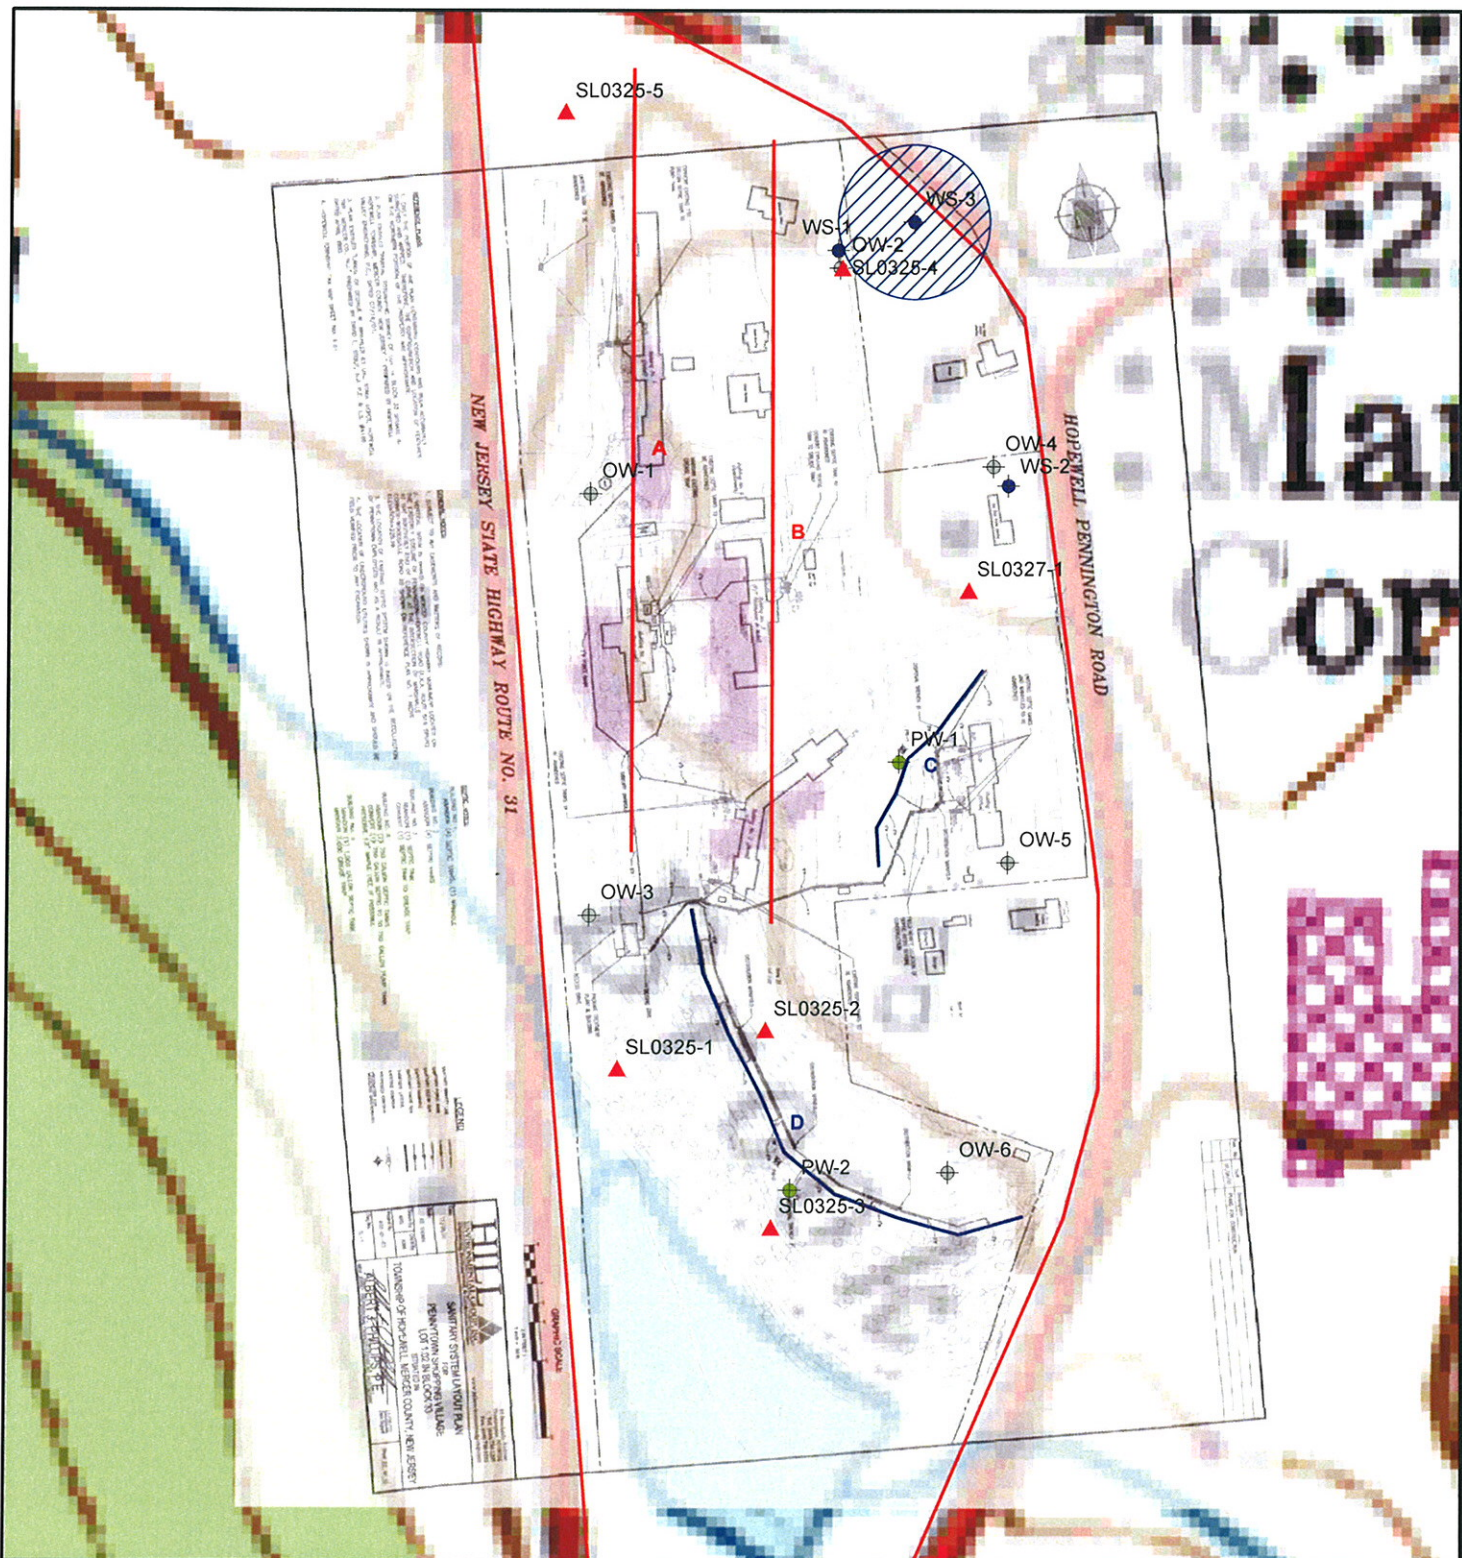
# Appendix B – Well Test/Soil Test Data

The test wells and borings were installed at locations distributed around the undeveloped portion of the property. Each well was drilled to approximately 25 feet below ground surface to characterize the shallow weathered bedrock. Wells with an adequate volume of water were subsequently pump tested to determine hydraulic properties of the shallow weathered bedrock aquifer. Results of this testing indicate shallow depths to bedrock and generally low hydraulic conductivities across most of the site. An area of higher hydraulic conductivity was observed in the northeast portion of the site, in the vicinity of the water supply test wells installed by others.

Soil profiles were described in 6 excavations at various locations around the undeveloped portion of the property to determine soil types and limiting conditions within the soils and uppermost bedrock. Permeability testing was conducted within 3 of these excavations and laboratory analyses were performed on 8 samples collected from the profile logs. Results of this testing indicate low permeability and limiting conditions exist in the soil and uppermost fractured bedrock across most of the site. An area of higher permeability was observed in the northeast portion of the site, in the vicinity of the water supply test wells installed by others.
