# HOPEWELL TOWNSHIP MUNICIPAL BUILDING EVALUATION REPORT

APRIL 24, 2009

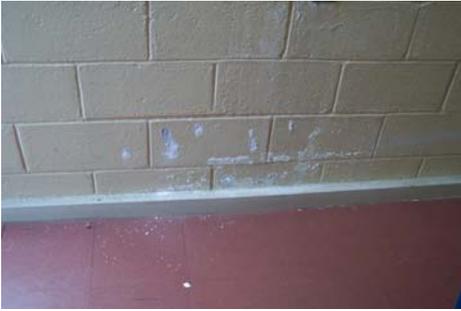
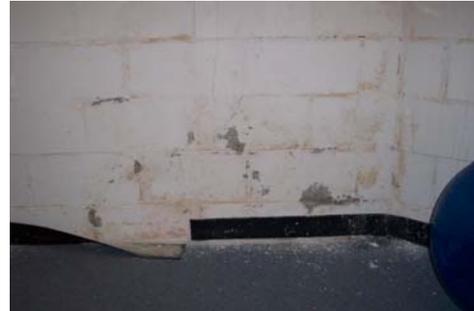
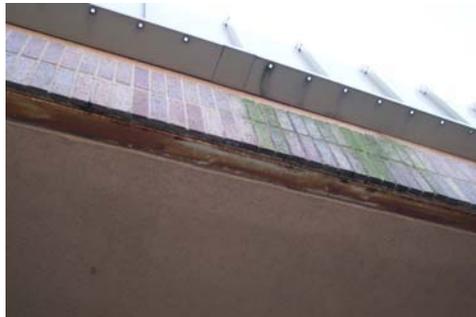
### *Observation 2*

Another concern with the existing masonry is the lack of any visible weep holes at the base of all exterior brick walls and above all windows and doors. It is unknown if thru-wall flashing is present. The lack of weep holes and thru-wall flashing results in water penetrating the wall, thus not having the ability to exit the wall cavity. Currently, rainwater is absorbed through the masonry/brick and into the interior space resulting in issues such as peeling wall paint leading to the potential for mold and mildew development. There is also the potential for freeze thaw cycles to occur with trapped water resulting in structural issues and failure. Many window and door lintels are rusting due to the lack of proper weep holes. This also includes the lintels supporting the brick façade at the cantilevered entrance.

Our recommendation is to install all necessary weep holes (24" on-center) and continuous thru-wall flashing into the existing exterior brick. This solution should result in promoting moisture drainage from the wall cavity. The installation of weep holes and thru-wall flashing in a retrofit situation requires the removal and replacement of brick (3 courses or 1 soldier course). Our recommendation would be to also replace all steel lintels with new galvanized steel lintels.

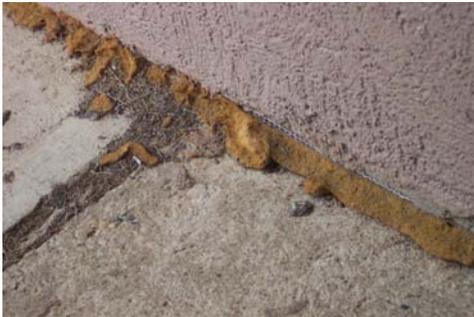
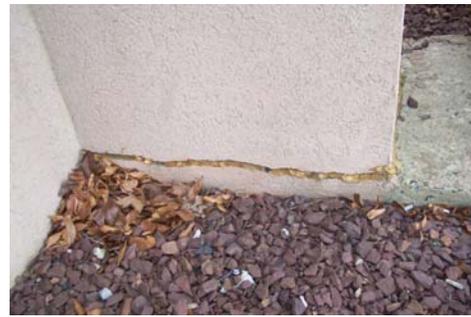
### *Observation 1*

The existing EIFS on the building is original to the 1986 addition. Therefore, its 23 years old age has reached it's life expectancy. The included infrared report prepared by Jersey Infrared indicates that large portions of the façade are suspected of having water damage. Currently a portion of the perimeter has been sealed with expandable foam where the EIFS adjoins the walkway. This product tends to absorb water and retain moisture behind the EIFS.

The EIFS façade has exceeded its expected service life of 20 years. As illustrated, there are numerous deficiencies which without repair will lead to further deterioration. This deterioration could lead to increased water infiltration and therefore possible indoor air quality issues. As shown on the attached report from Jersey Infrared, the existing EIFS is expected to be saturated. Our recommendation is to completely replace the existing EIFS with a new drainable EIFS system or an alternate exterior siding material such as fiber-cement board siding, metal wall panels or thin-brick.

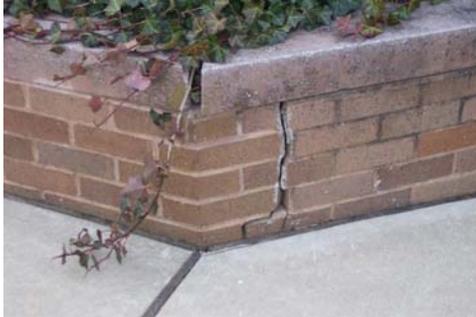
### *Observation 1*

The existing brick planter walls are also showing signs of settlement and/or water infiltration and improper drainage. This has resulted in some severe cracking and shifting, minimizing the structural integrity of the wall.

It is recommended that the existing planter walls be replaced in their entirety. Proper drainage design would be incorporated into the new design including excavation of the soil, new drainable fill material and drainage piping to relieve rainwater from collecting behind the planter walls. Piping should be connected into the underground storm-water drainage system.

- A. Replace planters with keystone type landscaping wall block
- B. Replace planters with brick and pre-cast concrete cap.

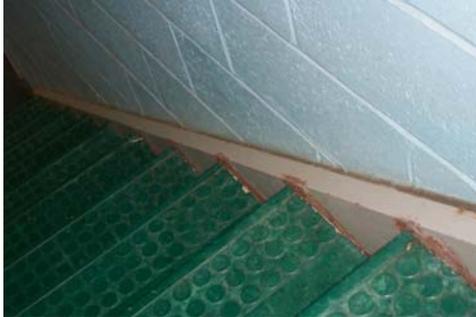
### *Observation 1*

There is evidence of rust and corrosion on the interior stair steel stringers in the front stairwell. This appears to be caused by a mixture of storing salt in the stairwell, over salting the steps outside of the doorway, and water getting under to door and into the stairwell.

It is recommended that the existing exterior hollow metal door and frame to the front stairwell be replaced with a FRP door and aluminum frame with proper weather seals and hardware. The FRP door and aluminum frame are less susceptible to damage from water and salt and is therefore recommended for exterior applications. Additionally, the steel stair stringers in the entire stairwell should be sanded, prepped, treated, and repainted.

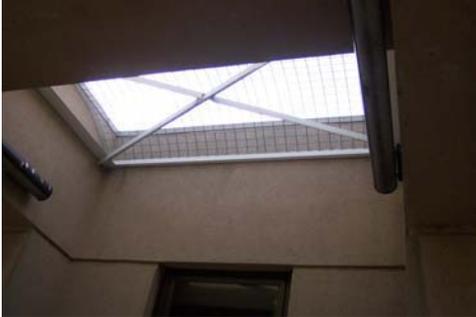
### *Observation 2*

The existing open light wells at the front entrance are provided with screens only and therefore allow rainwater to enter the covered roof area as well as discoloration of the EIFS on the pilasters between the windows.

We recommend the installation of enclosed skylights to provide a weather tight situation under the covered roof. This will maintain the natural light into the adjacent office spaces.

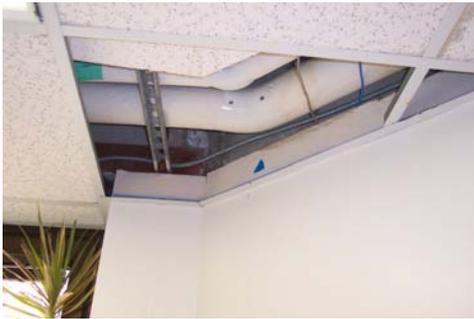
### *Observation 3*

During our observations, we were advised by the on-site maintenance staff that there had been a previous problem with mold in the lower level of the building in the Health Care Suite. The maintenance staff suggested that the problem was related to condensation from overhead pipes and that indications of water damage would appear after heavy rain storms. We were also advised that the ceiling tiles in this area have been replaced several times a year because of the water damage and that the finishes on some ceiling diffusers have been compromised.

Further investigation is required to fully ascertain the cause of the aforementioned issues. We recommend that additional surveying and testing be performed by a plumbing/mechanical professional engineer.
