**GUIDELINES FOR
EXTERIOR WOODWORK**

Township of Hopewell Historic Preservation Commission

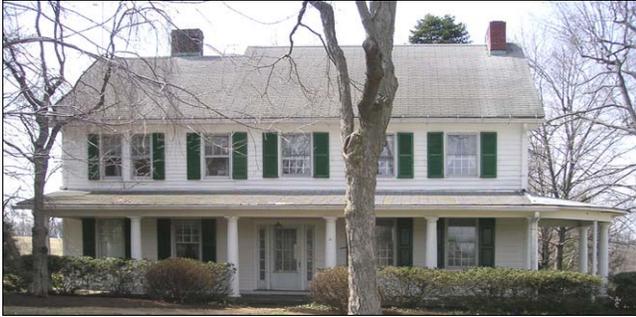
Wood clapboard siding is one of the most common historic exterior wall materials in Hopewell Township.

- **Clapboard Siding**, also known as weatherboard or beveled siding, is made from long boards, tapered across the width. Clapboard is installed by nailing an upper board overlapping a lower board with joints staggered across the wall surface. The boards are usually nailed to allow approximately four inches of exposure, or visible board surface.
- **German Siding**, also known as drop siding, is a flat faced board with a concave top and notched bottom. German siding is installed by nailing the notched bottom of the upper board over the concave top of the lower board in a staggered joint pattern.

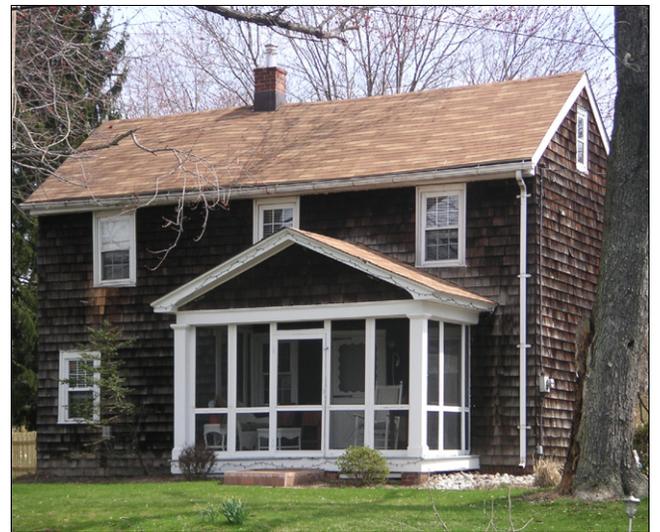
The dark brown color of these stained beveled shingles blends with the natural surroundings.

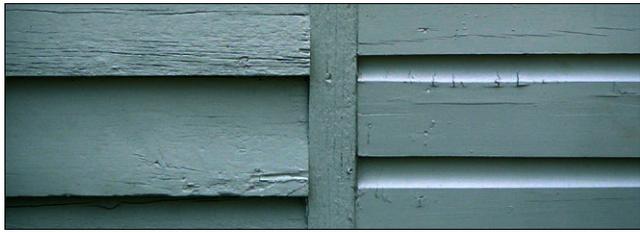
The original building to the left has clapboard siding, and the later addition, located to the right, has German siding.

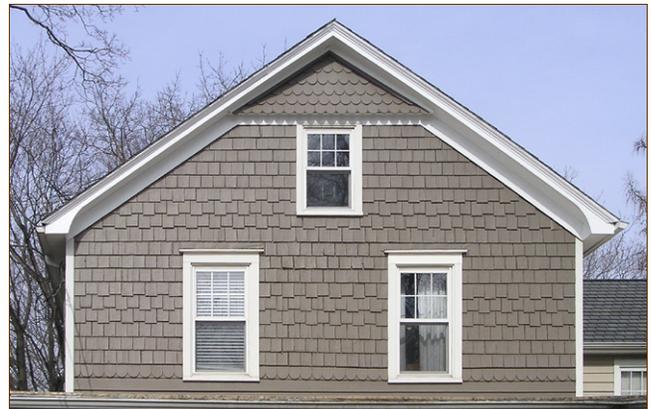
This house combines fishscale, beveled and staggered shingles.

- Chisel or Bevel:** Rectangular shape, similar to roof shingles
- Fishscale:** Bottom shingle edge cut in a U shape with multiple rows forming a fishscale pattern
- Diamond:** Bottom shingle edge cut in a V shape with multiple rows forming a diamond pattern
- Staggered:** Chisel or beveled shingles with alternating greater and lesser exposure
- Octagonal:** Bottom shingle corners cut with 45° angle with multiple rows forming an octagonal pattern
- Sawtooth:** Bottom shingle edge cut in a W shape with adjacent shingles forming a sawtooth pattern

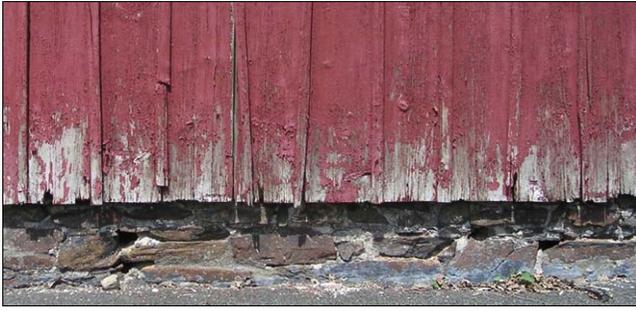
Historically board and batten siding was typically used for secondary buildings and farm structures. This example includes visible signs of deterioration. Problems include bare wood from peeling and missing paint, splitting or checking along the bottom edges of the siding, and unsecured battens.

- **Vertical Board Siding**, also known as vertical plank siding, is made from long wide boards fastened vertically across a façade.
- **Board and Batten Siding** is similar to vertical board siding, although the joints between the wide vertical boards are covered with narrow boards or trim known as battens.

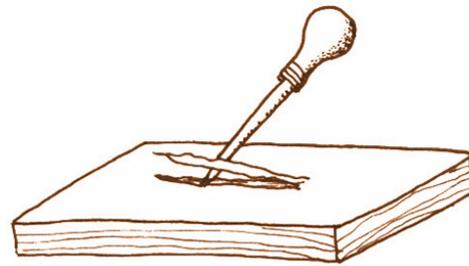
Less penetration and long splinters are an indication of healthy wood

A simple means of testing for rot is to stab the wood member perpendicular to the grain with an awl or ice pick. Then measure the penetration depth and evaluate the type of splintering using the following criteria:

- If the penetration is less than ¼ inch, the component does not need replacement
- If the penetration is more than ½ inch, the component might need replacement
- If long splinters are produced, the wood is healthy and the component does not need replacement
- If short sections broken across the grain are produced, the component might need replacement

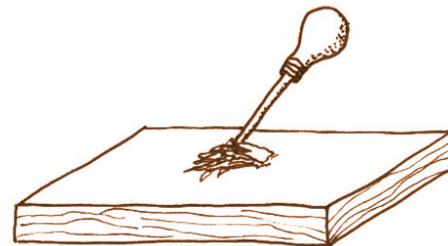
Greater penetration and short splinters against the grain are a possible indication of rot

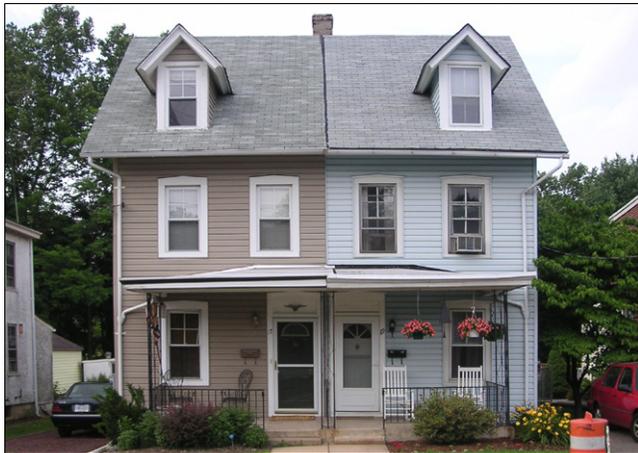
Vinyl siding of different colors has been installed at each residence. The siding is not aligned and obscures wood window surrounds.

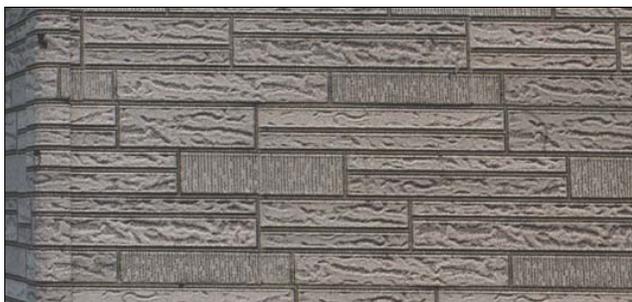
Asphalt siding often simulates brick or stone wall surfaces.

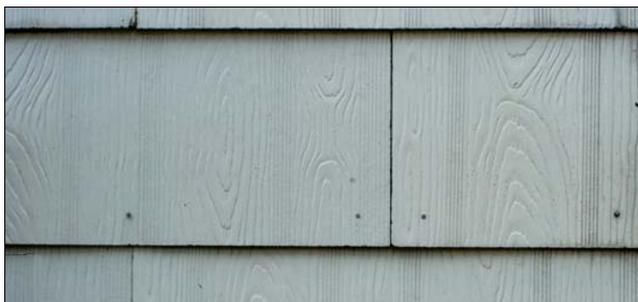
Asbestos siding is often embossed with a wood grain pattern. The removal of asbestos siding can be dangerous and should be undertaken by trained professionals.

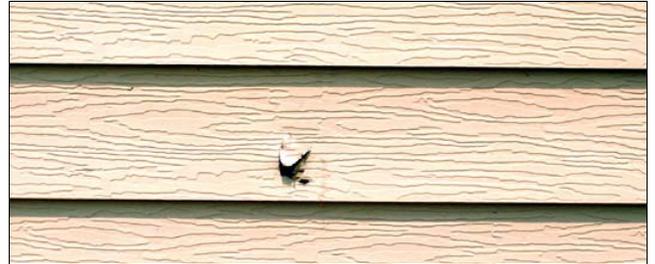
If considering artificial siding, a smooth finish is recommended rather than a wood-grain finish. Replacement of this aluminum siding section would be the best way to repair the puncture. Since siding colors tend to fade from sunlight, the replacement siding probably would not match the existing siding.

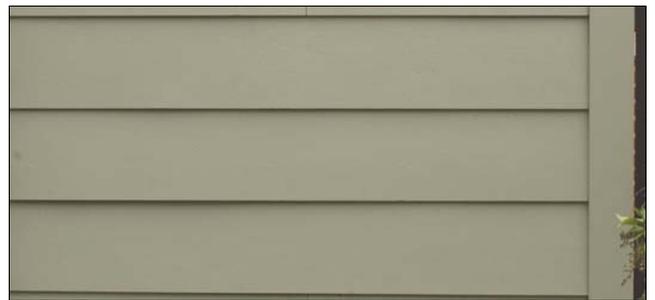
Fiber-cement siding material is a good economical alternative for an addition to an historic house. The surface of the Hardiplank siding above was painted to match the existing paint scheme.

Fiber-cement siding is a lightweight, solid material that is a durable and visually more compatible material to wood than vinyl or aluminum siding. It is manufactured in similar sizes and shapes to wood products including siding, shingles and trim, making it easier to duplicate historic characteristics. The installation method is similar to wood, and it can be cut to shape on-site using hand tools, and painted to match any color scheme. Manufacturers indicate that fiber-cement products are resistant to rot, termites, fire and delamination, and are dimensionally stable, allowing paint to last longer. Fiber-cement products cost more than vinyl or aluminum siding but much less than wood siding. They are increasingly common in this region, and some manufacturers offer warranties for as long as 50 years.

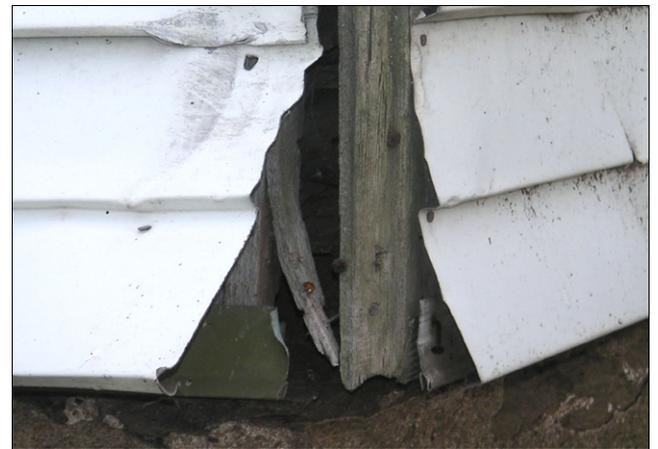
The wood siding remains under the aluminum siding.

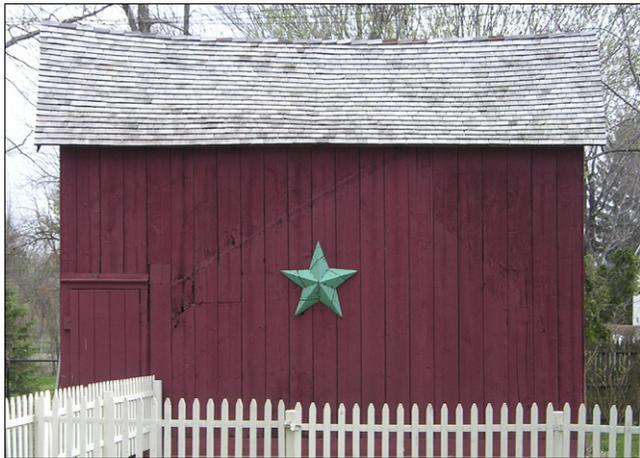
Agricultural outbuildings historically were typically painted red and usually featured vertical board or board and batten siding.

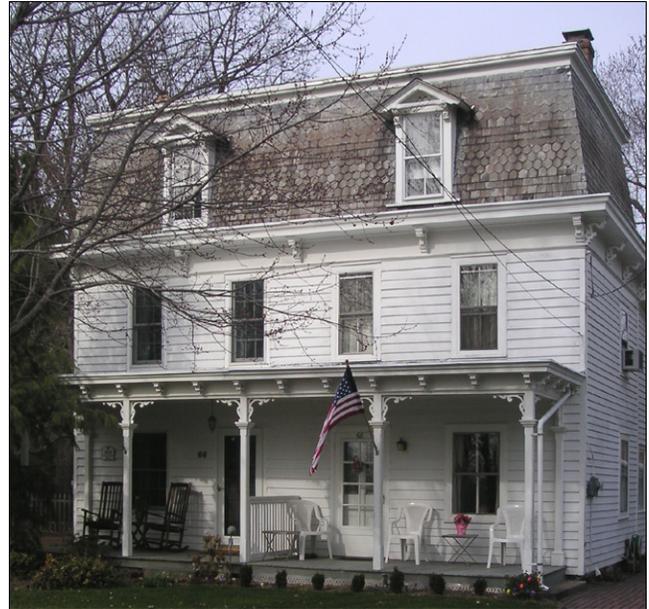
The owners of each half of this semi-detached house applied a uniform paint scheme, making it appear like a larger single home. Architectural woodwork details including the overhanging cornice, decorative brackets and porch posts remain and provide architectural richness.
