GUIDELINES FOR MASONRY & STUCCO

Township of Hopewell Historic Preservation Commission

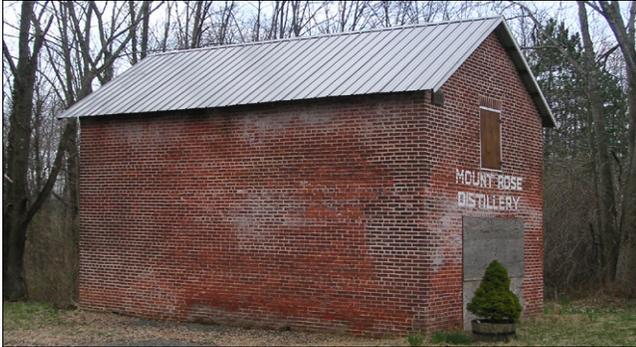
The Mount Rose Distillery is built of common bond brick.

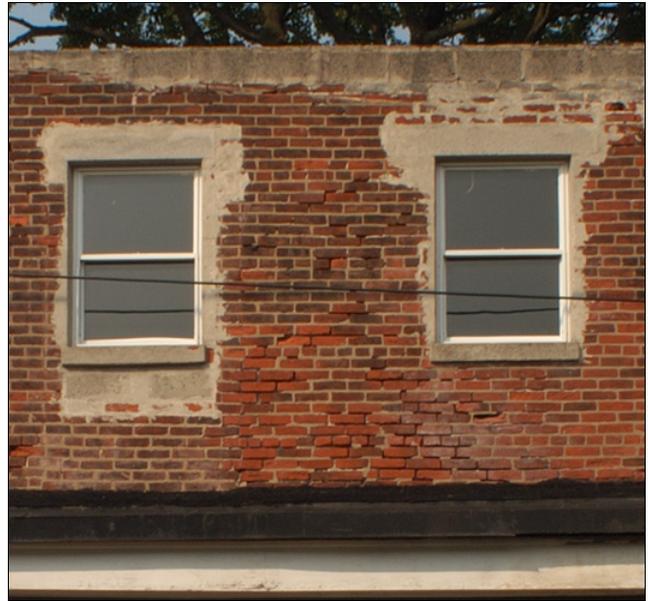
Surface delamination of the bricks, several open joints and poor patching are visible. The delaminated areas and open joints can allow water penetration and accelerated deterioration.

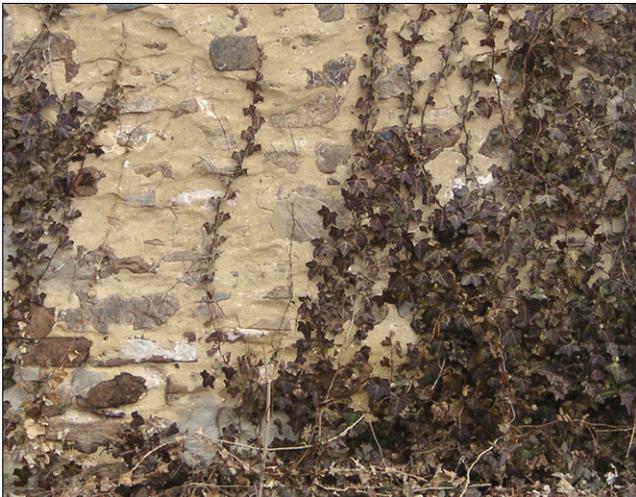
The roots of ivy or other vegetation growing on walls tends to loosen stucco and mortar, creating openings in the surface. Surface vegetation also has a propensity to reduce evaporation and increase trapped moisture.

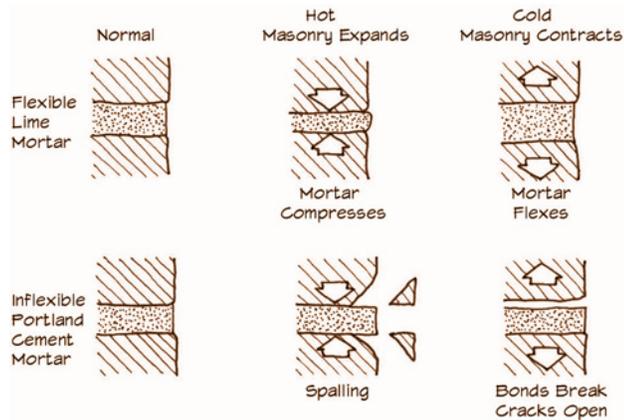
Temperature changes cause masonry units to expand when heated and contract when cold. The expansion and contraction of the masonry units results in compression and flexing of the adjoining mortar joints.

Lime based mortar is pliable and is more likely to compress and flex through temperature cycles. If properly installed, it should also be softer than the adjoining masonry allowing it to deteriorate before the adjacent masonry.

Portland cement based mortars are significantly harder than lime based mortars and far less elastic. In addition, cement mortars tend to be substantially harder than historic masonry. When masonry units expand in warm temperatures, they press against the harder cement mortar and tend to spall at the edges. During colder temperatures, masonry units tend to pull away from mortar resulting in open cracks that can allow moisture penetration.

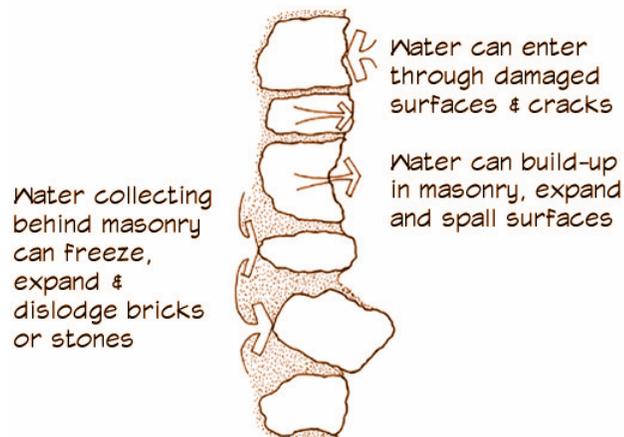
Moisture can enter walls through various ways including mortar cracks, spalled surfaces, groundwater and interior conditions. Moisture and impurities in masonry walls can cause outward pressure and result in spalling, dislodging of masonry units and deterioration of mortar joints.

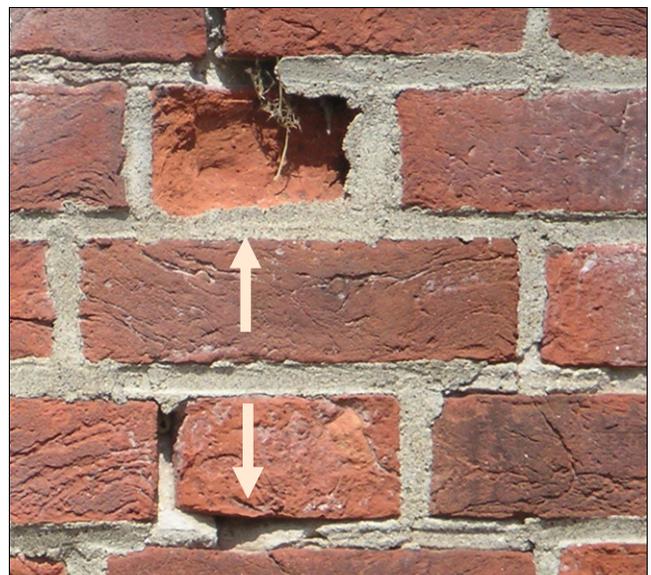
The surface of the upper brick noted by the arrow has spalled. The repointing mortar is probably harder than the bricks. The mortar is also beginning to crack and pop out of the lower joints.

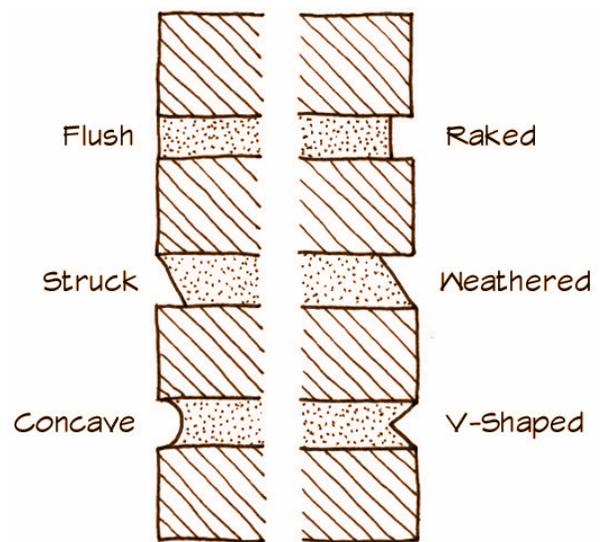
There are numerous joint profile types, with each producing different shadow lines and highlights. When repointing an area of masonry, it is important to tool mortar to match the existing joint profile for a consistent appearance.

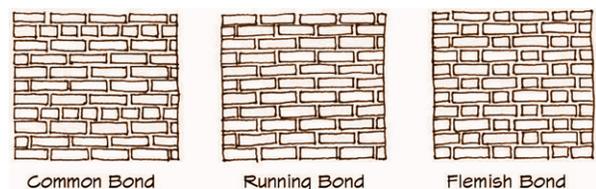
The most frequently constructed brick bonding pattern is common bond, which features stretcher courses with a header course every 6th row. Other familiar brick bonding patterns include running bond, comprised of only stretcher courses, and Flemish bond, alternating single stretchers and headers.

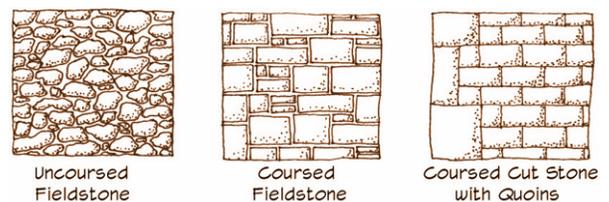
Uncoursed and coursed fieldstone are common building and landscape wall materials in Hopewell Township, particularly for foundation walls. There are fewer cases of cut stone walls. Quoins are large rectangular stones located at a building's outside corners. Historically, quoins were used in a variety of bonding patterns including fieldstone.

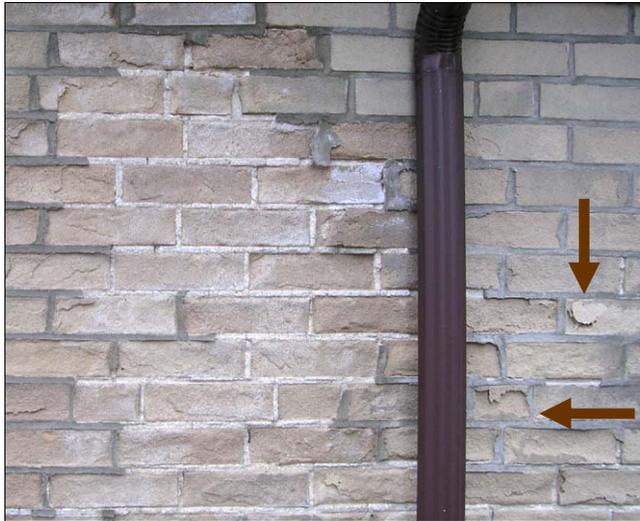
The surface of the bricks are peeling off or delaminating due to continuous moisture from a faulty gutter and downspout as well as the application of hard Portland cement based mortar.

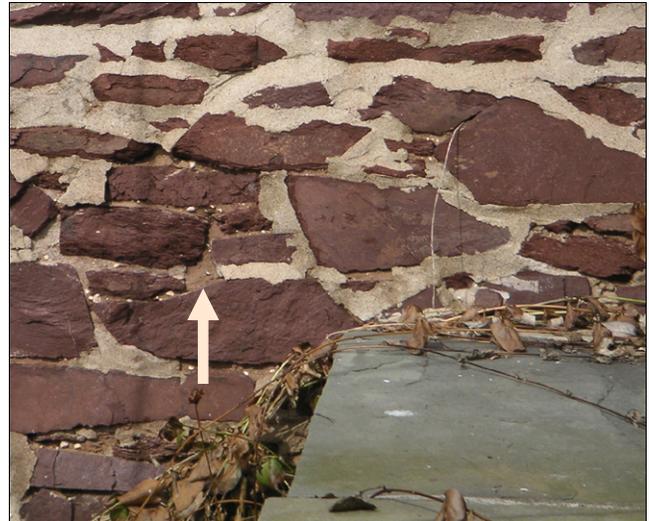
There is a stark difference in color between the more recent repointing and the underlying historic mortar, as indicated by the arrow. The newer mortar has been installed with butter joints smeared over the existing mortar without proper keying and obscuring the stone edges. The newer mortar also appears to have a high Portland cement content, making it harder than the underlying mortar and increasing the possibility of spalling.

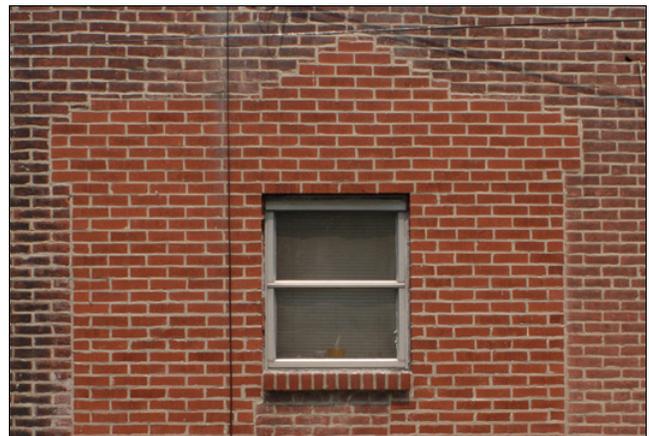
The brick in-fill area is very visible and outlined by a thicker mortar joint. The replacement bricks are not keyed into adjacent brickwork and a different size and color than the historic bricks.

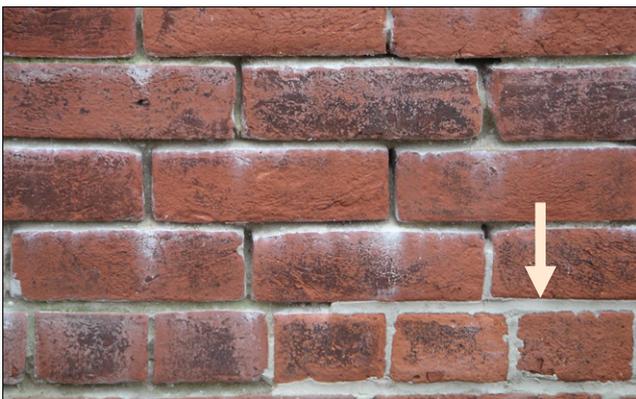
The mortar between the bricks has deteriorated particularly at the vertical joints, increasing the potential for moisture infiltration. The area at the lower right of the photograph has been recently repointed and mortar smeared rather than tooled.

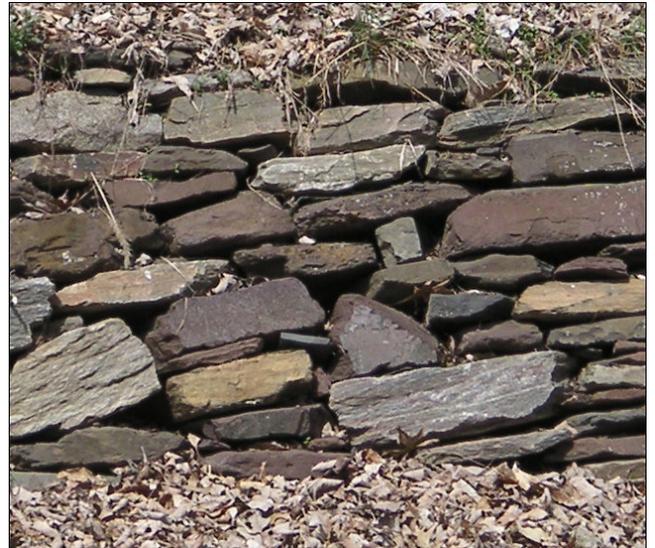
In rare cases, such as this random stone retaining wall, the masonry should not be pointed. The open joints allow the moisture and storm water collected in the soil behind the wall to permeate through the wall, minimizing the potential for bulging and collapse of the wall from seasonal freezing and thawing.

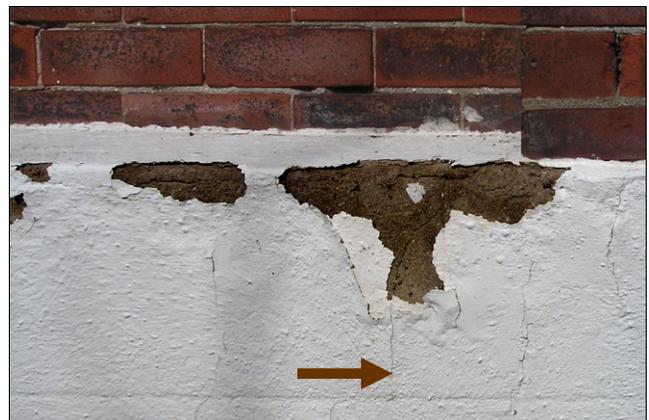
The peeling paint, surface delamination and cracking of the stucco surface can promote or be caused by moisture infiltration. Before repairing the stucco, possible sources of moisture infiltration such as deteriorated gutters and downspouts should be investigated. The loose and flaking paint should be removed and cause for peeling determined before repointing.

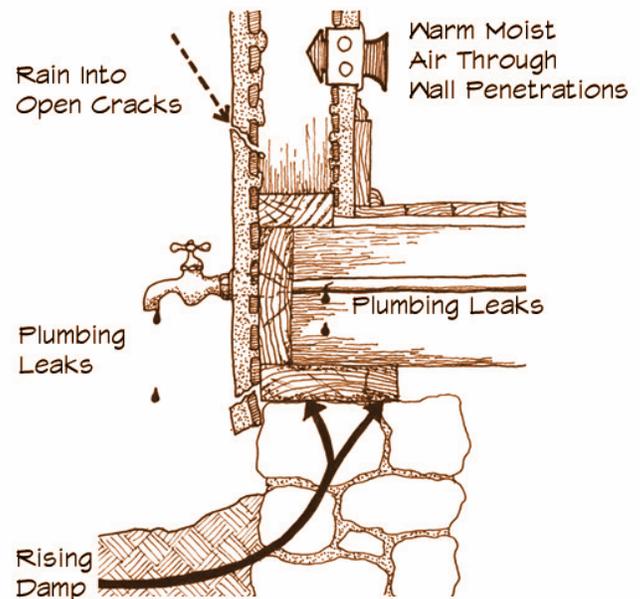
Stucco walls are affected by similar sources of moisture infiltration as stone and brick walls. Trapped moisture within a wall or floor framing system can lead to wood rot, mold and insect damage.

Rain and Precipitation can enter stucco walls through damaged or cracked surfaces and crevices with adjacent materials including window and door frames.

Rising Damp is the migration of moisture from the soil into the building structure through capillary action. The soil adjacent to the foundation can become saturated through improper drainage from gutters and downspouts and vegetation planted adjacent to the foundation.

Plumbing Leaks include piping as well as bathroom fixtures, kitchen and laundry appliances.

Condensation occurs when warm moist air from bathrooms, kitchens and laundry facilities comes in contact with cold surfaces and changes to water droplets.

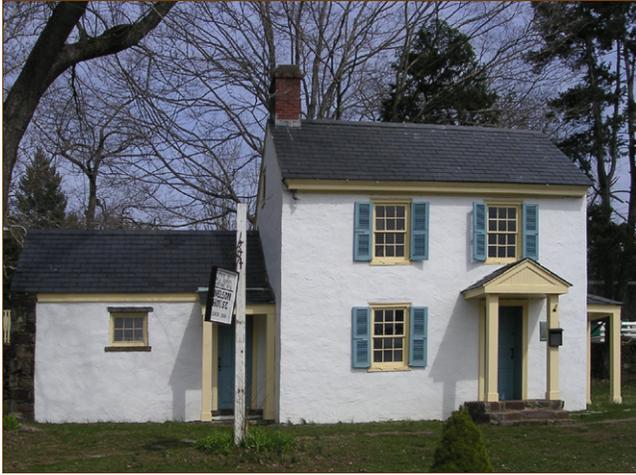
The irregularity of the stucco surface suggests the underlying wall is constructed of uncoursed fieldstone and any future repairs should match the texture.

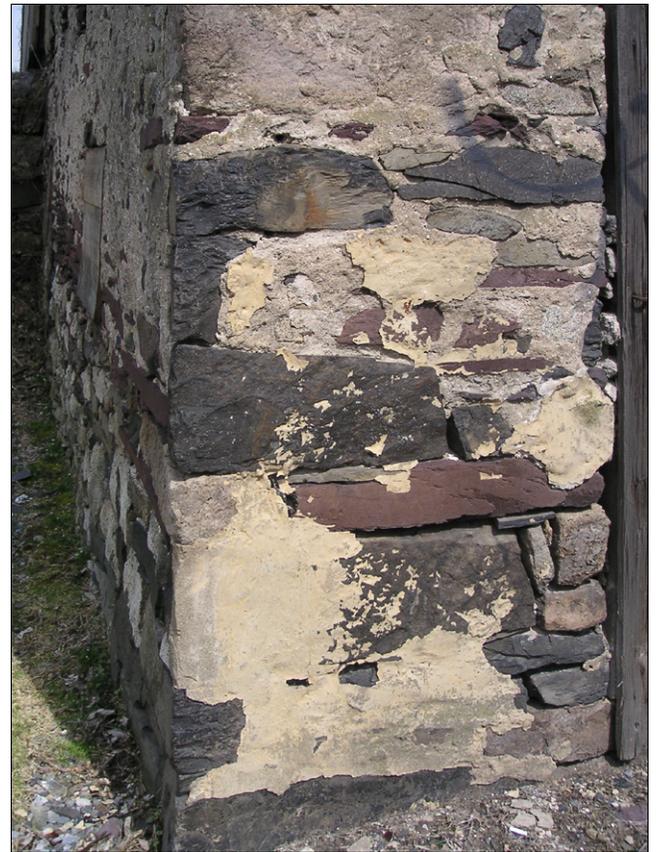
The stucco surface and some of the pointing mortar have worn off of the lower portion of this uncoursed fieldstone wall increasing the possibility of moisture infiltration and further deterioration.

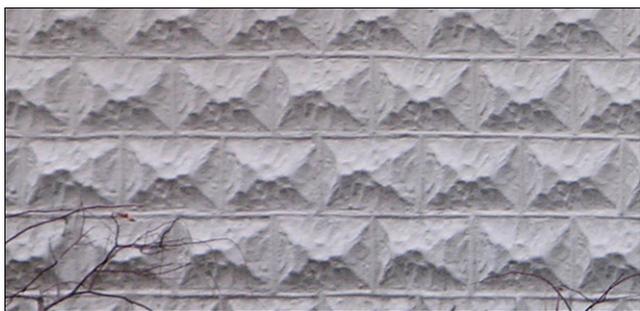
Rusticated concrete block was a popular building material of the early twentieth century.

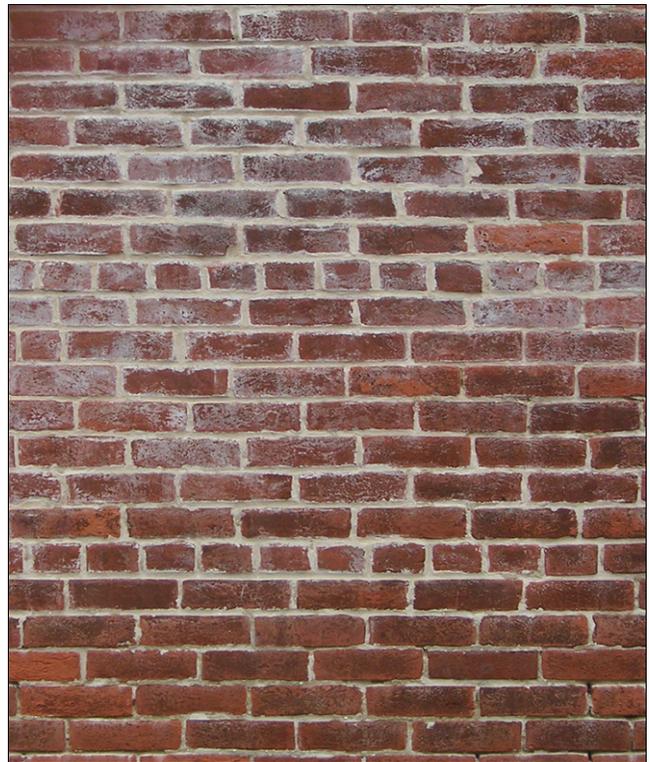
Efflorescence is clearly visible on the brick wall. It is typically evident as a white powdery substance on a masonry surface. The ongoing presence of salts can increase the propensity of crystallization and masonry spalling.
