Township of Hopewell Historic Preservation Commission

GUIDELINES FOR ARCHITECTURAL STYLES

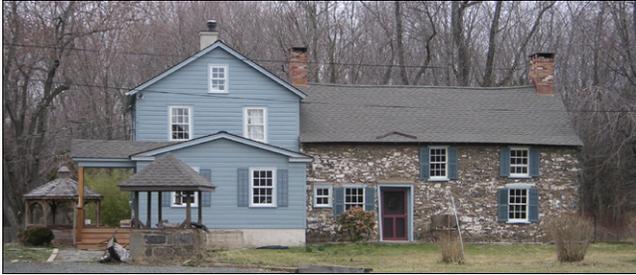
The Jeremiah Van Dyke House is an early 18th century Dutch Colonial dwelling with a later wood framed addition.

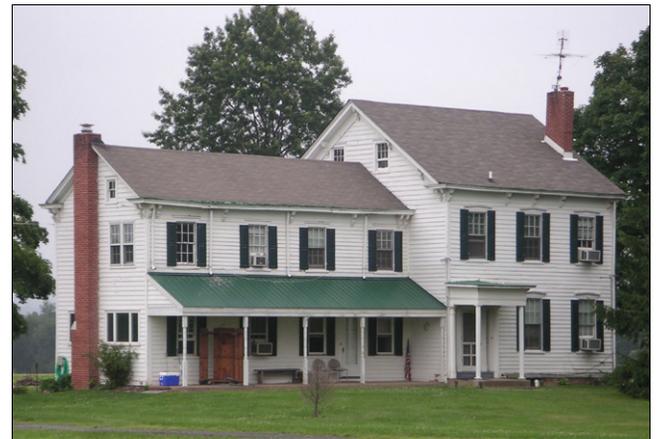
This Federal house on Scotch Road has brackets at the roof eave and turned wood posts on the left shed roof porch that were probably added as later embellishments.

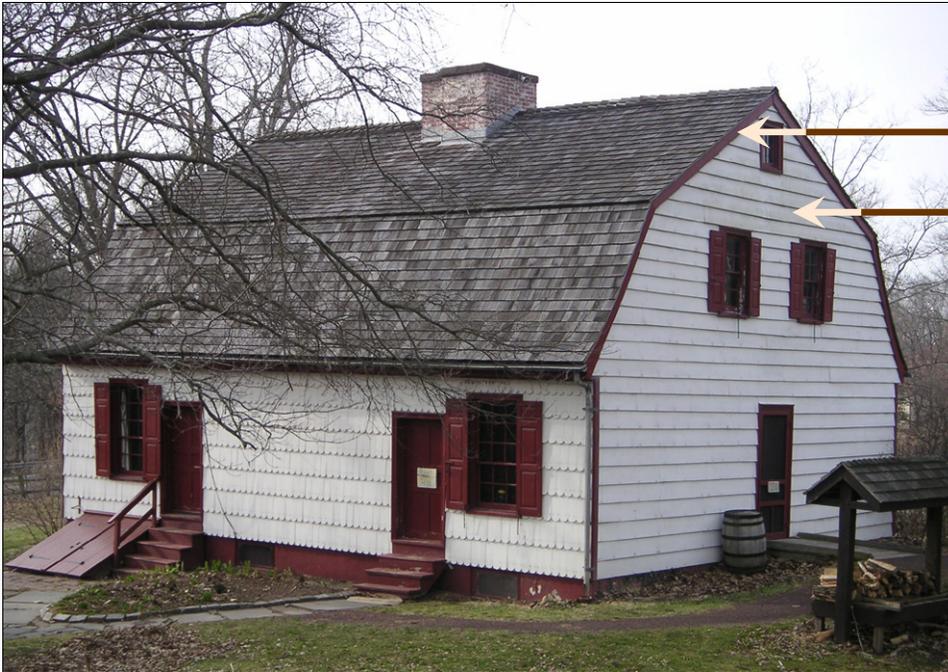
Side gambrel roof form with minimal rake overhang

1½ stories in height

The c. 1740 Johnson Ferry House typifies Dutch Colonial style with its gambrel roof.

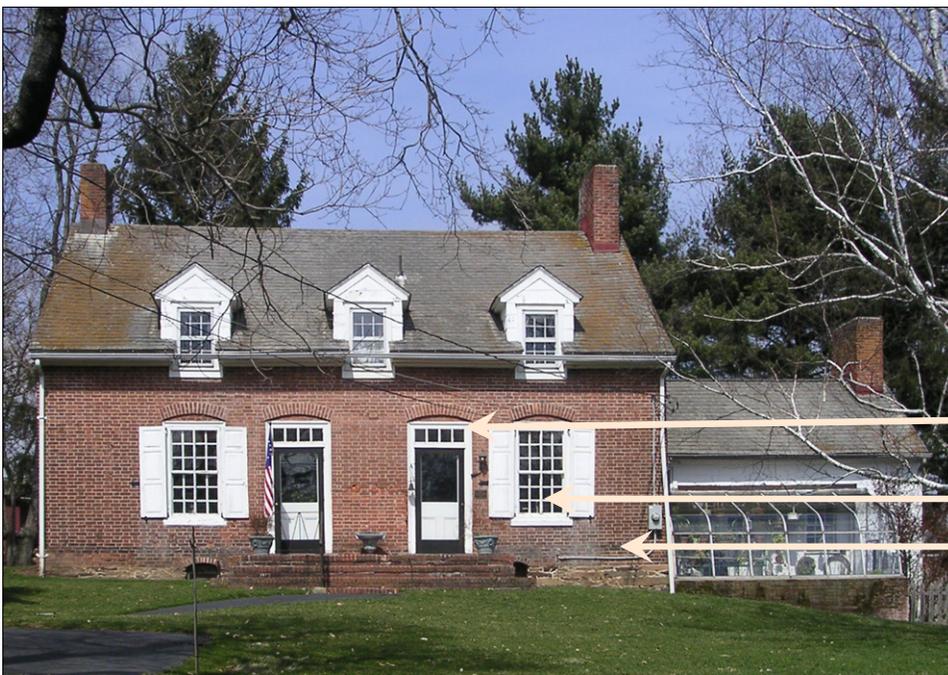
Rectangular transom window over door

12/12 double-hung windows

1½ stories in height, Flemish bond brick pattern

The c. 1765 Jeremiah Woolsey House has an I-shaped plan and combines both Dutch Colonial and later Colonial Revival features such as the dormer windows and later additions.

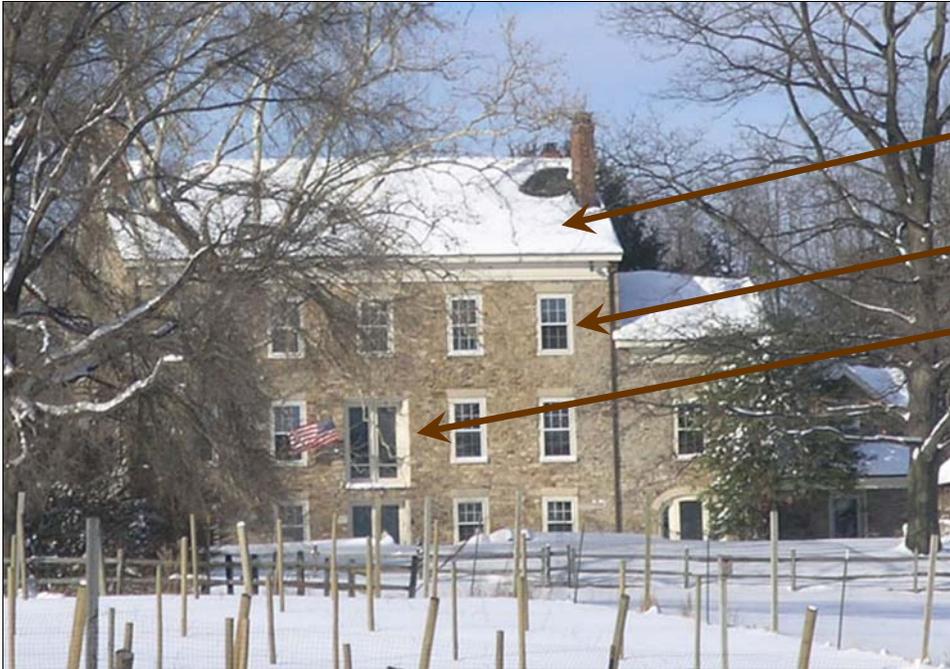
The Georgian style Colonel Joseph Stout House was constructed c. 1752, and shows development of organized window and door openings.

Side gable roof form with chimneys near gable ends and projecting cornice

Individual 6/6 double-hung window sash

Central wood entry at 5-bay façade

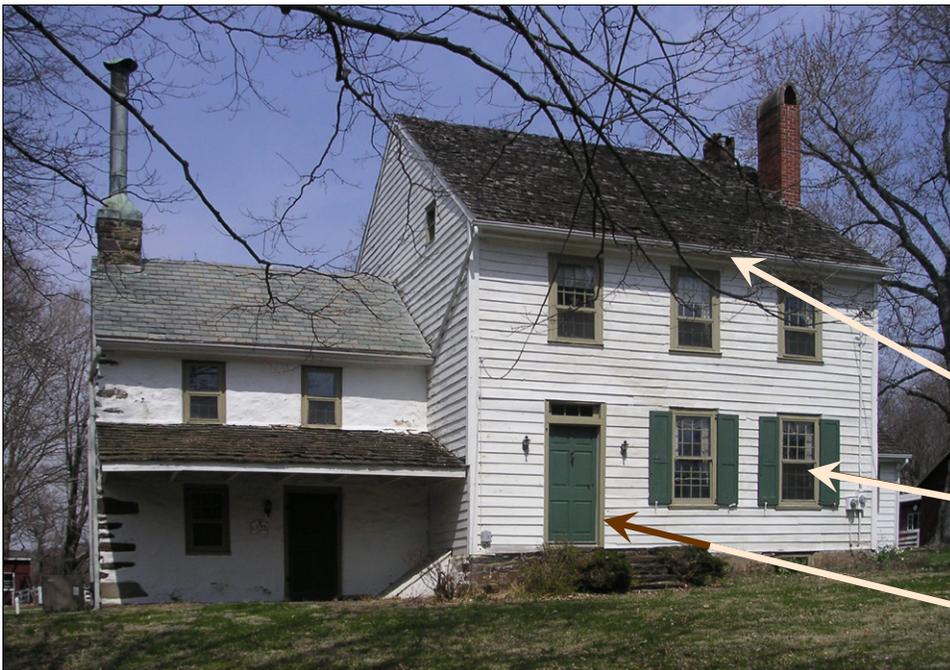
The c. 1785 Federal style Major Henry Phillips House is an example of the cow-and-calf building form.

Side gable roof with chimneys located near the gable ends

12/12 double-hung windows with paneled wood shutters at the first floor

Paneled wood entry door with rectangular transom

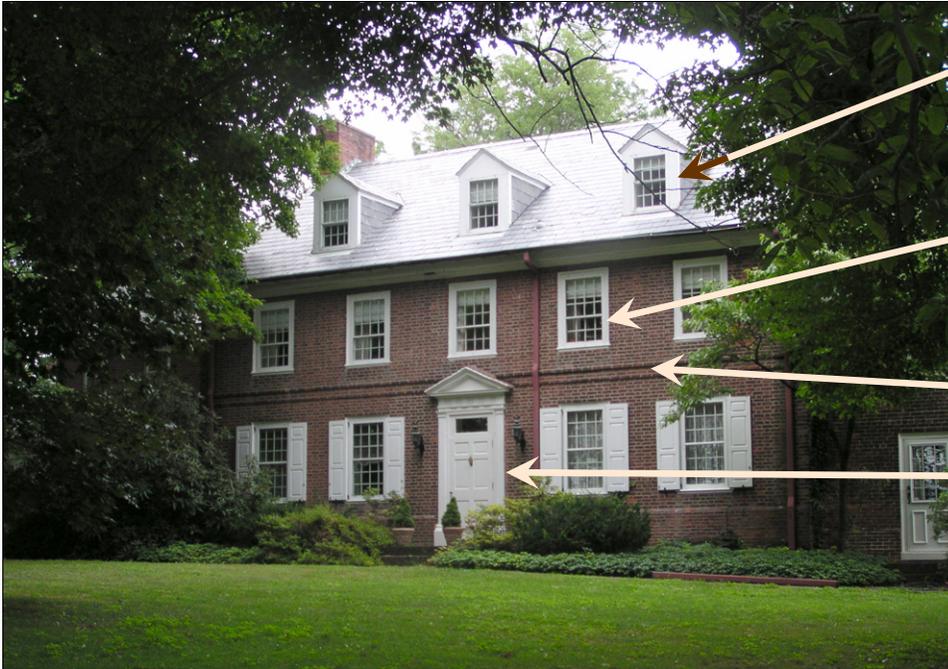
- Side gable roof form with chimneys near gable ends, projecting cornice, and gable roof dormer windows with 8/8 double hung windows
- Individual 12/8 double-hung window sash at the second floor and 12/12 double-hung windows at the first floor with paneled wood shutters
- Symmetrical 5-bay brick façade with a double belt course
- Central paneled wood entry door with rectangular transom and pedimented surround

The c. 1790 Federal style John Burroughs House, is constructed of brick with a double belt course.

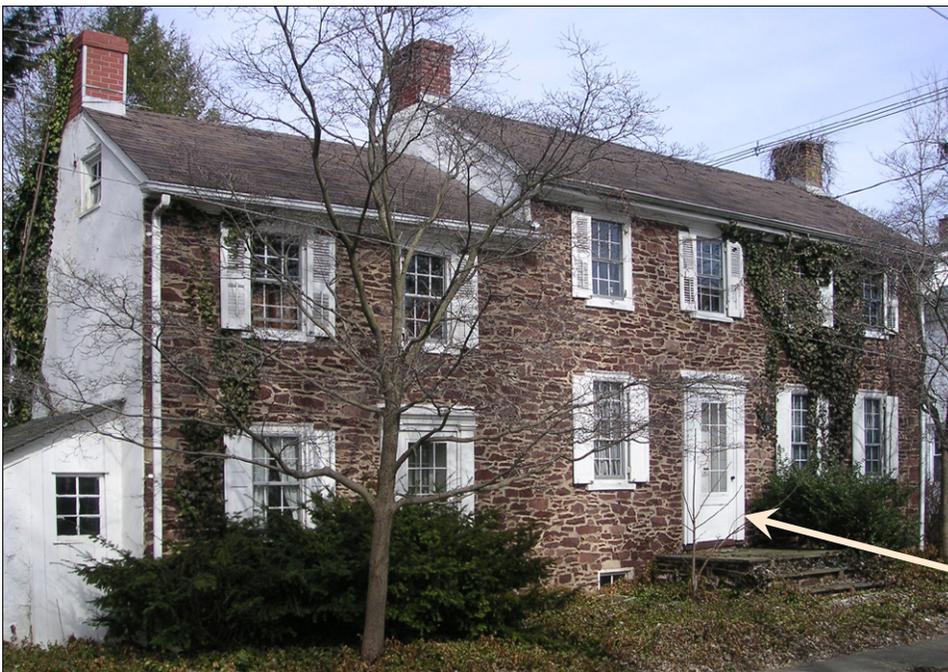
- Central paneled wood entry door with detailed surround

The early 19th century Levi Knowles House in Titusville is typical of this region and constructed of local stone.

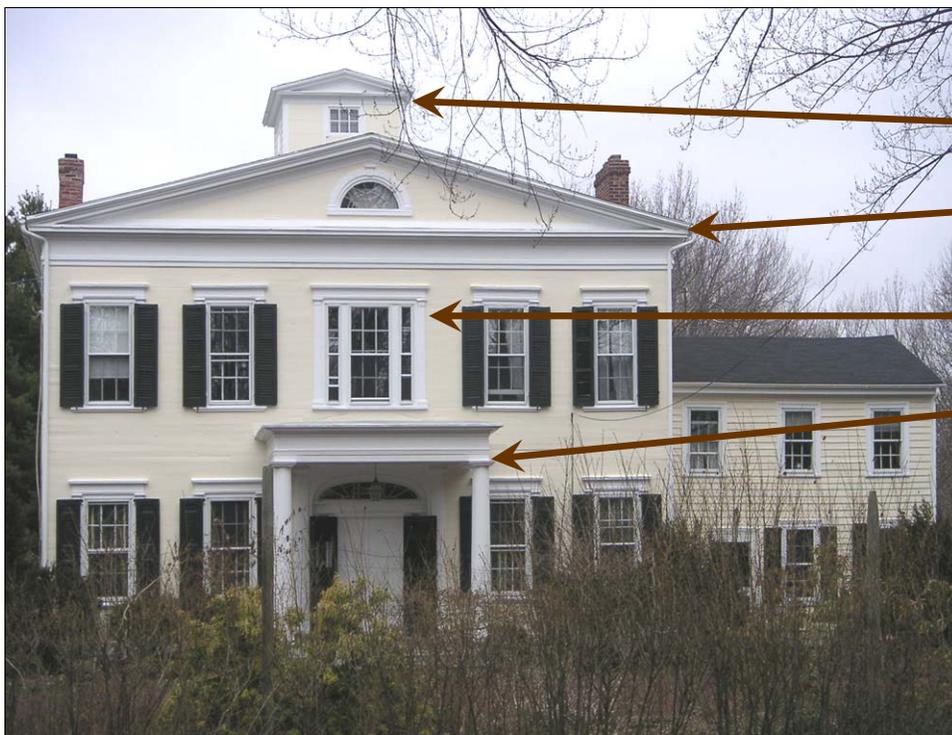
The c. 1835 Ichabod Leigh House typifies the Greek Revival style with its front pedimented gable roof and classical detailing surrounding the windows, with a later clapboard addition.

- ← Front gable roof, square cupola with pediment detailing
- ← Pedimented, low slope front gable roof, cornice emphasized with wide band of trim
- ← Tripartite window with classical detailing at wood surround
- ← 1 story entrance porch supported by un-fluted Doric columns with relatively plain capitals and an emphasized horizontal entablature

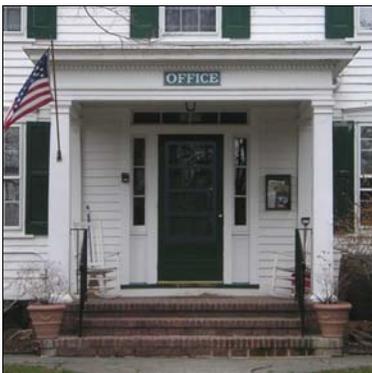
This later porch has Greek Revival detailing including the central porch with prominent, square Doric posts and emphasized entablature, as well as a paneled entry door with narrow sidelights and a transom window above.

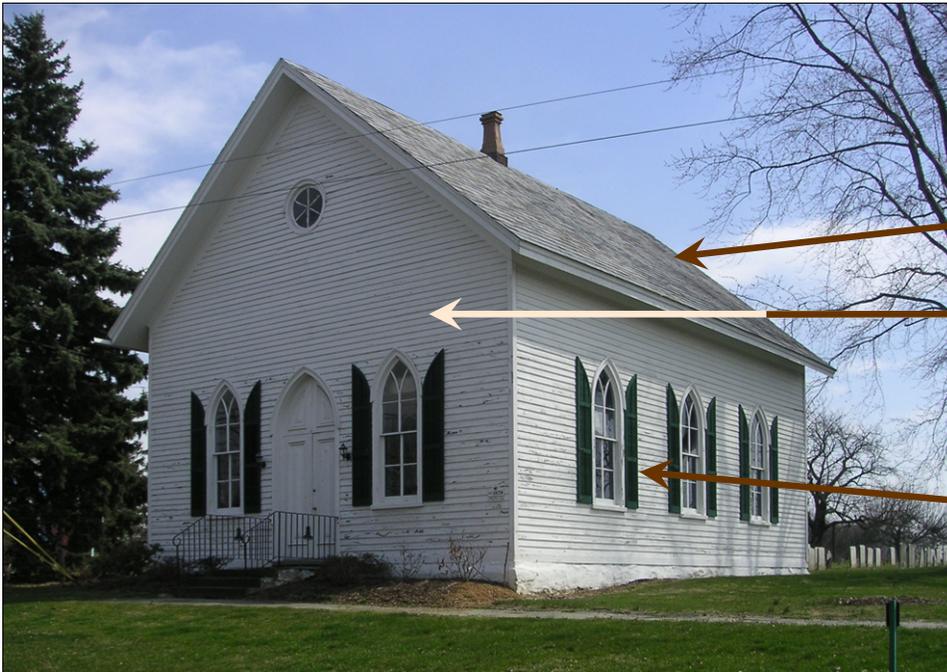
Steeply pitched roof

Front façade is symmetrical and extends into gable without a visible break, such as a change in materials or detailing

Pointed arch lancet windows

The 1879 Harbourton Baptist Church reflects a Gothic Revival chapel style of Protestant architecture which was common in the years following the Civil War.

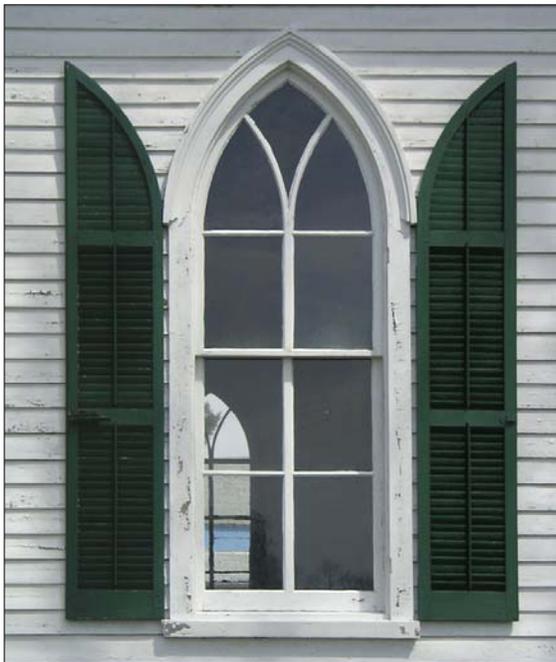
Pointed arched windows, also referred to as lancet windows, are a typical feature of Gothic Revival architecture. This example includes wood louvered shutters.

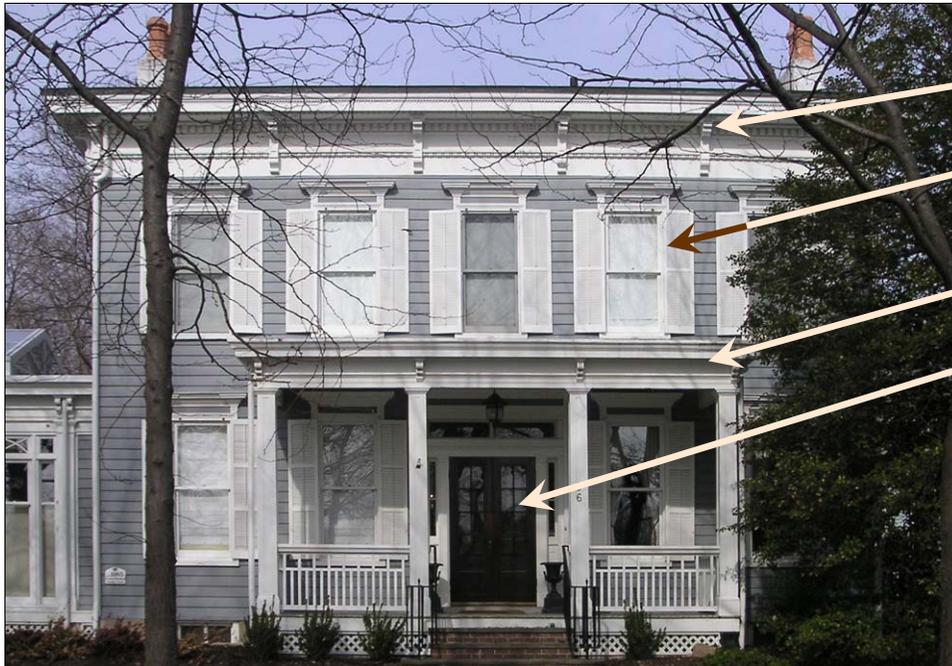
Flat roof with elaborate, overhanging bracketed eaves

2/2 tall, narrow, double-hung windows with elaborate hood molding at symmetrical façade

Restrained entry porch with square wood posts

Central paired entry doors

This Italianate residence has elaborate wood detailing particularly at the eaves and window frames.

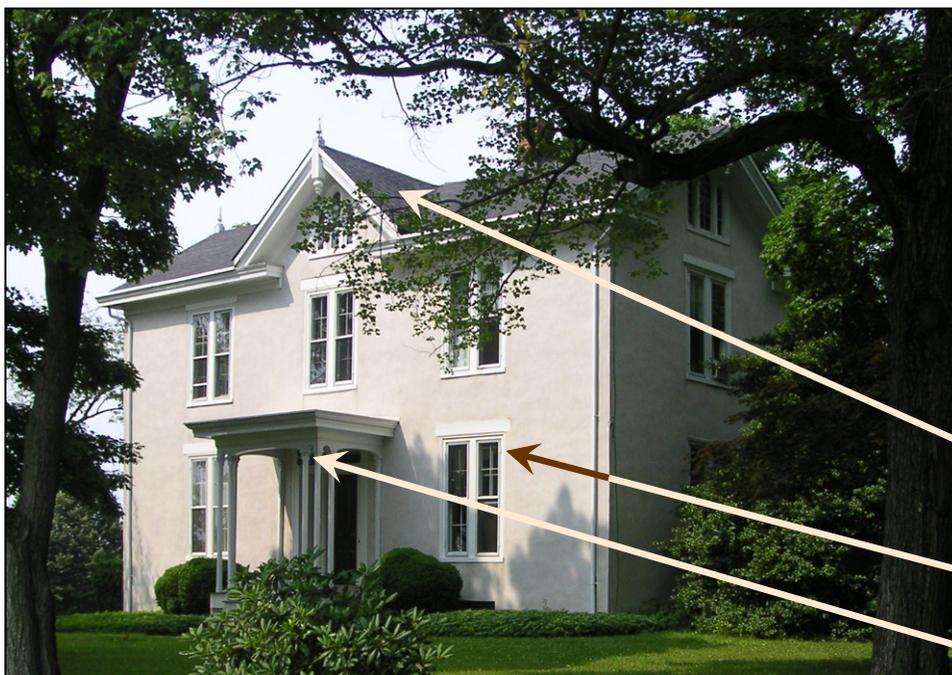
Low-pitched, cross-gabled roof with finial and heavily molded cornices at overhanging eaves

Paired, tall, narrow double-hung windows at symmetrical façade

Restrained entry porch, paired square wood posts, arched lintels

The mid 19th century Burroughs Farmhouse is simpler in design and detailing, and possibly incorporates an earlier 18th century building.

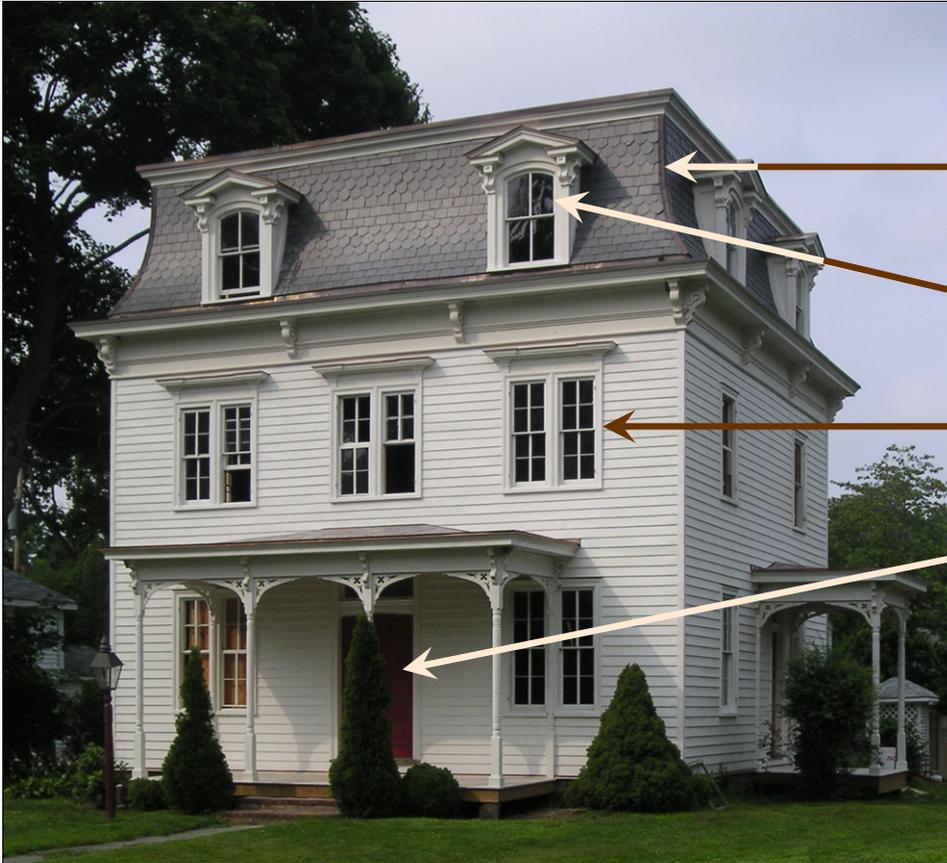
Concave Mansard roof with alternating bands of square and fishscale slates and overhanging, bracketed eaves

Bracketed, gable roof, dormer windows with arched 2/2 double-hung windows

Tall, narrow, paired double-hung windows with elaborate hood molding

Central entry door and shallow hipped roof porch at symmetrical façade

The Mansard roof is a prominent feature of the c. 1870 Bidwell House in Titusville.

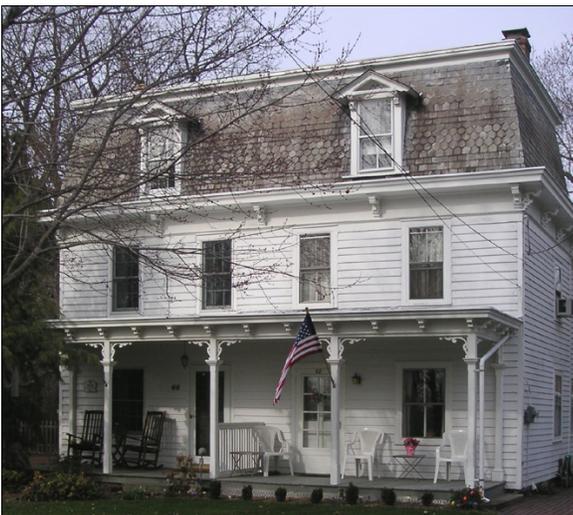
This Mansard roof at this double residence is straight rather than concave as in the Bidwell House above.

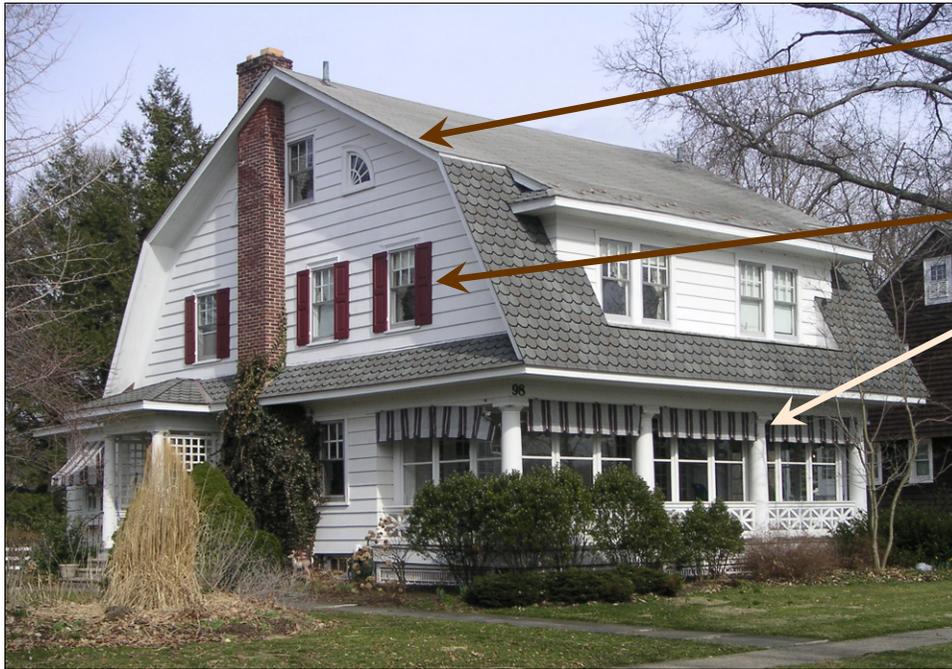
Gambrel roof with overhanging eaves and rake boards has continuous shed roof dormer with paired 6/1 double-hung windows

6/1 double-hung windows with shutters

The full-width porch, now enclosed, is supported by classically inspired columns

Dutch Colonial Revival houses with a continuous shed dormer were popularized in the 1920s.

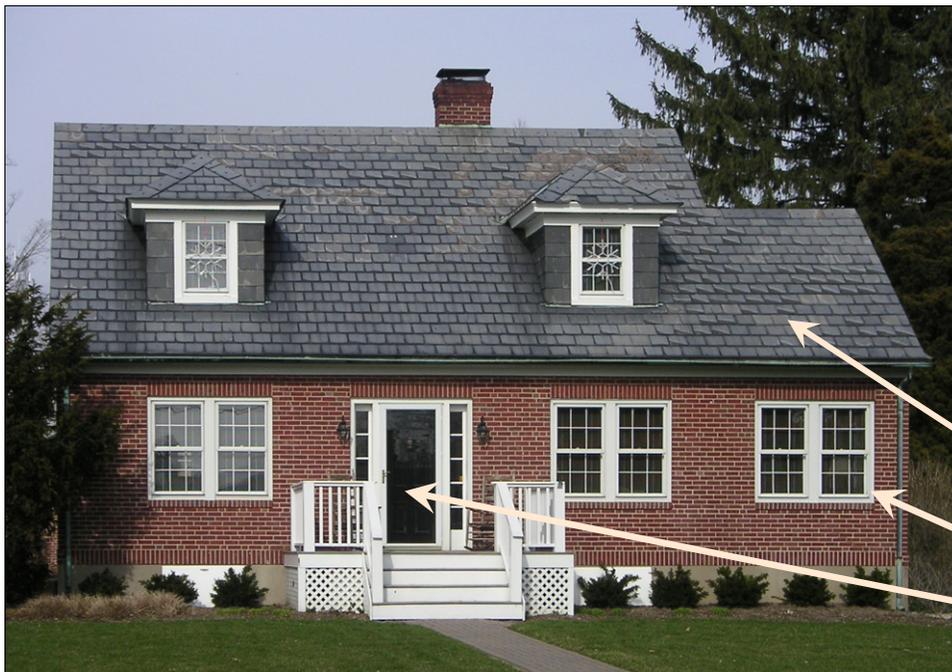
Side gable slate roof with hipped roof dormers

Paired 6/6 windows

Central entry door with sidelights

This modest scale house features Colonial-era materials including brick walls and a slate roof.

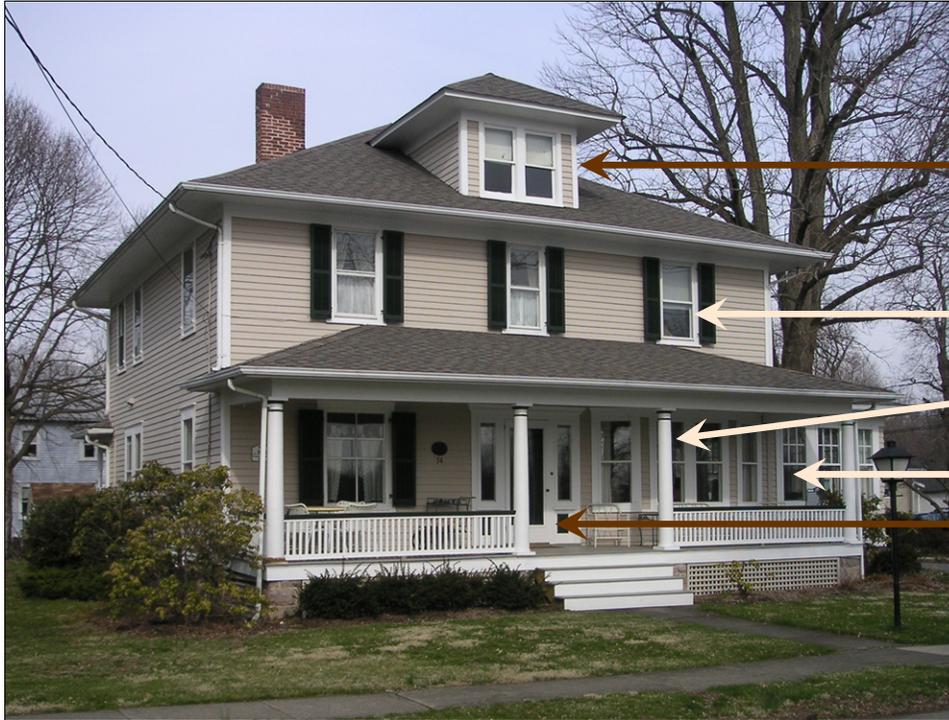
- ← Hipped, pyramidal roof with overhanging eaves and a hipped dormer with paired double-hung windows
- ← Double-hung windows with shutters
- ← Full-width, hipped roof porch supported by Doric columns
- ← Grouped double-hung windows
- ← Accentuated central entry with elaborate surround and sidelights

At 3 bays in width, this is an unusually large example of a Foursquare.

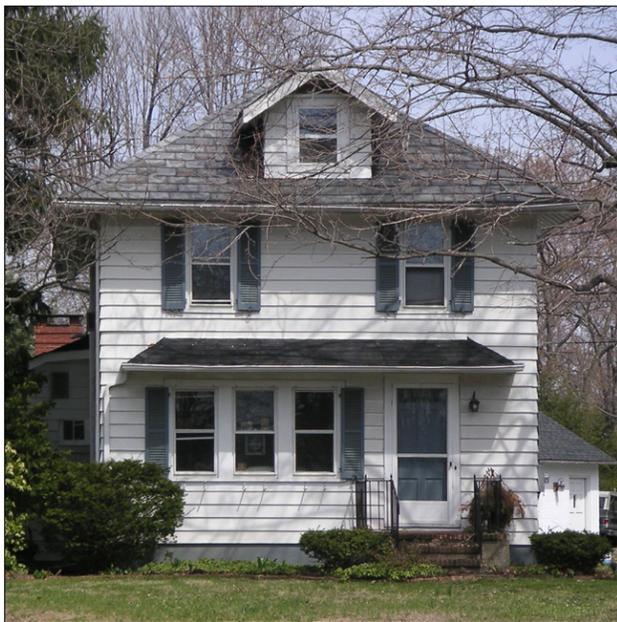
Most Foursquares are two bays wide such as this example. Most Foursquares have a full width porch rather than a pent roof, suggesting this house might have been modified.

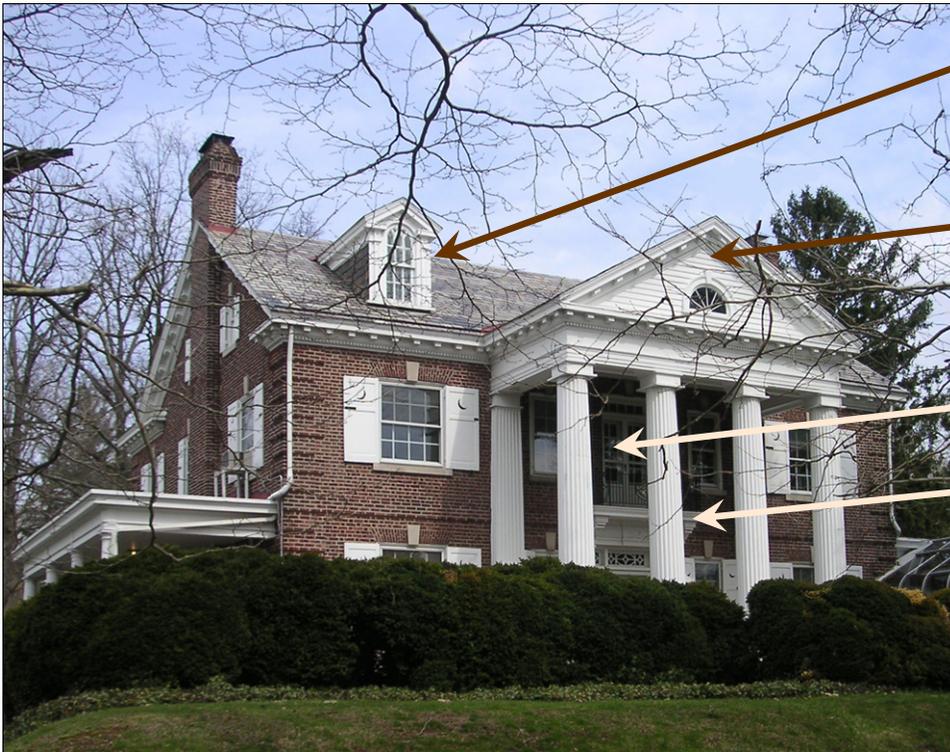
Side gable, slate roof with elaborate pronounced cornice featuring dentils and modillions and gable roof dormers with double-hung windows

Full-height classically inspired entry porch, with fanlight at pediment, supported by fluted columns at center of symmetrical facade

Single and grouped, multi-paned, double-hung windows

Elaborate entrance doors possibly with door hood, transom windows and sidelights

The overall form is typical of Colonial Revival architecture, but the porch and classical detailing distinguish this as a Neoclassical style residence.

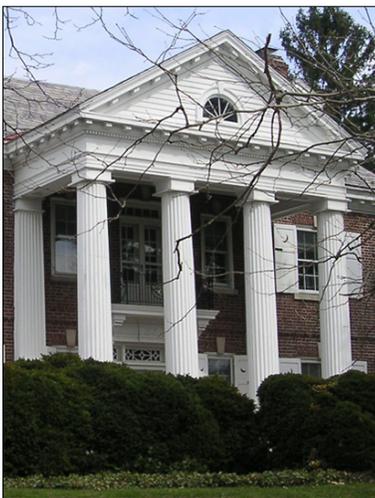
This full-height, classically inspired entrance porch is typical of Neoclassical architecture.

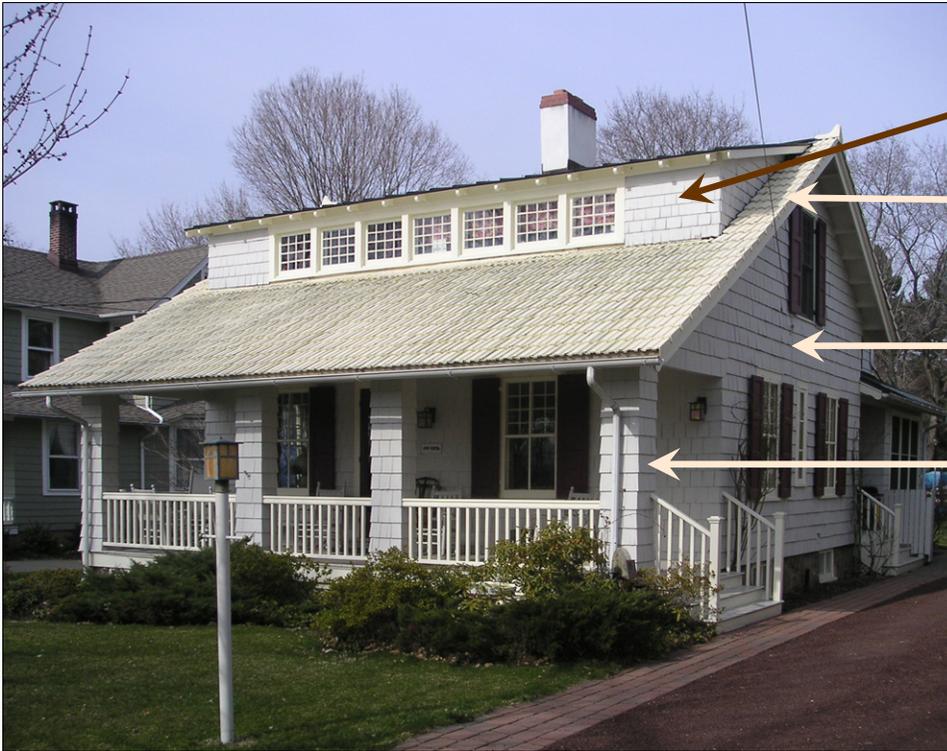
Continuous shallow shed roof dormer with grouped multi-paned casement windows

Accentuated low-pitched gable roof with exposed rafters at overhanging eaves and a prominent chimney

Wood shingle walls and stone foundation with lack of applied detailing

Full-width, recessed porch supported by square piers extending to porch level or ground

Bungalows are not common in Hopewell Township; this example probably dates from the 1920s or 1930s.

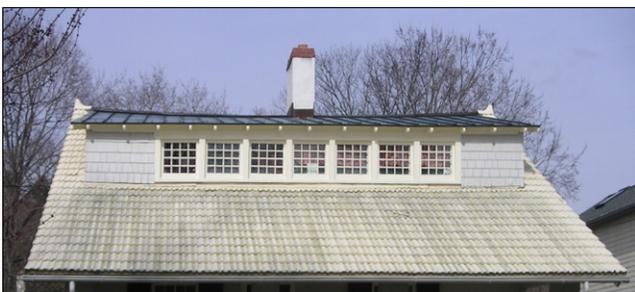
Another unique feature of this house is the concrete shingle roofing.

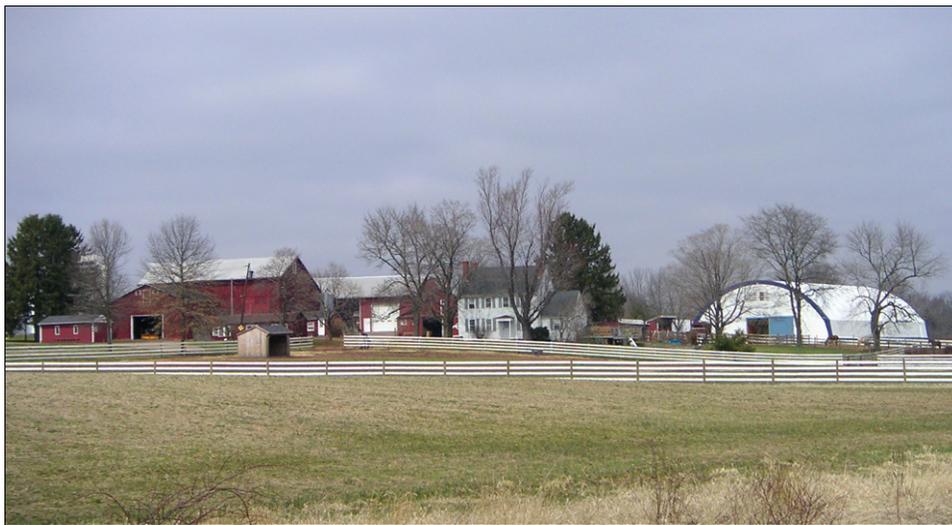
This farm complex includes older and more recent farm related buildings.

Grouped farm related buildings with scattered deciduous trees

Main residential building surrounded by deciduous trees

Building complex surrounded by fields providing long vistas and view sheds

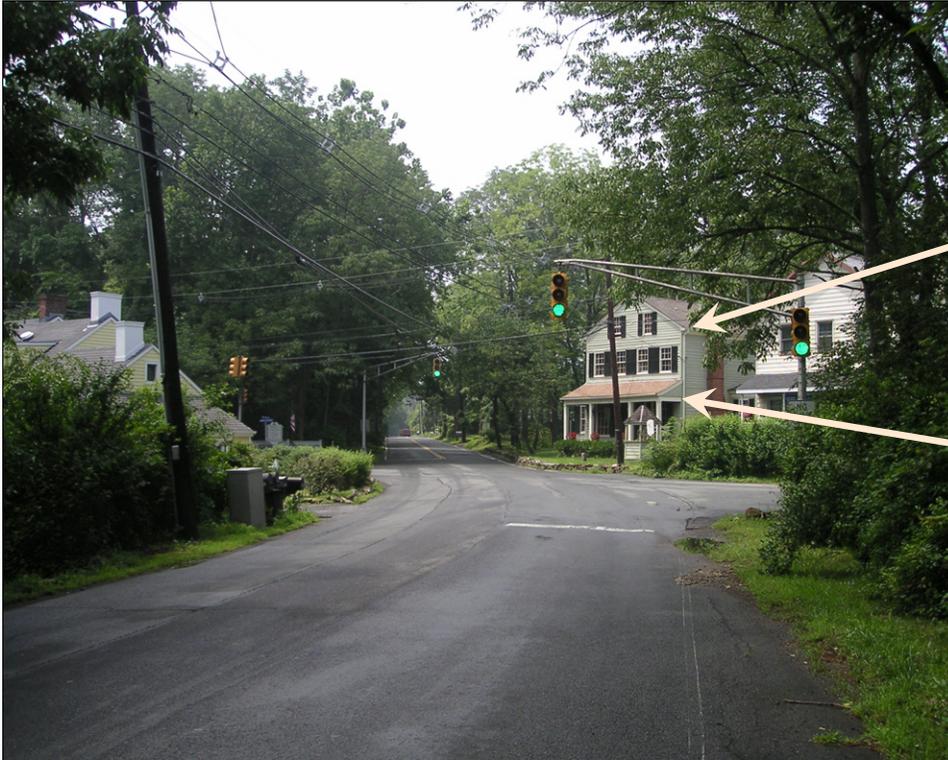
Frame buildings, with later additions, are in proximity to roadway on relatively small sites with a mature deciduous tree canopy with parking and secondary structures located at the rear of main buildings

Adaptive reuse of buildings such as this former general store that is now used as an office

Mount Rose developed in the 19th century as a crossroads village community.

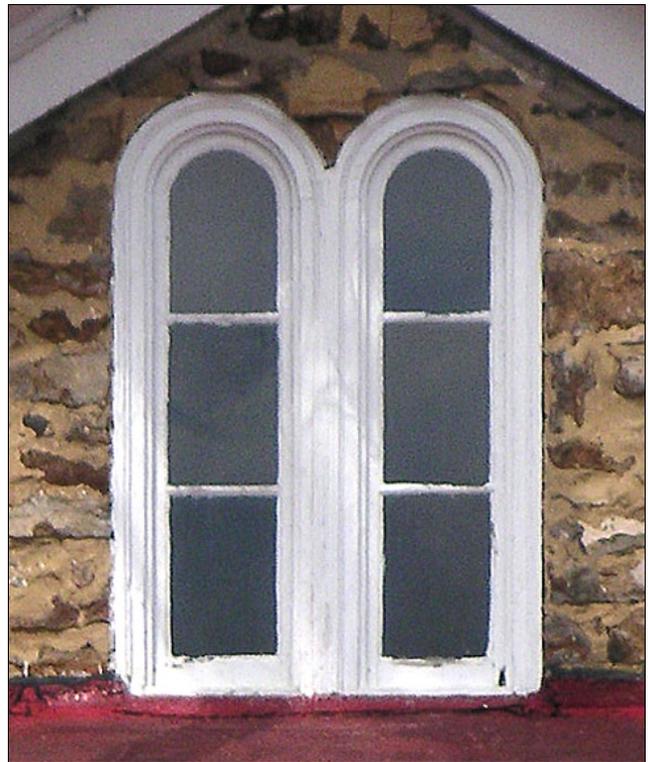
The paired arched windows at the front gable of the former Marshalls Corner Schoolhouse suggest Italianate influences.
